Homeowner Grant Program

1432 "W" Street, SE

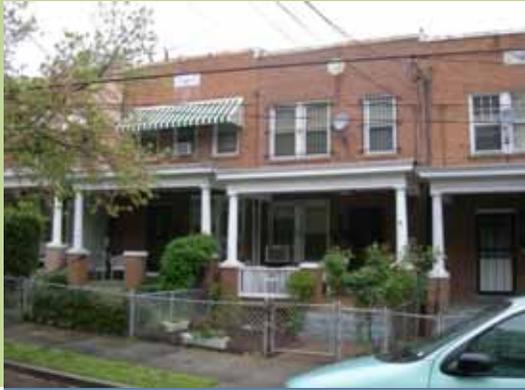
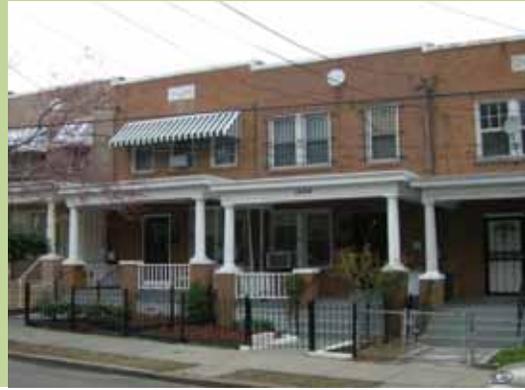
Removed the existing rotted front porch floor, including deteriorated structural support systems, severely deteriorated front porch columns and cornice elements, the existing metal porch railings and entry step pipe rail. Remove the existing broken concrete entry walk, the existing concrete stairs & chain link fence. The existing historic roof was raised, stabilized and re-attached to the house. The existing flat metal roof on the porch was cleaned, spot patched and coated with new HYDRO STOP roofing/waterproofing system, Restored the existing turned wood porch columns, wood porch beams, historic beaded wood ceiling,

fascia, cornice mouldings. Replaced the 3 1/4" finished wood floor and sub structure and under porch lattice enclosure. Install new wood rail and square picket system, *Smoot SM-8840 top rail, LWM-237 balusters spaced @ 4" o.c. and SM-8841 bottom rail*. Restored the existing front door. Provided a new decorative iron handrail on each side of the new concrete porch steps. Installed a new loop and post iron fence and gate along the street front and on the north side yard lines only. Provide new poured concrete walk to replace the existing broken walkway. Install in the same location, same width and general layout
