**HISTORIC PRESERVATION REVIEW BOARD
STAFF REPORT AND RECOMMENDATION**

Property Address:	515 Cedar Street, NW	X	Agenda
Landmark/District:	Takoma Park Historic District		Consent Calendar
Meeting Date:	July 1, 2021	X	Concept Review
H.P.A. Number:	21-373		Alteration
Staff Reviewer:	Steve Callcott	X	New Construction
			Demolition
			Subdivision

Applicant MSP1 LLC, with plans prepared by Main Street Design, seeks concept review for construction of a two-story frame house on a vacant lot in the Takoma Park Historic District.

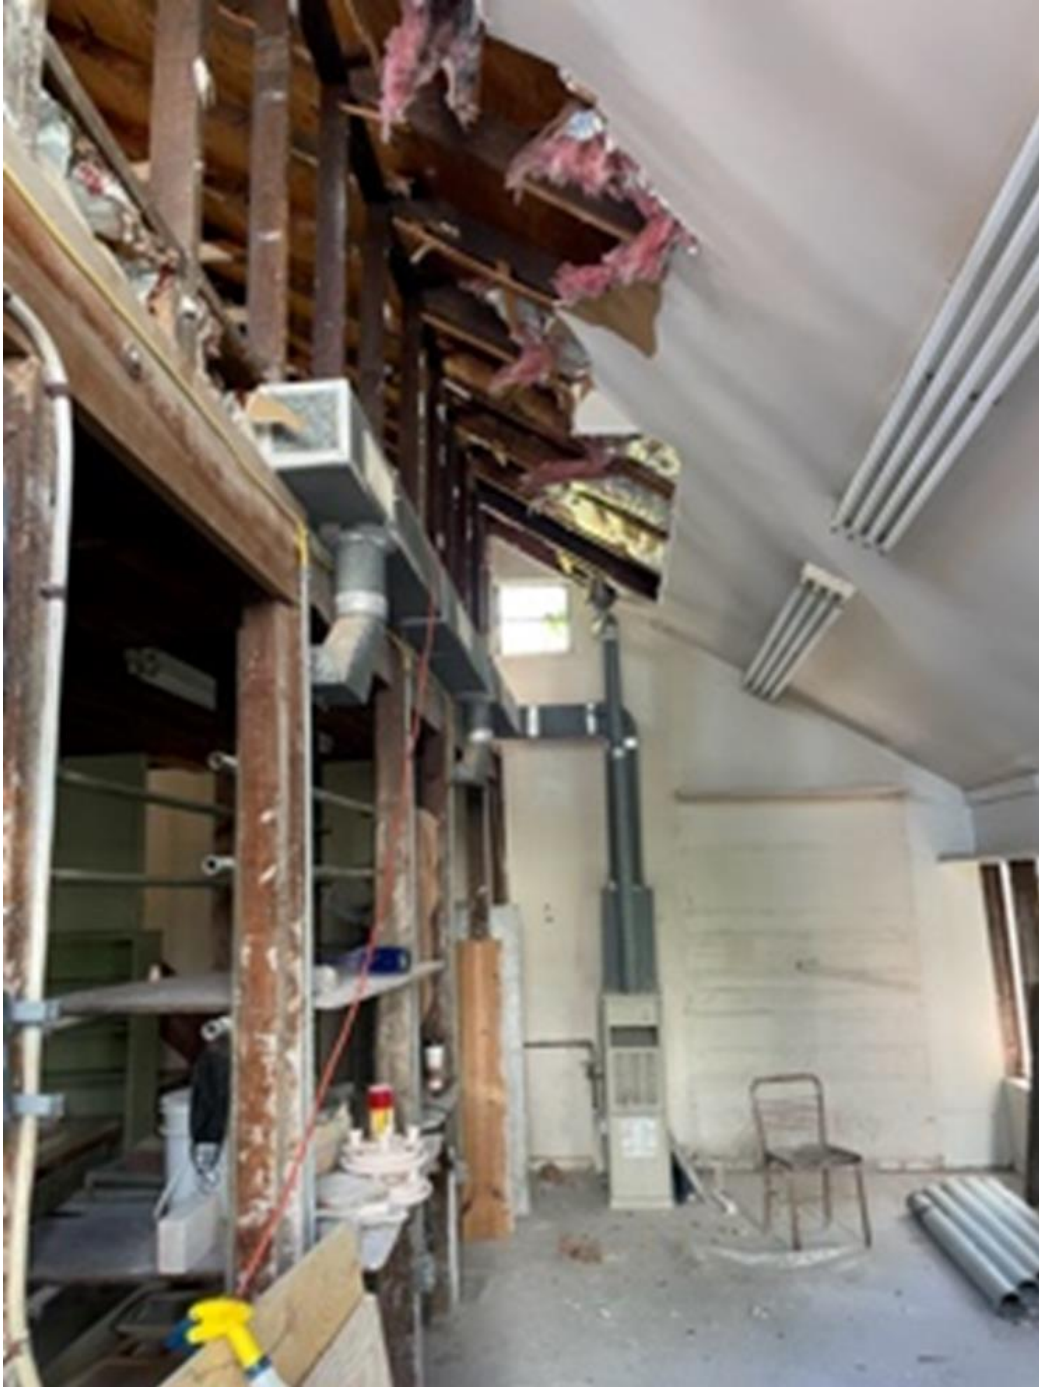
While the outbuilding at 515 Cedar is an unusual structure and it is possible that portions of it may date from the period of significance for the historic district (1883-1940), the building's extensive alterations and overall condition do not warrant classifying it as a contributing building to the historic district.

Interior of outbuilding at 515 Cedar showing older wall framing and newer roof framing. The older framing elements are of different sizes, possibly indicating that they were reclaimed and reused.

HPO recommends that the Board find the existing outbuilding at 515 Cedar to non-contributing to the historic district and that the design be further developed as outlined above and return to the Board for further review when ready.

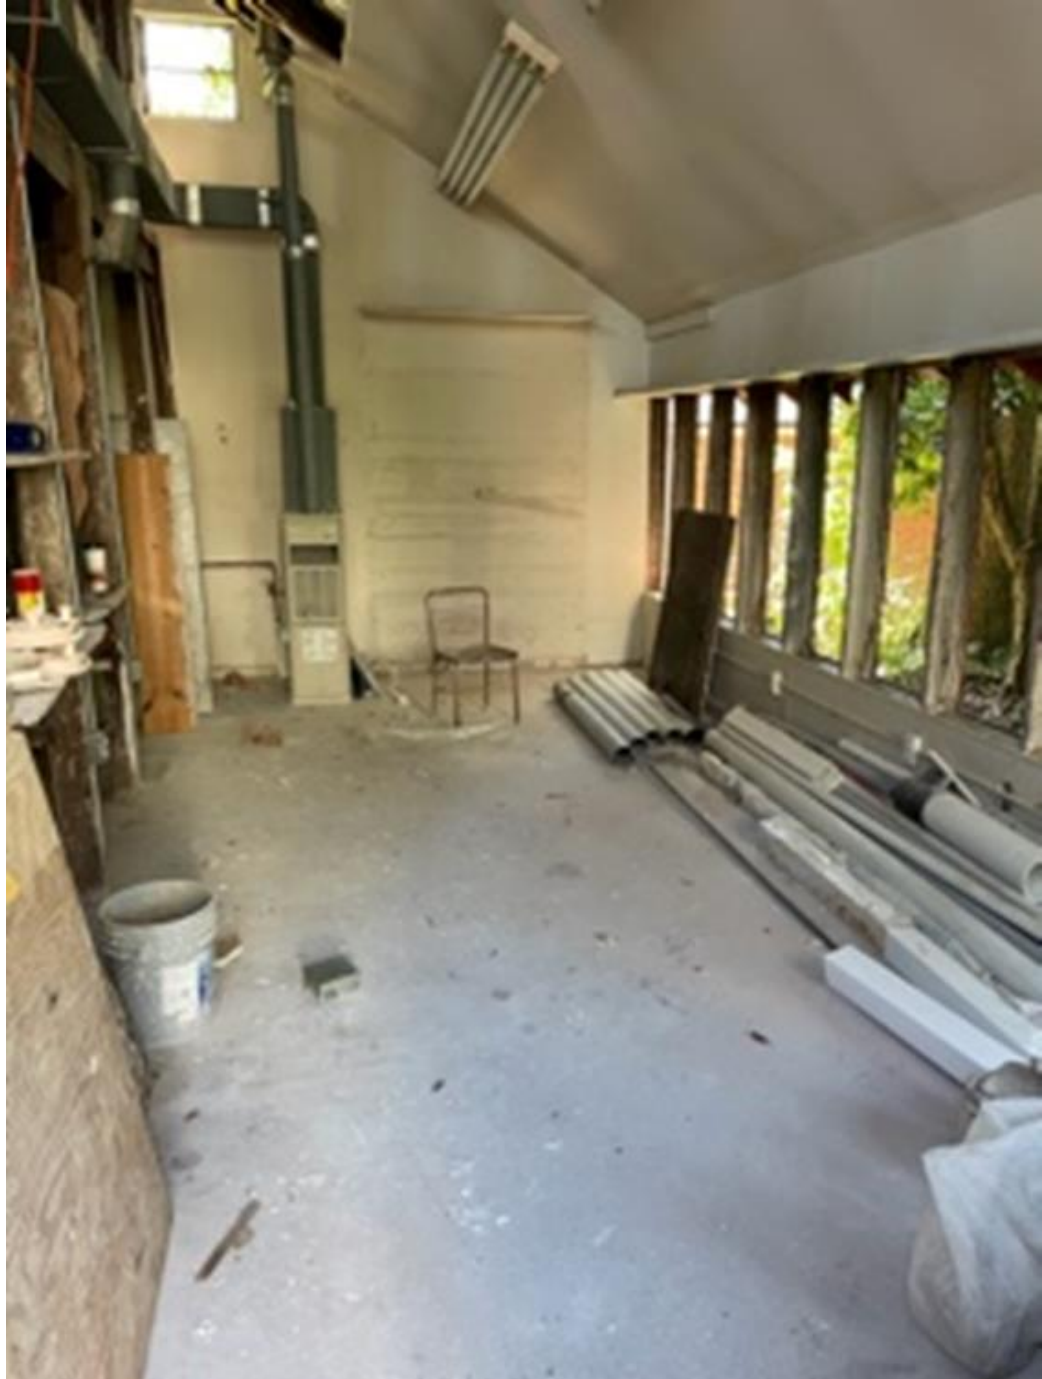
Modern concrete floor and foundation of 515 Cedar outbuilding

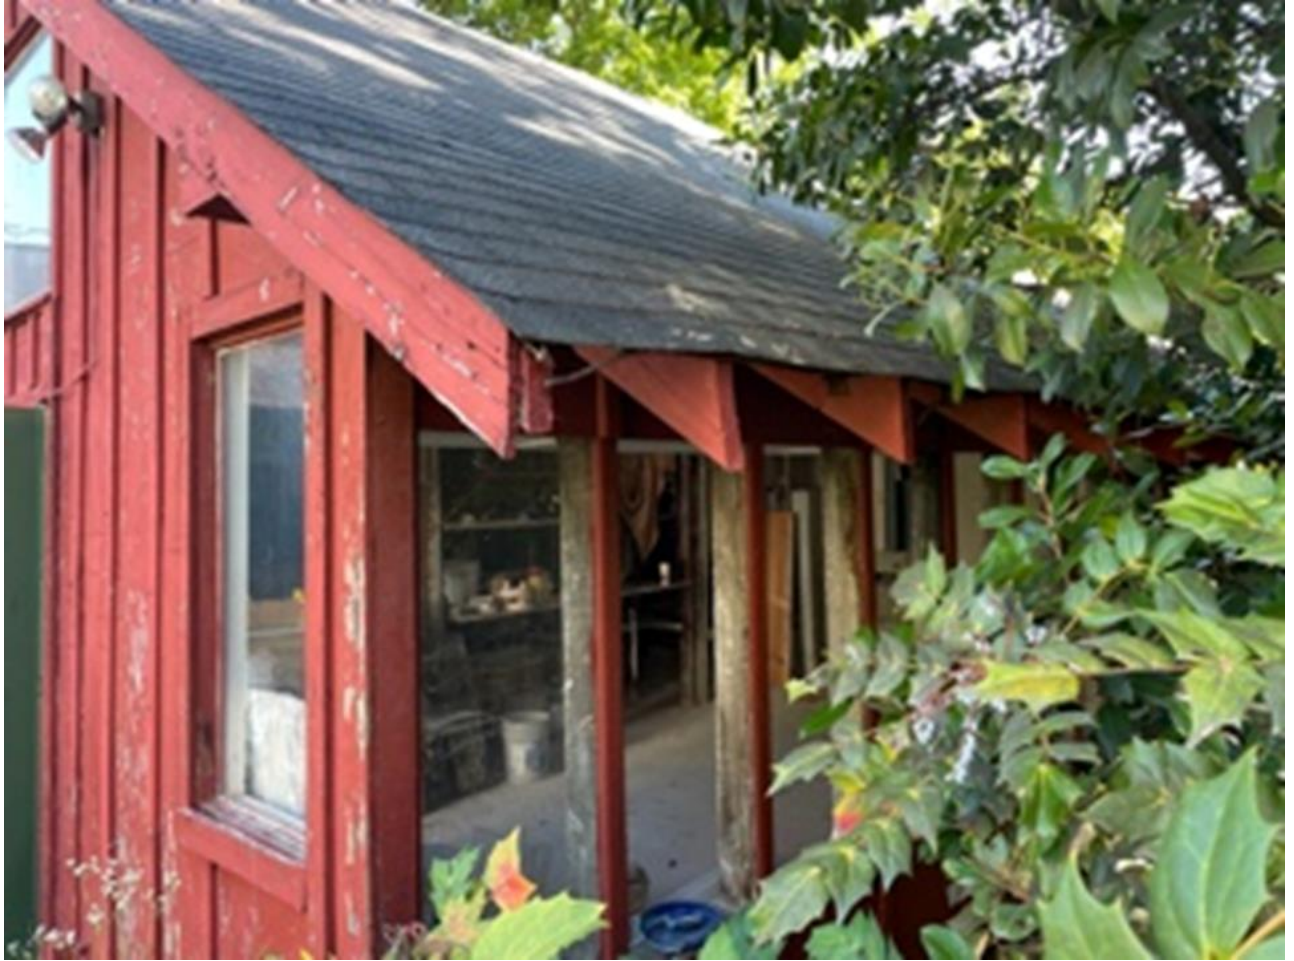
Modern roof framing and plexiglass windows at 515 Cedar outbuilding
