# HISTORIC PRESERVATION REVIEW BOARD STAFF REPORT AND RECOMMENDATION

Address: 420 11<sup>th</sup> Street SE () Consent ANC: 6B (x) Concept

Case Number: 21-253 ( ) Demolition

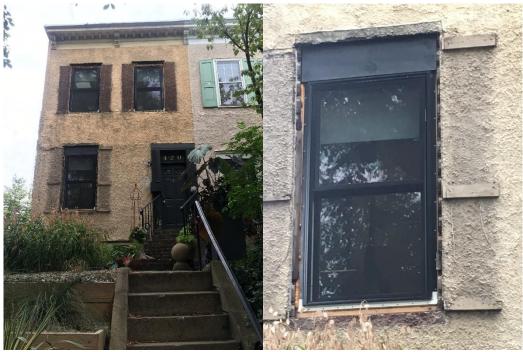
Front elevation of 420 11th St SE, detail of first story replacement window (photo date 10-09-2019)

The windows that were in situ prior to the 2019 window replacement were not the original windows. Based on the age of the building, the original windows would have likely been wood multi-pane windows. Six-over-six double-hung sash are most likely, although a two-over-two configuration could also have been possible- both with flat window casings. Per 2305.11 *If the existing windows in an historic building are not historic windows, replacement windows should be consistent with the historic window design if known, or should be consistent with the period of the building and compatible with its general historic character.* The existing windows that were installed without permit do not meet the Regulations. The windows should be replaced, with the required building permit being obtained, with either 6/6 or 2/2 wood windows consistent with the Preservation Regulations and the Board's Window Repair and Replacement Preservation and Design Guidelines.

The outstanding unpermitted windows should be addressed and corrected before new work is permitted. Once the windows have been corrected, the HPO recommends the Board find the project for a rear addition and alterations to be compatible with the Capitol Hill Historic District, with conditions that the parapet walls of the addition roof deck and the front door design be revised, and delegate final approval to staff

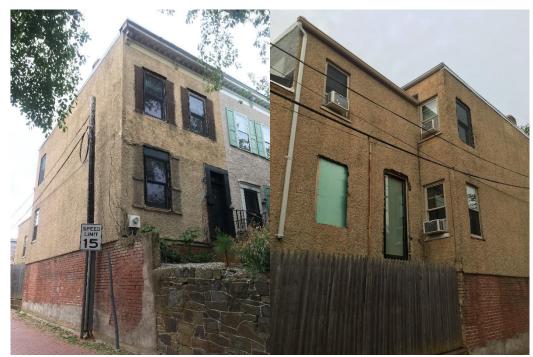
North elevation along Walker Court SE (photo date 10-09-2019)

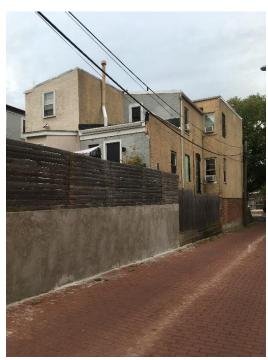
Rear elevation as seen from Walker Court SE (photo date 10-09-2019)
