**HISTORIC PRESERVATION REVIEW BOARD
STAFF REPORT AND RECOMMENDATION**

Landmark/District: **Anacostia Historic District** (x) Agenda
Address: **1340 Maple View Place SE**

Meeting Date: **June 23, 2016**
Case Number: **16-439** (x) Alteration

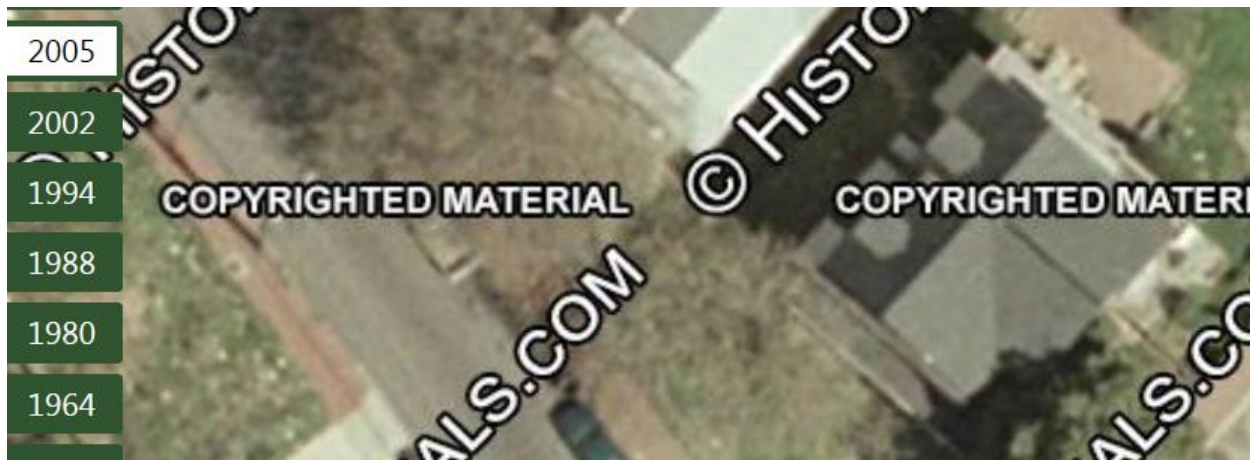
Courtesy of HistoricAerials.com

According to the records of the D.C. Recorder of Deeds, the property owner purchased the house in 1985.¹ The eave on the side of the house was extended and a deck built on top after 2005, when the aerial photograph below was taken.² The dormers were modified to take multi-light doors in order to facilitate access to the deck. A knee wall was constructed between the dormers. The records of the Department of Consumer and Regulatory Affairs show no permits issued for this type of work.³

² The photo clearly shows the eave projection the same along the entire northwest side of the house.

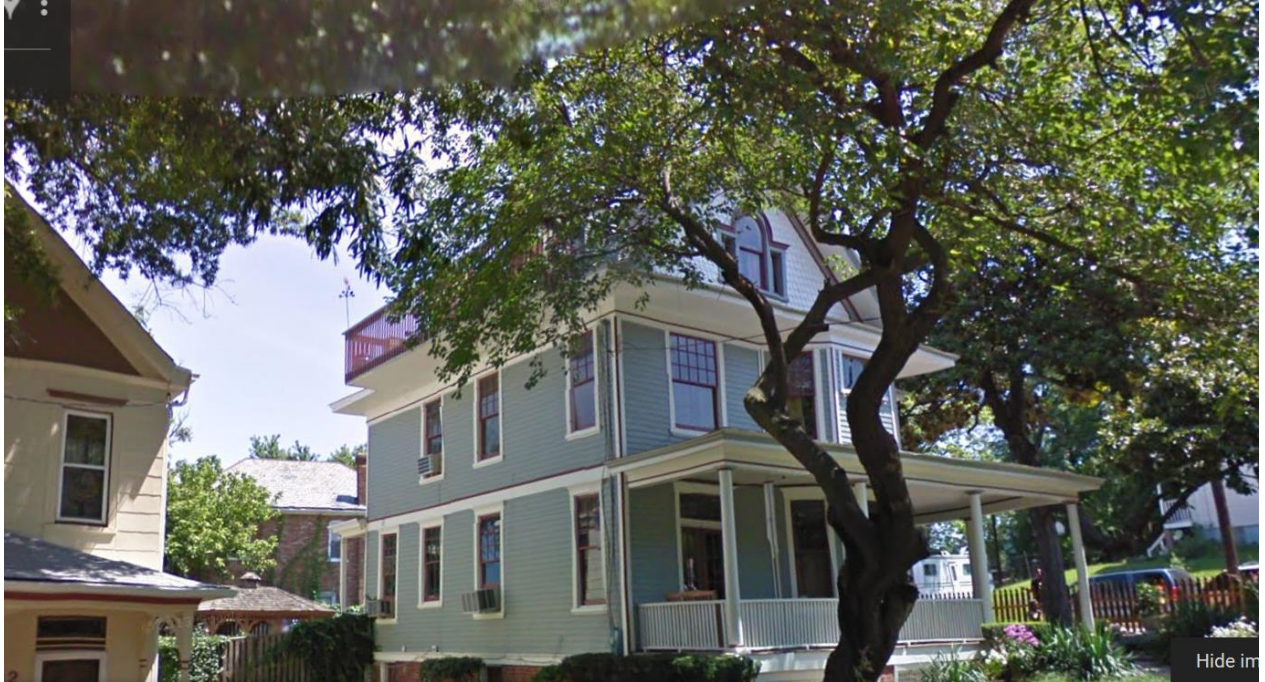
The 2009 Google Streetview photo above shows the deck beyond the tree. In January 2016, a historic preservation inspector issued a stop-work order after it had been reported that new work was in progress:

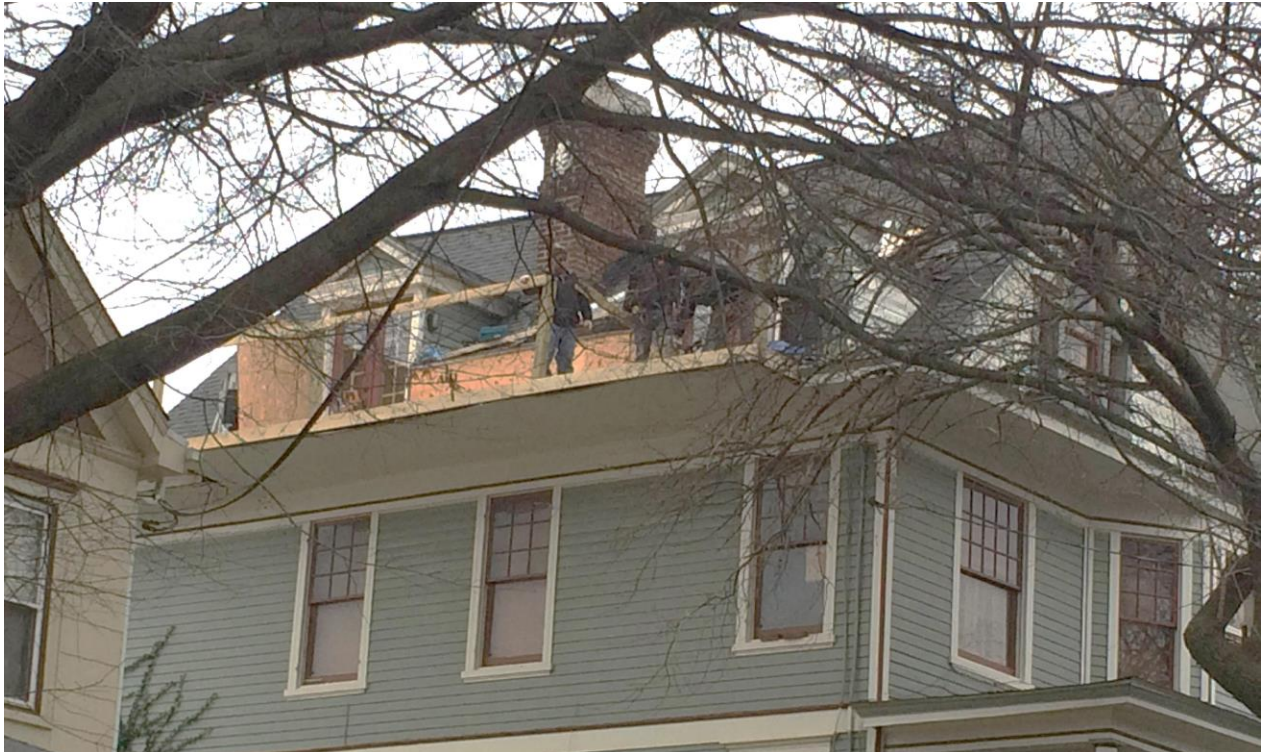
At the very least, the railing and decking were being replaced, and it appears that the roof had been modified by the addition of wing walls at the outside ends of the roof, to accept the railings and to direct water away from the dormers and deck.

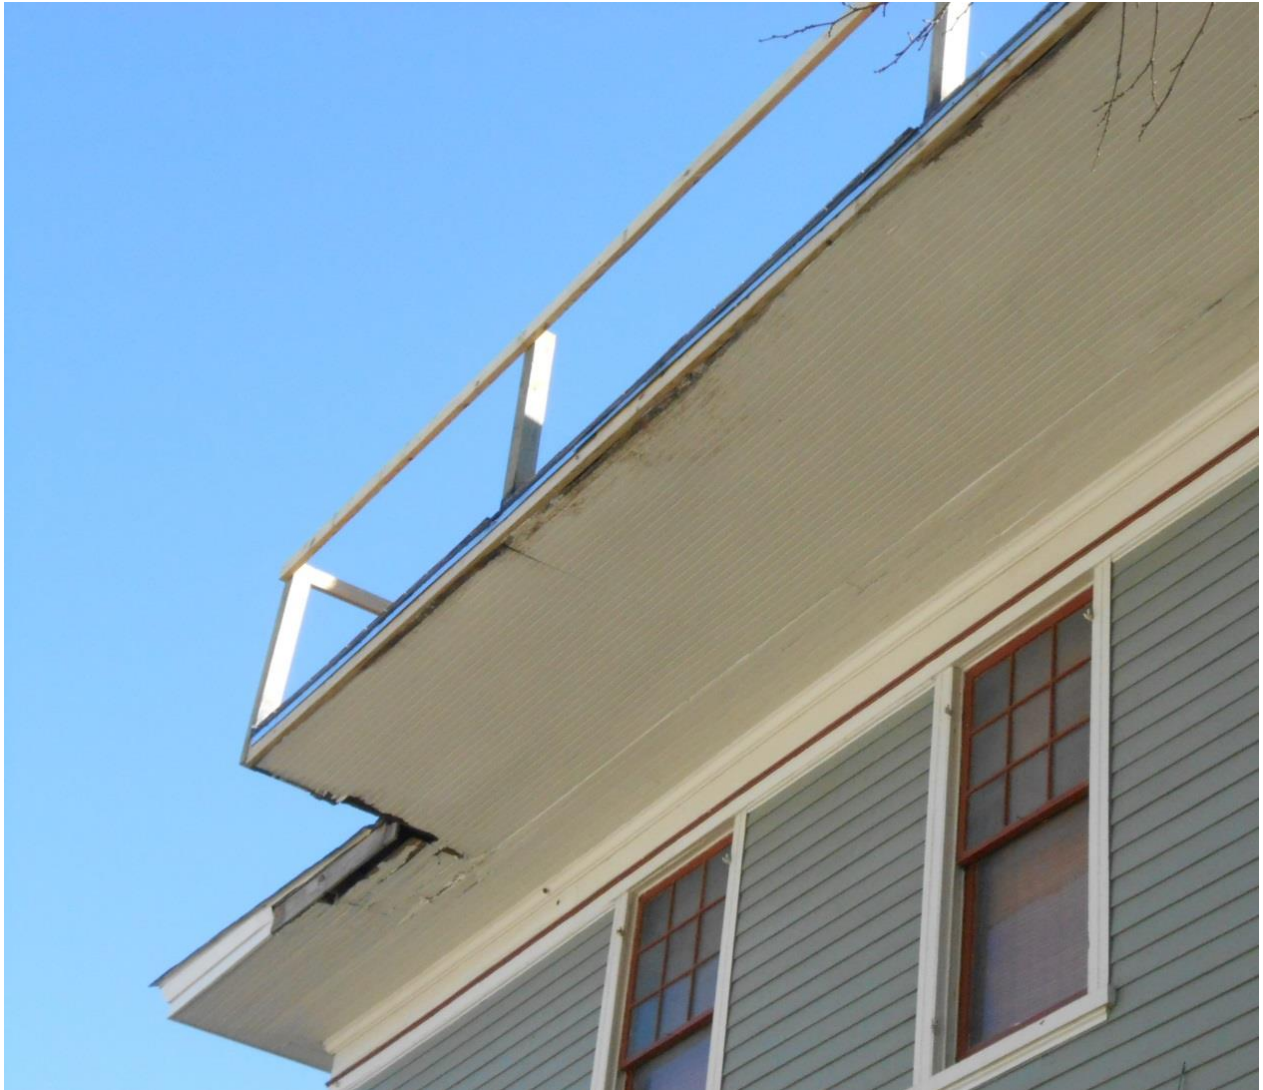
It was clear that, although only a few years old, the deck construction had caused damage to the roof because of the failure of water to drain properly off the new surface (see photos below).

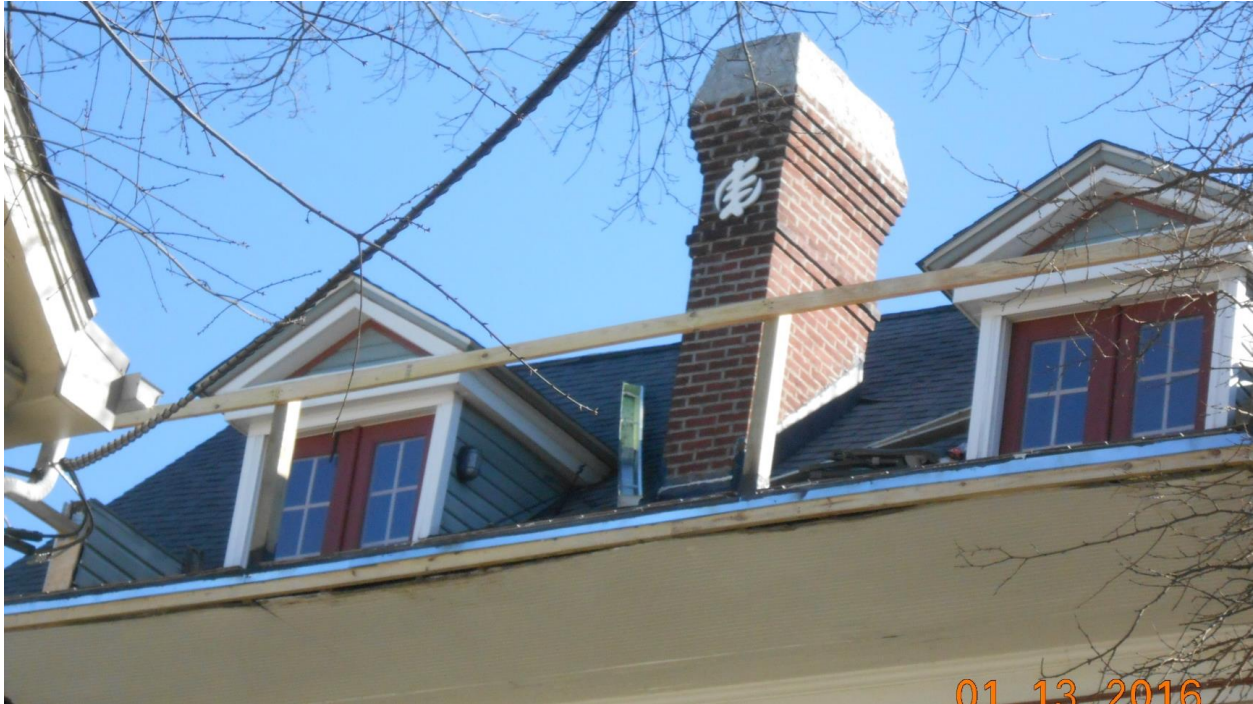
The proposed rail is very much a deck rail—widely-spaced, face-nailed, pressure-treated—suited to a rear-yard deck and not to a roof on a prominently visible side of a high-style house. Code-complaint deck rails are proportionally too tall to place prominently atop most historic houses; they are taller than historic porch balustrades, let alone roof balustrades.
