**HISTORIC PRESERVATION REVIEW BOARD  
STAFF REPORT AND RECOMMENDATION**

Landmark/District: **Capitol Hill Historic District** (x) Agenda  
Address: **621 Maryland Avenue NE**  
ANC: **6C** (x) Concept

Meeting Date: **September 28, 2023** (x) Alteration  
Case Number: **23-500**

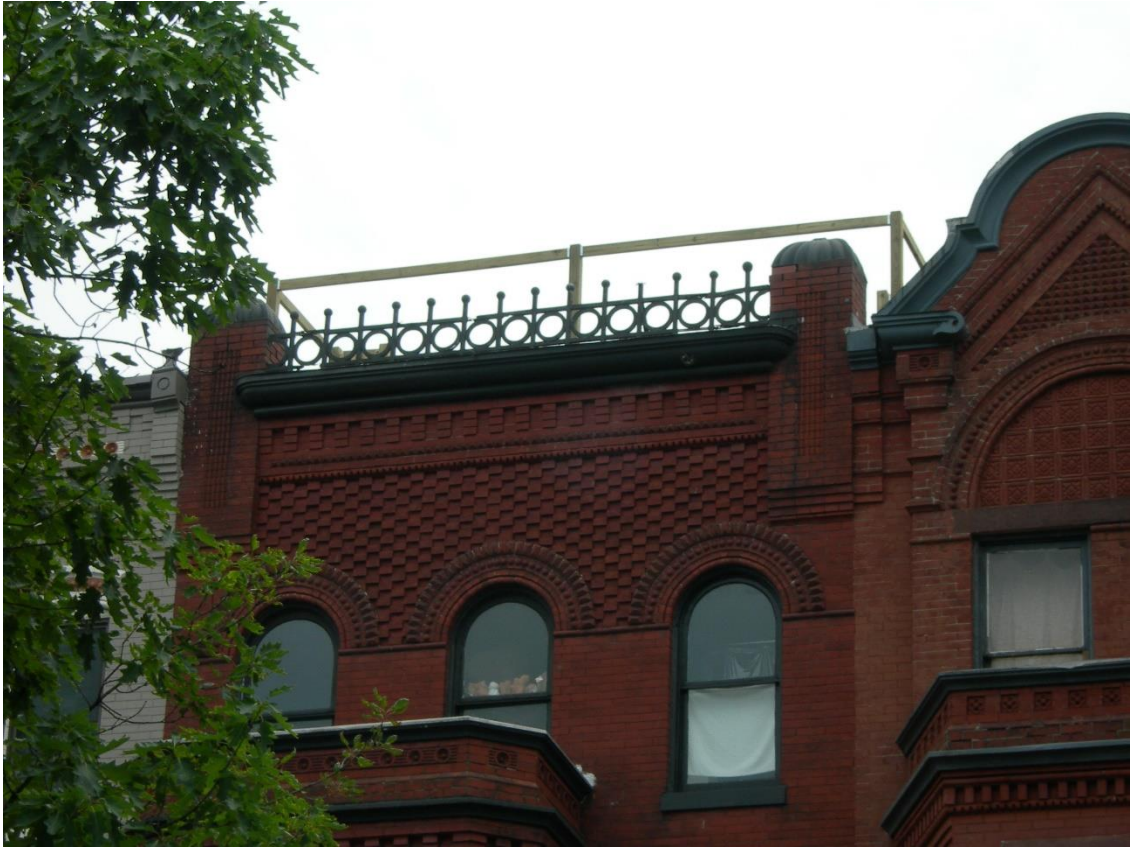
*6-5-06 Inspector Photo*

The property was in the same ownership as presently in 2006, when a stop-work order was issued for a rooftop structure partly visible from Maryland Avenue over the house's roof ridge. A January 2007 permit was approved for "Installation [of] roof decks on 2nd & 3rd story roofs, with spiral staircase and railings, on sfd, and decks, supported on brick exterior walls, repair/replace existing metal railing on 3rd story roof to exactly match existing". The permit was approved with the condition that a railing be removed or pulled rearward to render it invisible from the public space.

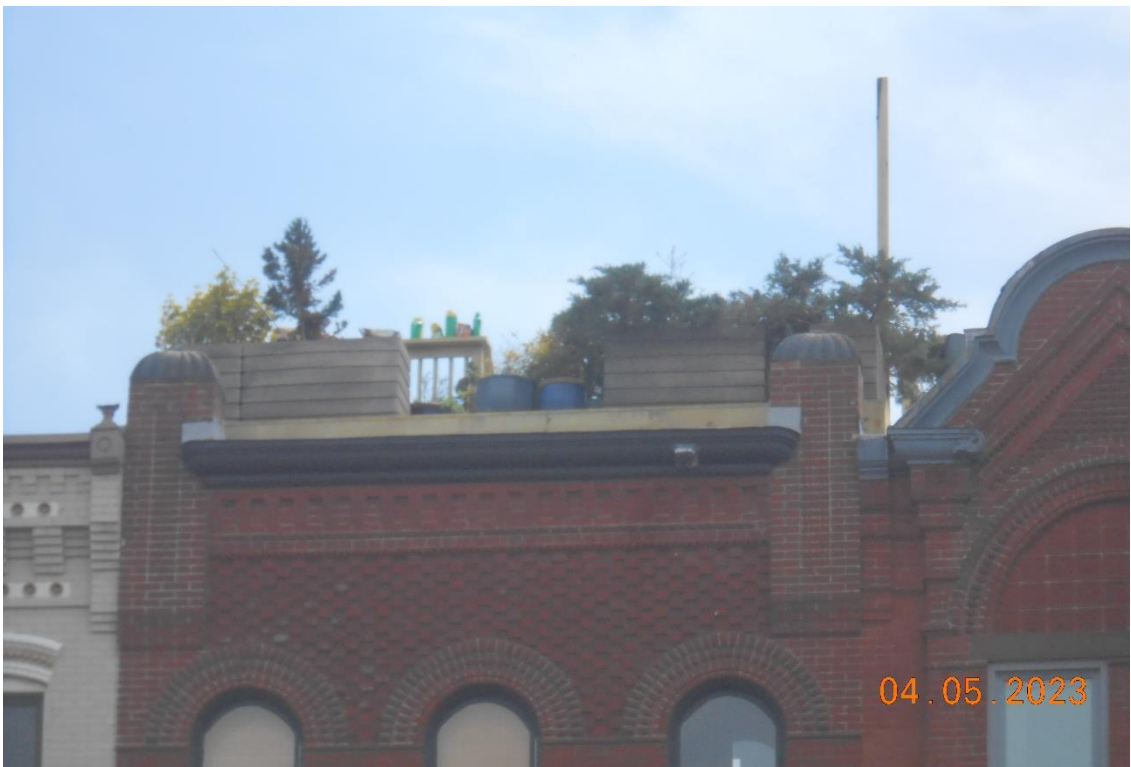
*4-5-23 Inspector Photo*

In April 2023, HPO received a report of a visible roof deck. In addition to what appears to be a built-up platform, various planters and railings and a pergola on the deck are now visible from points along Maryland Avenue. Two permit applications for retroactive approval of the work completed are pending.

The deck covers much of the roof. Forward of the deck, close to the roof's front edge, are planters shown at three feet in height. Railings of about four feet in height enclose the deck's perimeter. A roofed pergola structure with a maximum height of over ten feet above the decking stands at the rear of the main block but it is partly visible from Maryland Avenue.

As with the 2007 review of a deck at this property, HPO has been clear that visible roof deck components built without permit are not considered compatible or subject to administrative clearance. The scope of the roof deck should be reduced to eliminate the planters and forward stairs accessing the front of the roof, as well as eliminating the roofed structure. Once the planters have been removed, a lumber mockup should be erected, and visibility test conducted to establish the outer points at which the deck railings would not be visible from the street. Once reduced to not being visible, the roof deck would be compatible with the Capitol Hill historic district and could be cleared administratively by HPO.

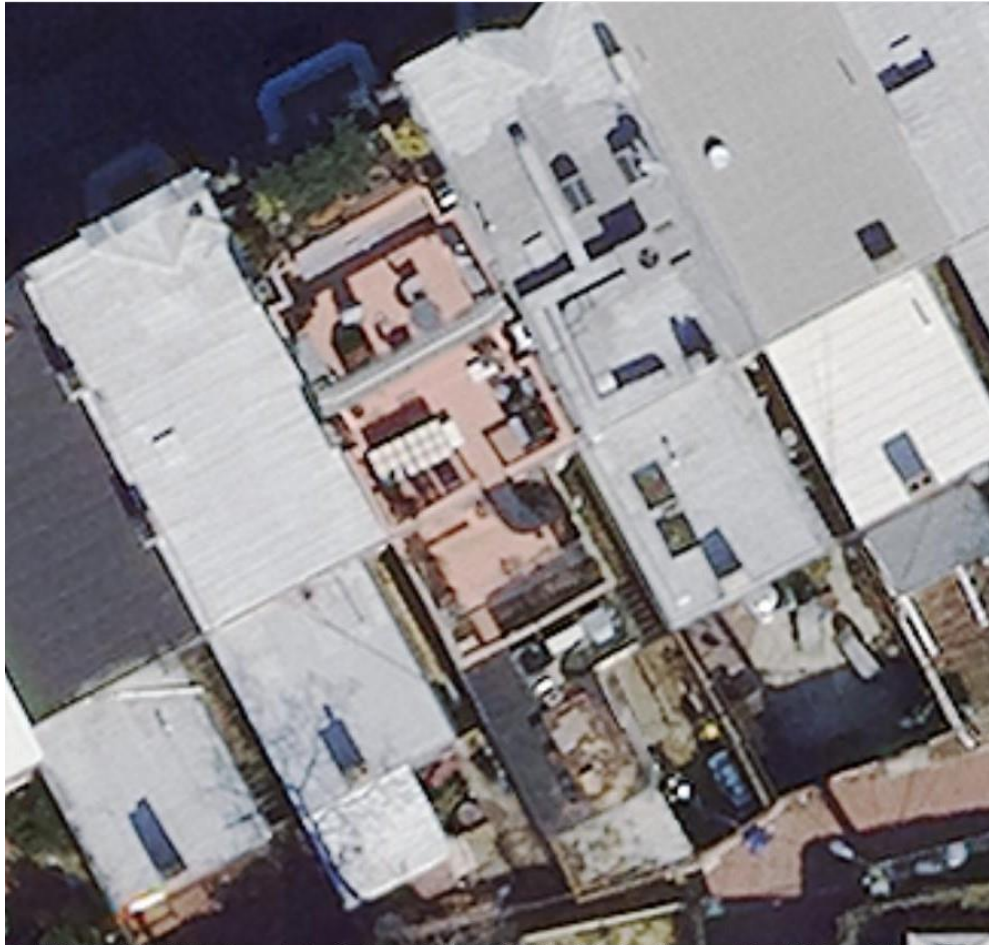
*2021 Aerial View of 621 Maryland Ave NE*

What the submitted photos reveal of the deck and its appurtenances is lumber that is recent. An examination of recent aerial photos indicates that the pergola/roof is new. Even the replacement of a previously approved deck requires a permit, first arising from the need to ensure that decks are not especially combustible, do not overload the underlying structure, are sound in themselves, and allow for sufficient emergency egress. Roofed structures are also subject to zoning review.
