**HISTORIC PRESERVATION REVIEW BOARD  
STAFF REPORT AND RECOMMENDATION**

Landmark/District: **Georgetown Historic District** (x) Agenda  
Address: **1051/1055 29<sup>th</sup> Street NW (West Heating Plant)**

Meeting Date: **November 2, 2017**  
Case Number: **17-633** (x) Demolition

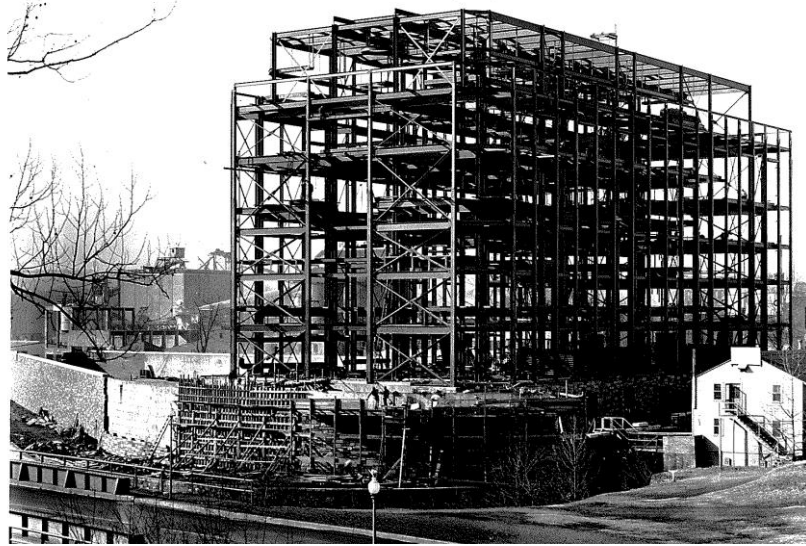
Heating plant under construction showing steel framing

Structural engineering reports do not conclude that the building is near collapse.<sup>3</sup> In evaluating the steel structure (photograph above), the engineers note the presence of rust scale at the base of the cavity in which the steel stands. It is not unusual for steel to rust when exposed to moisture, but the reports do not cite significant loss of bearing capacity as the major concern. Instead, inadequate lateral bracing, the effect of rust jacking on the brick walls, and inadequate structural capacity to support a new floor structure are among the issues cited. The reports discuss ways that these conditions could be addressed by appropriate repairs, reinforcement, improved moisture control, and insertion of new structural elements as part of rehabilitation.
