**HISTORIC PRESERVATION REVIEW BOARD  
STAFF REPORT AND RECOMMENDATION**

Landmark/District: **Georgetown Historic District** (x) Agenda  
Address: **1051/1055 29<sup>th</sup> Street NW (West Heating Plant)**

Meeting Date: **November 2/December 21, 2017**  
Case Number: **17-633** (x) Demolition

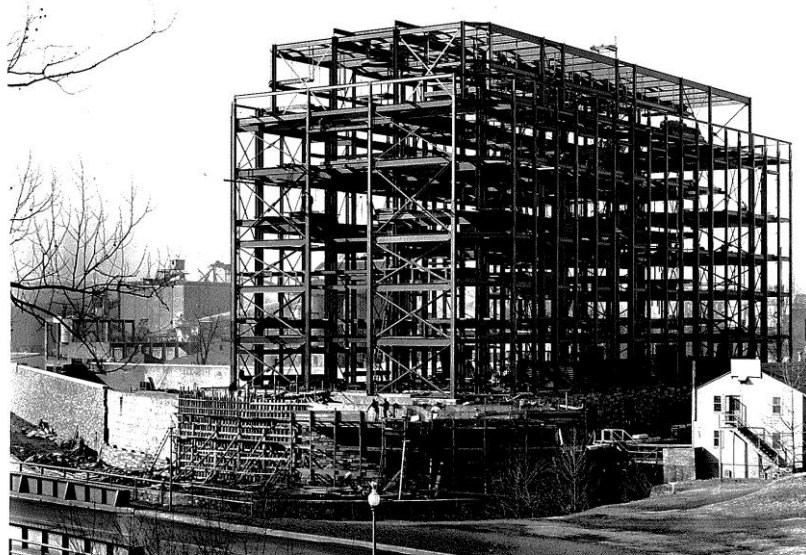
The heating plant's steel framing shown while under construction.

Structural engineering reports do not conclude that the building is near collapse.<sup>3</sup> In evaluating the steel structure (photograph above), the engineers note the presence of rust scale at the base of the cavity in which the steel stands. It is not unusual for steel to rust when exposed to moisture, but the reports do not cite significant loss of bearing capacity as the major concern. Instead, inadequate lateral bracing, the effect of rust jacking on the brick walls, and inadequate structural capacity to support a new floor structure are among the issues cited. The reports discuss ways that these conditions could be addressed by appropriate repairs, reinforcement, improved moisture control, and insertion of new structural elements as part of rehabilitation.
