**HISTORIC PRESERVATION REVIEW BOARD  
STAFF REPORT AND RECOMMENDATION**

Landmark/District:	<b>Mount Pleasant Historic District</b>	(x) Consent
Address:	<b>1656-1658 Park Road NW</b>	
Meeting Date:	<b>April 25, 2019</b>	(x) Subdivision
Case Number:	<b>19-208</b>	(x) Alteration
		(x) Revised Permit/Concept

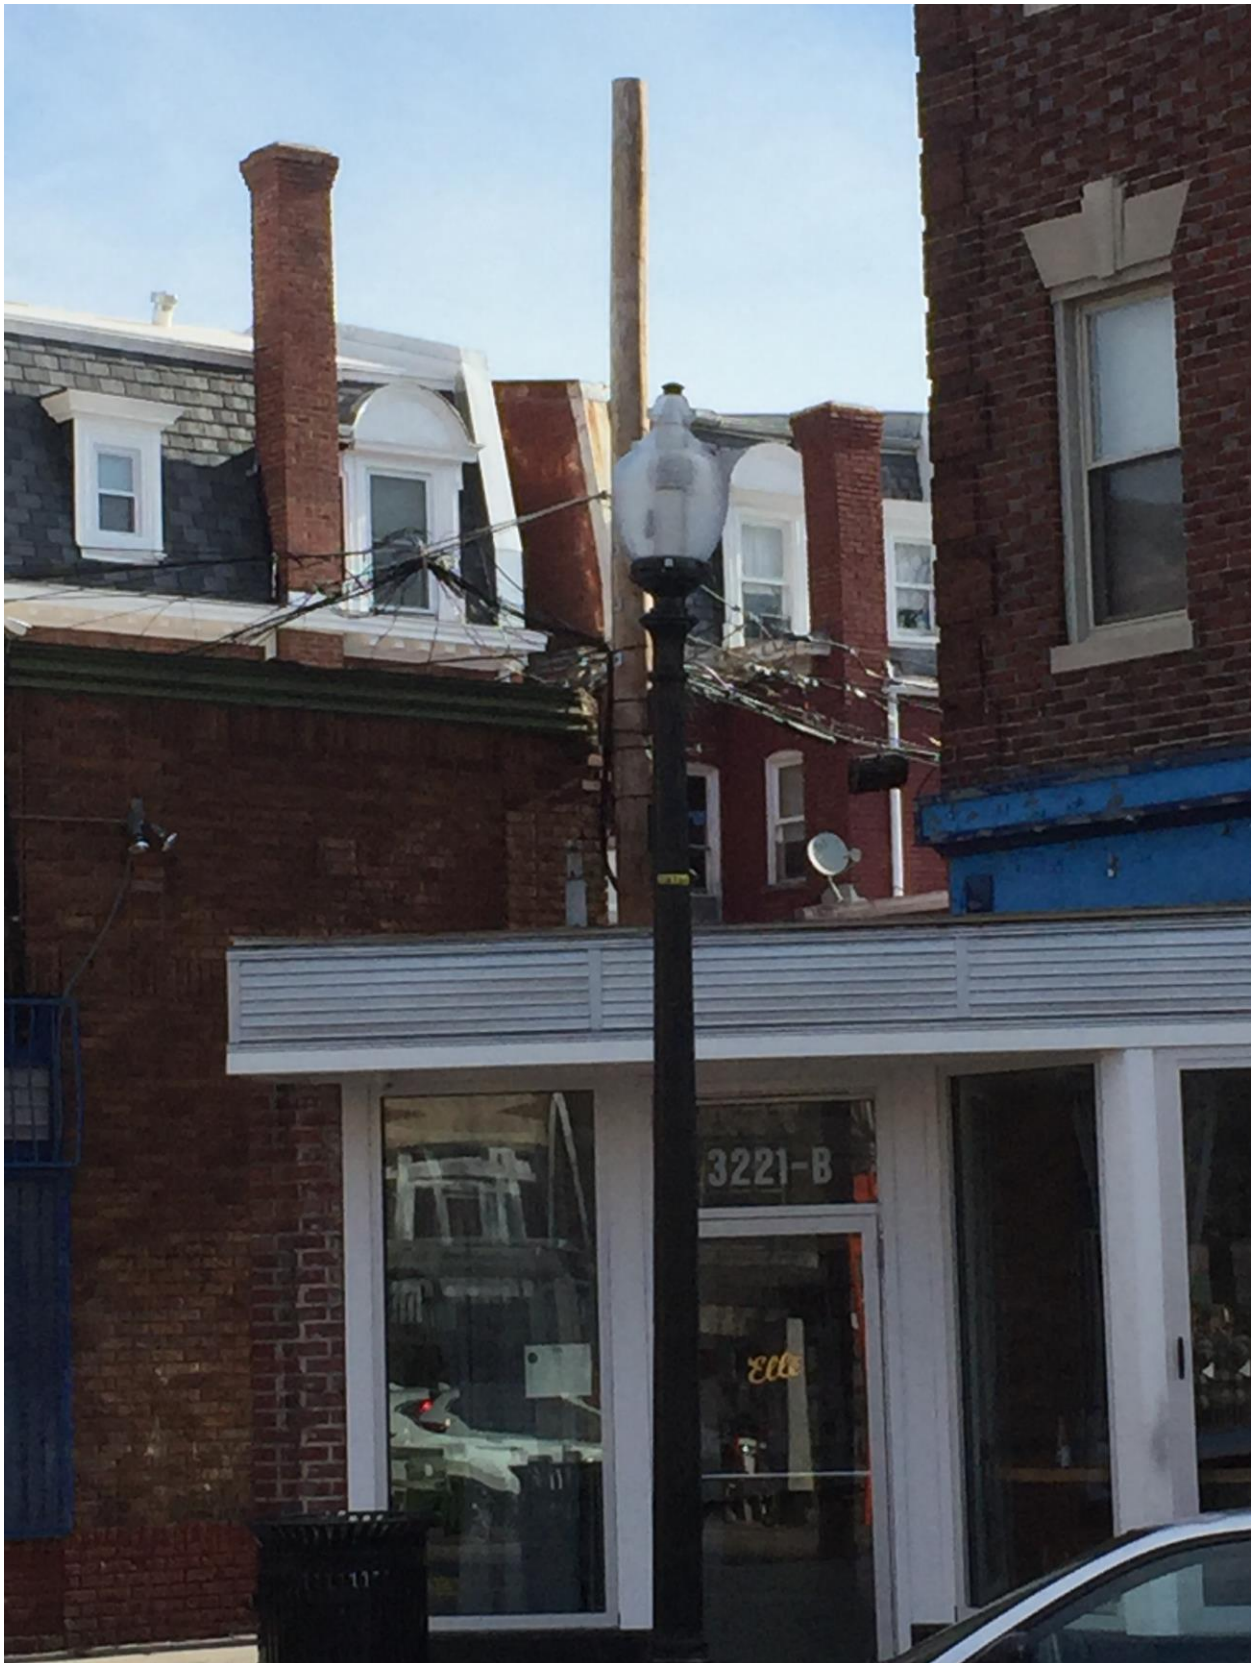
*The garage addition would be somewhat visible from Mount Pleasant Street, over the Heller's storefront.*

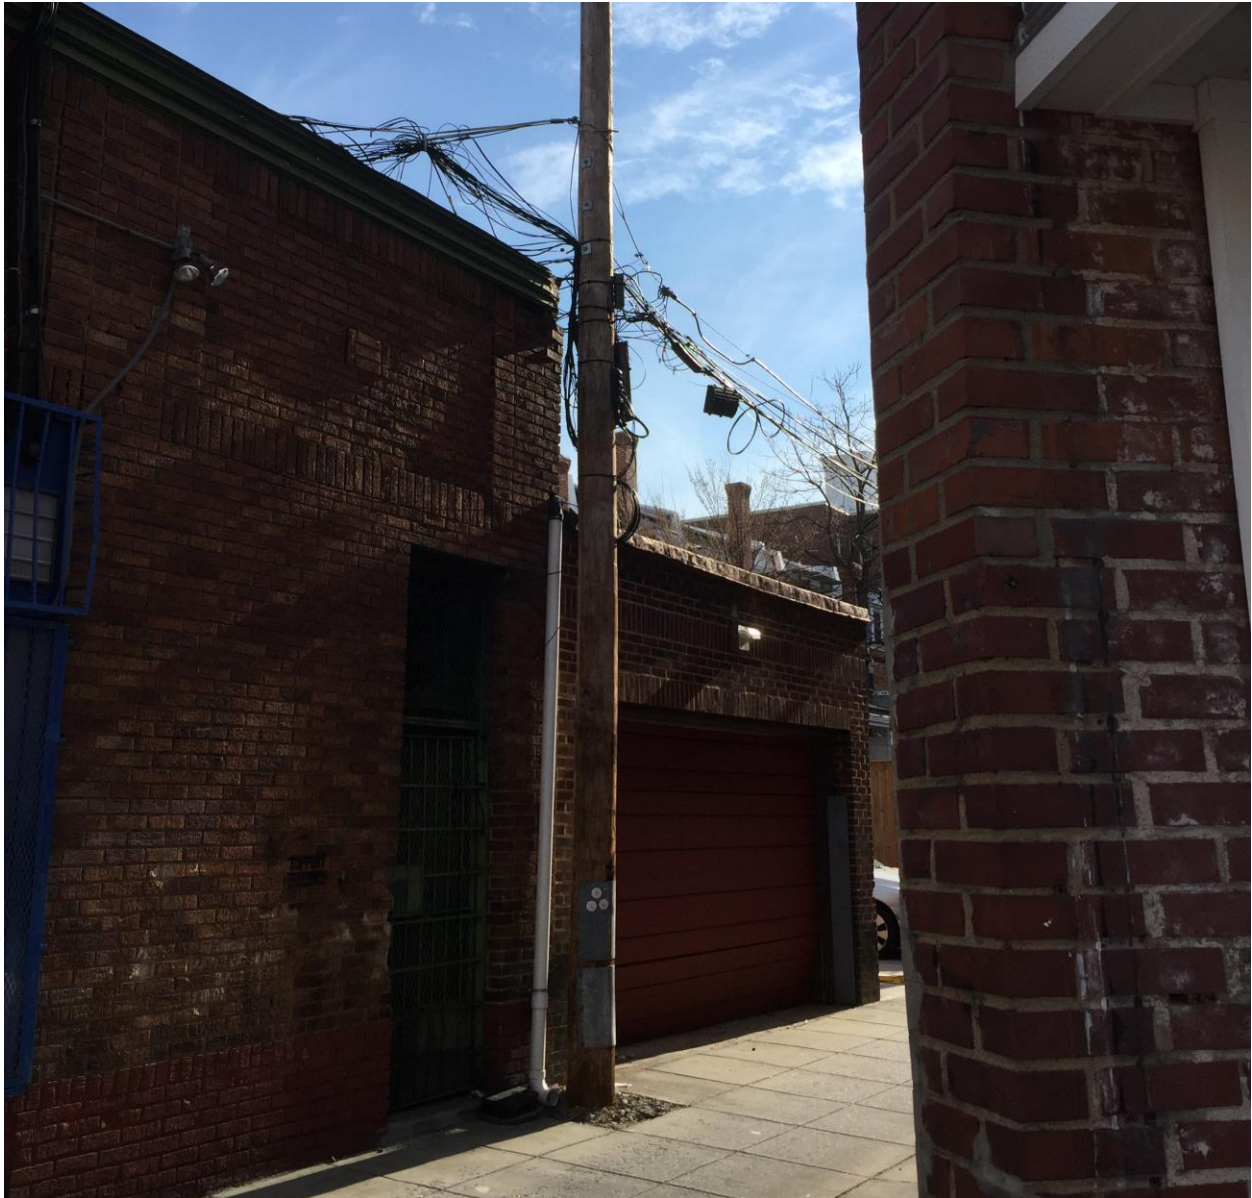
*The addition would be set forward enough from the alley to be invisible from the mouth of the alley.*

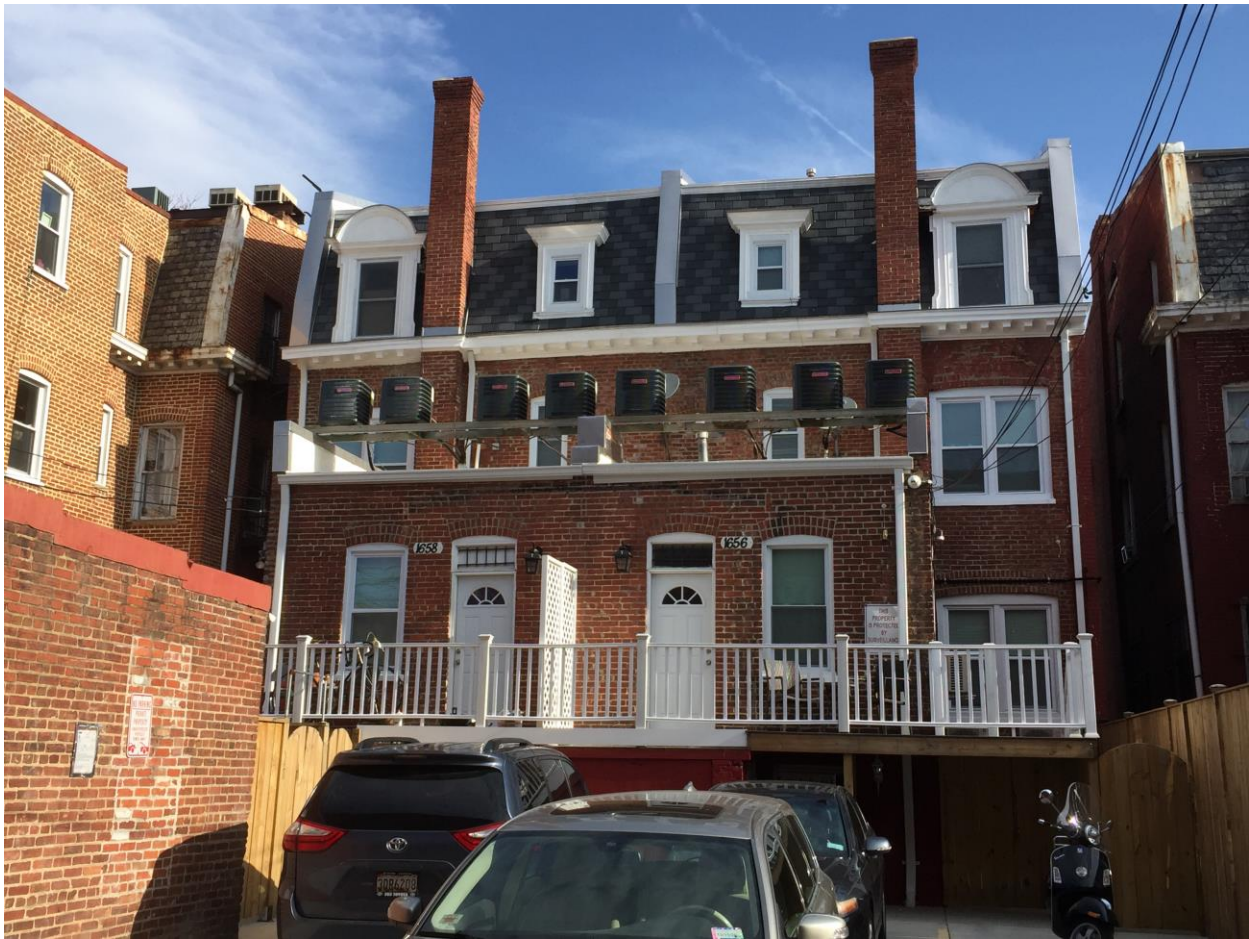
***The garage addition would obviously be visible from the alley at rear, and now about the rear wall of the one-story Samber Market building. The three-story construction at the far left is an addition to 1660-1662 Park Road.***

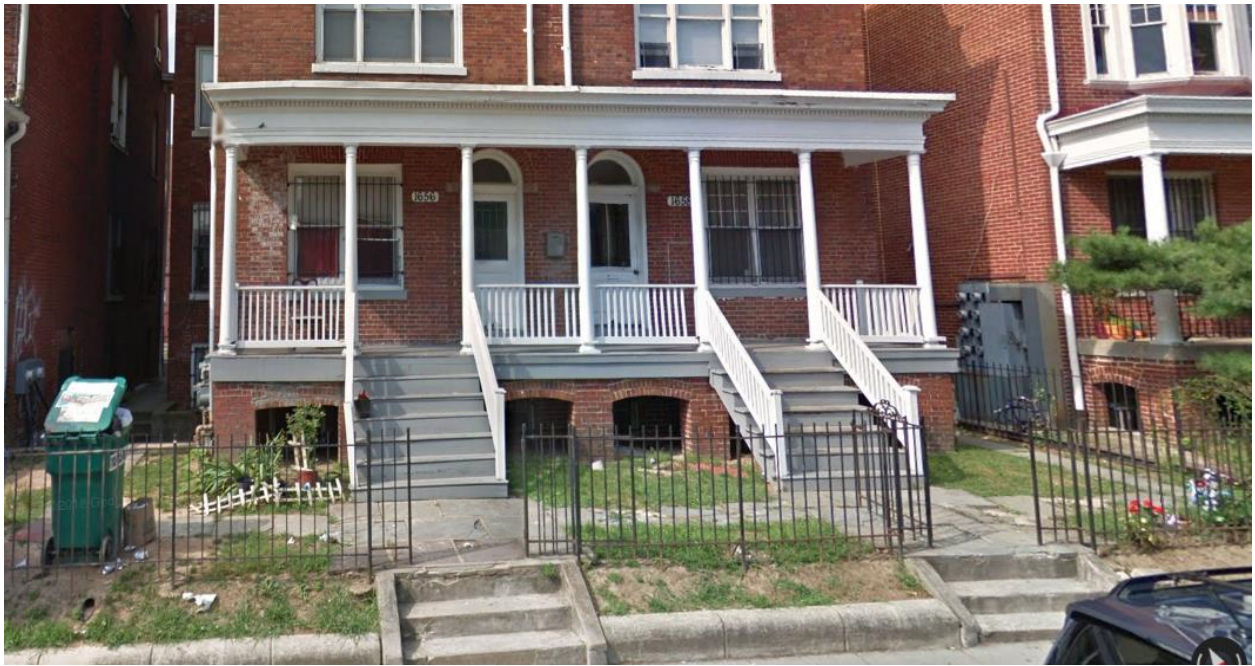
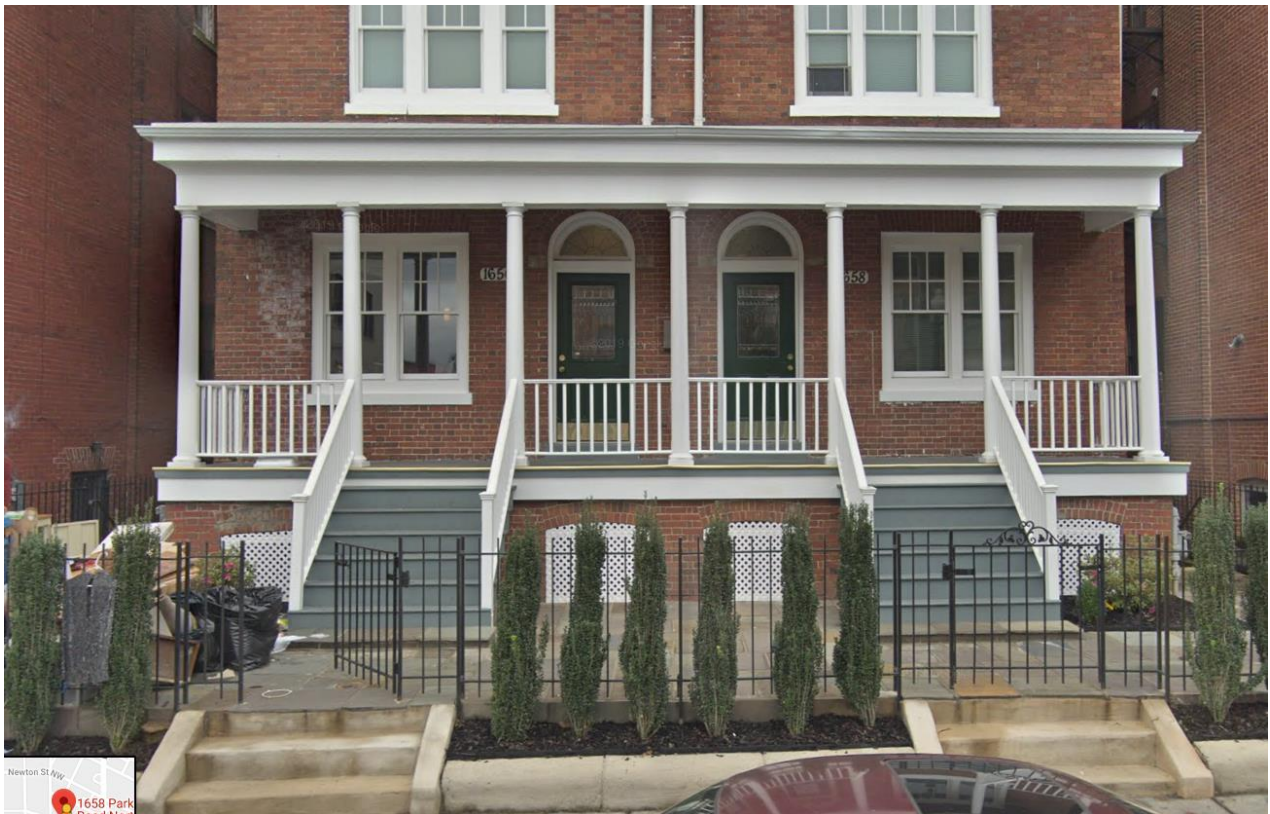
The other major item is the paving of the front yard. It had had straight-run concrete lead walks and steps, consistent with the rest of the row, bisecting grassed yards. The previous owners, rather than repairing or replacing the century-old walks, had stuck flagstones over them and had installed similar stepping stones as a walk around the buildings. The latter is consistent with the design guidelines, the former is not, in this instance. But now, nearly the entire surface of the yard has now been covered with flagstones, limiting the green areas to planters bounded by the paving and the curb at the public sidewalk (see photos, page 7). This requires a public-space permit and would not have been supported by HPO, because the Board's policy has long been to minimize front-yard paving, consistent with the published preservation design guidelines, the planning history of the District of Columbia, and recent comprehensive plans.<sup>3</sup> Staff is awaiting

*Above: The houses' front yard prior to the recent paving/repaving.  
Below: The front yard "after."*

a permit application to reduce the amount of paved area—and preferably to restore the concrete walks.

- 6. the restoration of true slate to the front roof—to match the color, cut, dimensions and coursing/exposure of the original slates—be carried out by May 28 or be subject to HPO enforcement action; and*
- 7. that the removal of the new paving from the front yard be carried out under a separate permit, to be cleared by HPO before or concurrent with the clearance of the subdivision and the addition permit.*
