**HISTORIC PRESERVATION REVIEW BOARD
STAFF REPORT AND RECOMMENDATION**

Landmark/District: **Mount Pleasant Historic District** (x) Agenda
Address: **1656-1658 Park Road NW**

Meeting Date: **March 28, 2019** (x) Alteration
Case Number: **19-208** (x) Permit/Concept

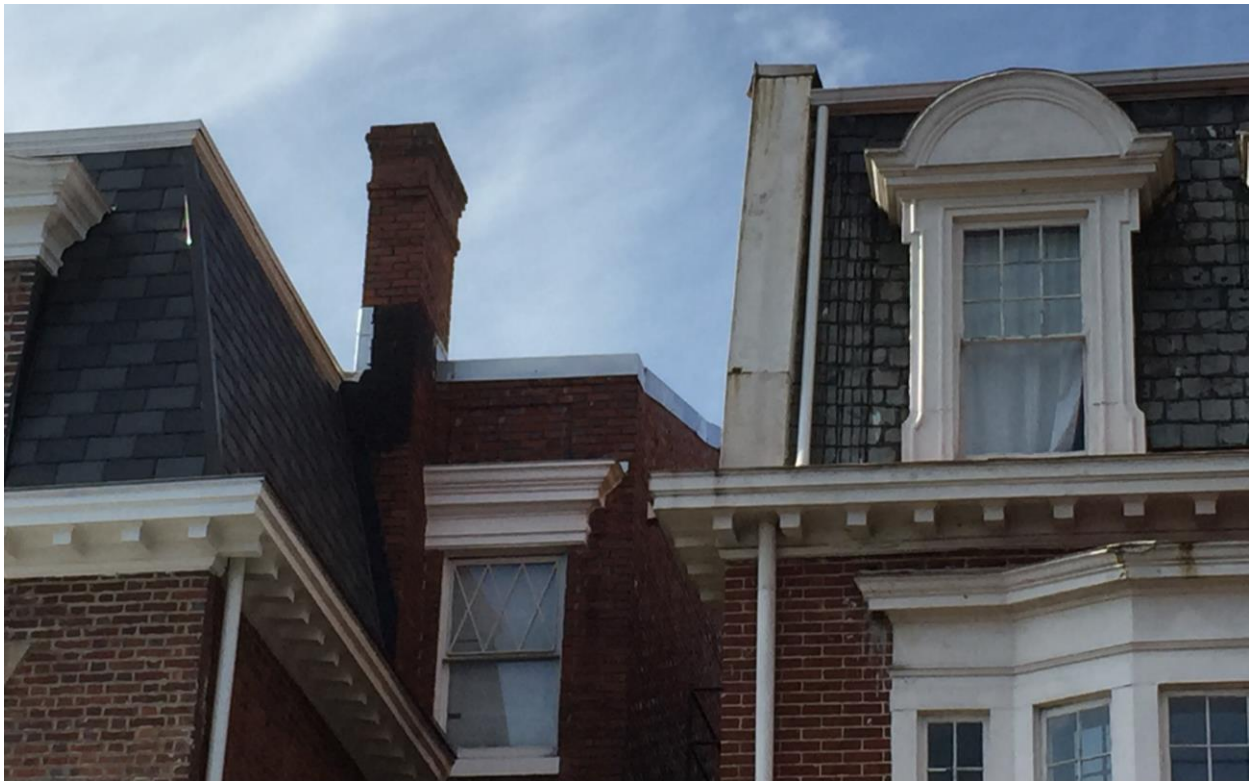
More important, the slates on the mansard roofs were replaced with fake slate, front and rear (see photo, page 5). On the front, this is something HPO would not have supported or cleared, because the roofing is so prominent, and the faux slates can be easily picked out in comparison to the real ones next door, for differences in color, finish and dimension. There is not so much roof surface at the front of the building that the use of real slate would have been cost-prohibitive in comparison.

*Above: The roof of 1658 Park, left, and 1660 Park, right.
Below: The altered front yard of 1656 and 1658 Park.*

- 1. that the infill of the garage’s vehicular opening be done with what looks like a vehicular door compatible with a circa 1930 garage, but with integral glazing as necessary;*
- 2. that the fiber-cement siding be smooth-faced, with an exposure not to exceed six inches;*
- 3. that the removal of the new paving from the front yard be included in the project drawings and be a condition of the permit;*
- 4. that the restoration of true slate to the front roof--to match the color, cut, dimensions and coursing/exposure of the original slates—be included in the project drawings and be a condition of the permit; and*
- 5. that the subdivision be cleared by HPO staff only if the connection between the buildings is minimal, and the total demolition of structure within the buildings is less than what constitutes “demolition in significant part” of each.*

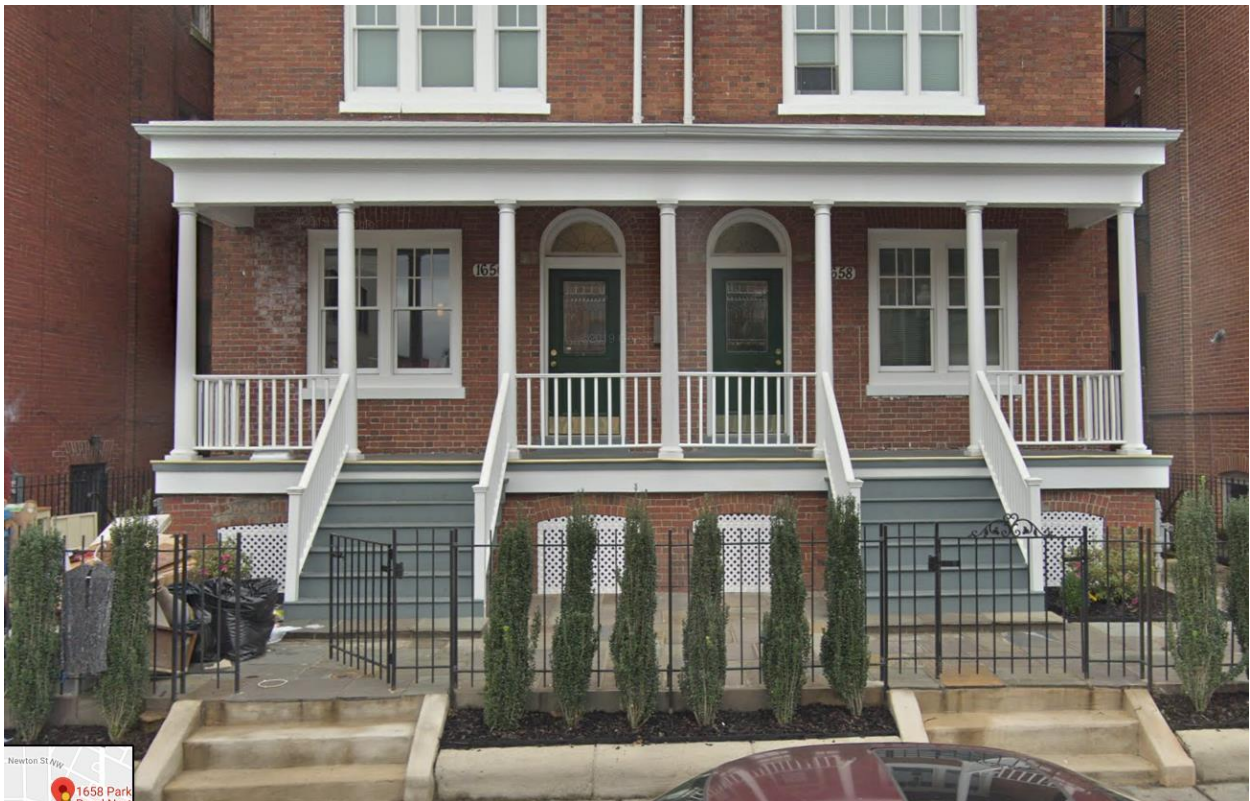
The third significant item is the paving of the front yard. It had had straight-run concrete lead walks and steps, consistent with the rest of the row, bisecting grassed yards.⁵ Nearly the entire

surface has now been covered with flagstones, limiting the green areas to planters bounded by the paving and the curb at the public sidewalk (see photo, page 5). This requires a public-space permit and would not have been supported by HPO, because the Board’s policy has long been to minimize front-yard paving, consistent with the published preservation design guidelines, the planning history of the District of Columbia, and recent comprehensive plans.⁶
