HISTORIC PRESERVATION REVIEW BOARD STAFF REPORT AND RECOMMENDATION

Landmark/District:	Mount Pleasant Historic District	(x) Agenda
Address:	3305 and 3307 18th Street NW (rear)	
Meeting Date:	November 2, 2017	(x) Raze
Case Number:	17-659	(x) New construction
Staff Reviewer:	Tim Dennée	(x) Concept

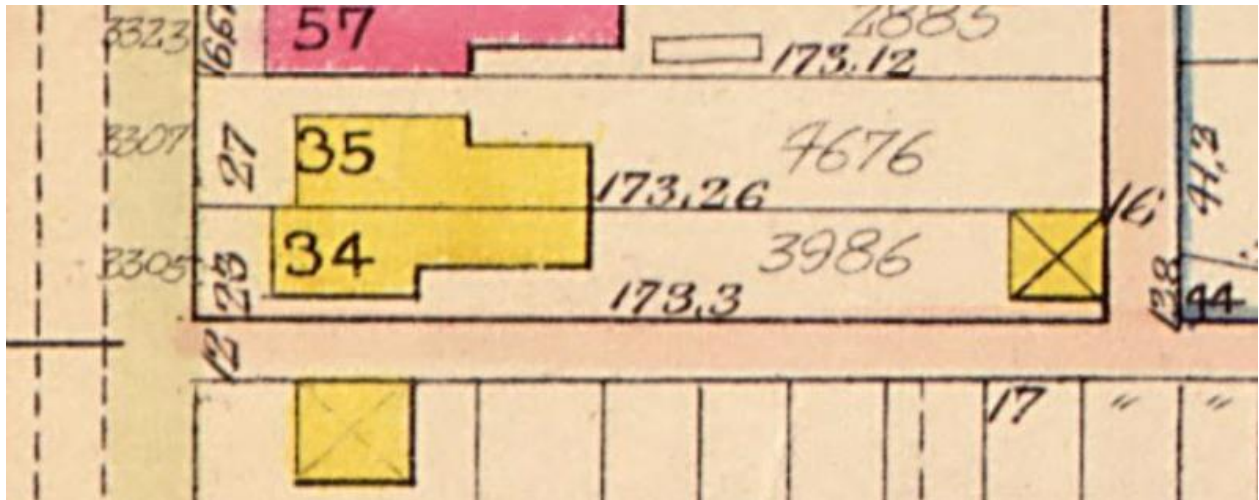
Above: A detail of the 1907 Baist Real Estate Atlas of Washington, District of Columbia. The 1903 atlas shows that nothing stood on the 3300 block of 18th Street only a few years earlier.

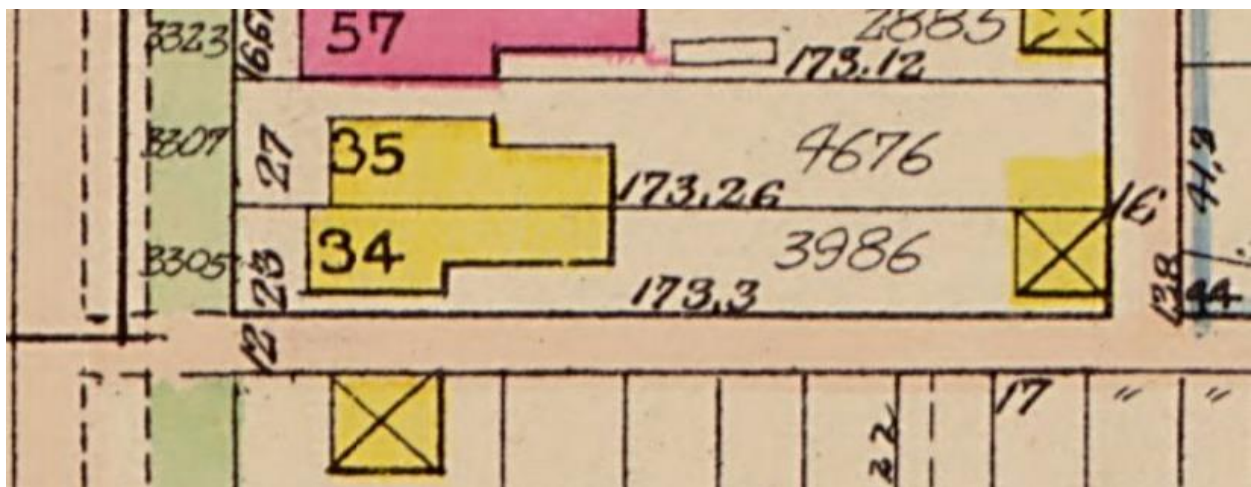
Below: The same detail from the 1909 atlas. It may not be clear in a black-and-white copy, but a rectangular area above the original stable has been colored yellow to indicate frame construction, despite the walls not being drawn in, nor an "X" to indicate a stable.

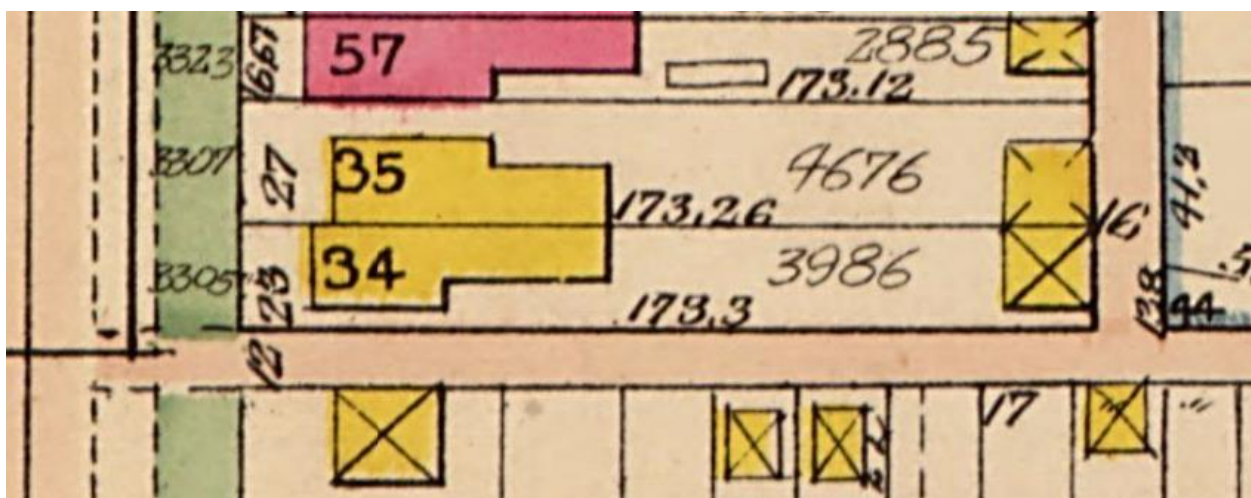
Above: A detail of the 1915 Baist atlas depicting the complete structure.

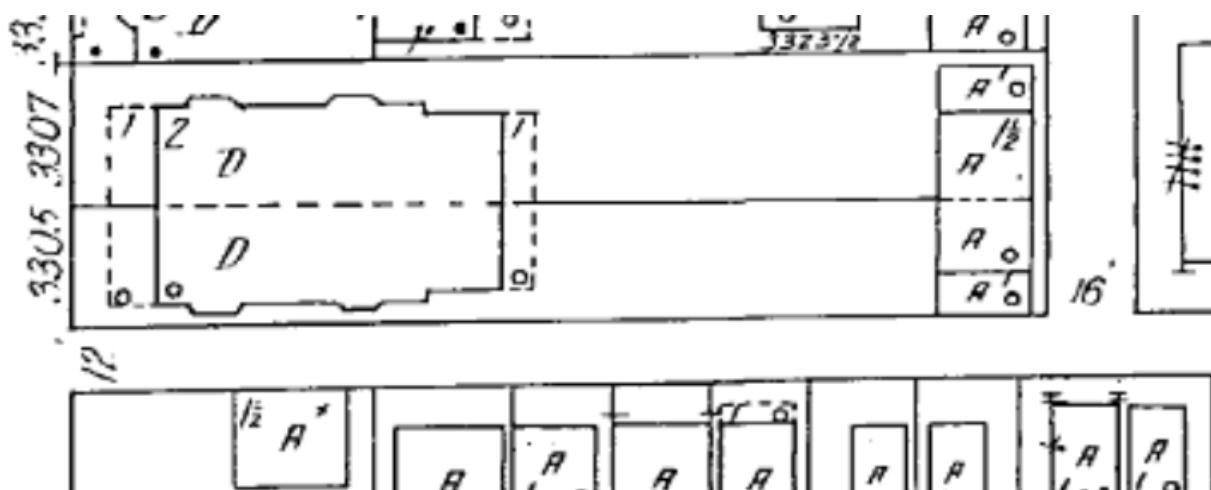
Below: A detail of a 1927 Sanborn insurance map showing the property with shed additions to the north and south ends of the stable/garage.
