**HISTORIC PRESERVATION REVIEW BOARD
APPLICATION FOR HISTORIC LANDMARK OR HISTORIC DISTRICT DESIGNATION**

Property name **Lunch Room Building and Oyster Shucking Shed**

Address **1100 Maine Avenue, SW, Washington, D.C., 20024**

Date of construction **1916-1918** Date of major alteration(s) **Pre-1931; 1946**

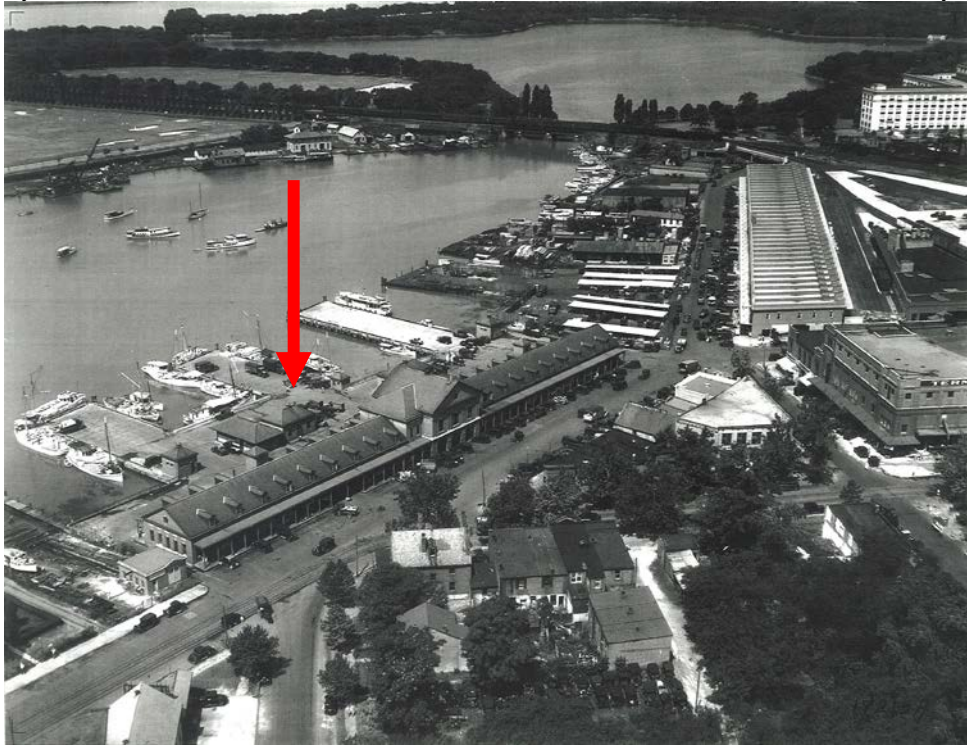
Lunch Room and Oyster Shucking Shed - Circa 1931; National Archives and Records Administration

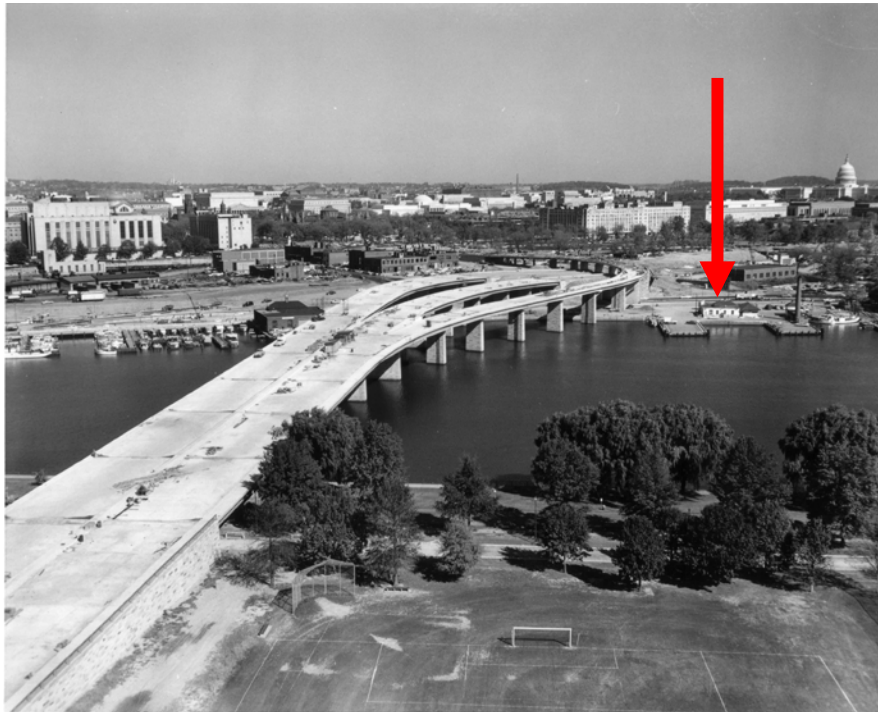
Lunch Room and Oyster Shucking Shed – Circa 1960; DDOT

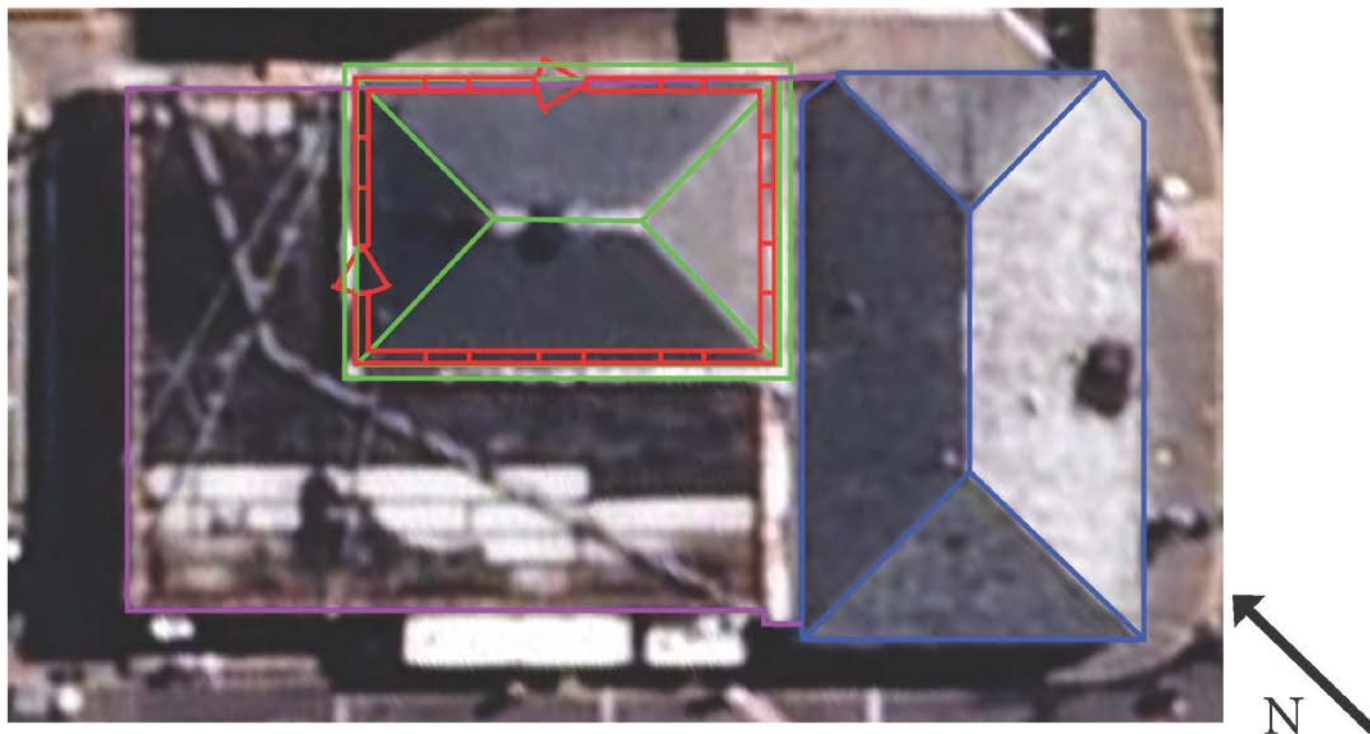
| | Original Lunch Room Drawing (pre-1916) | | Oyster Shucking Shed (1916-1918);

hipped roof and enclosure 1931 |

| | Lunch Room (1916-1918) | | Addition (1946) |

Lunch Room and Oyster Shucking Shed Construction Chronology, Google Maps Aerial

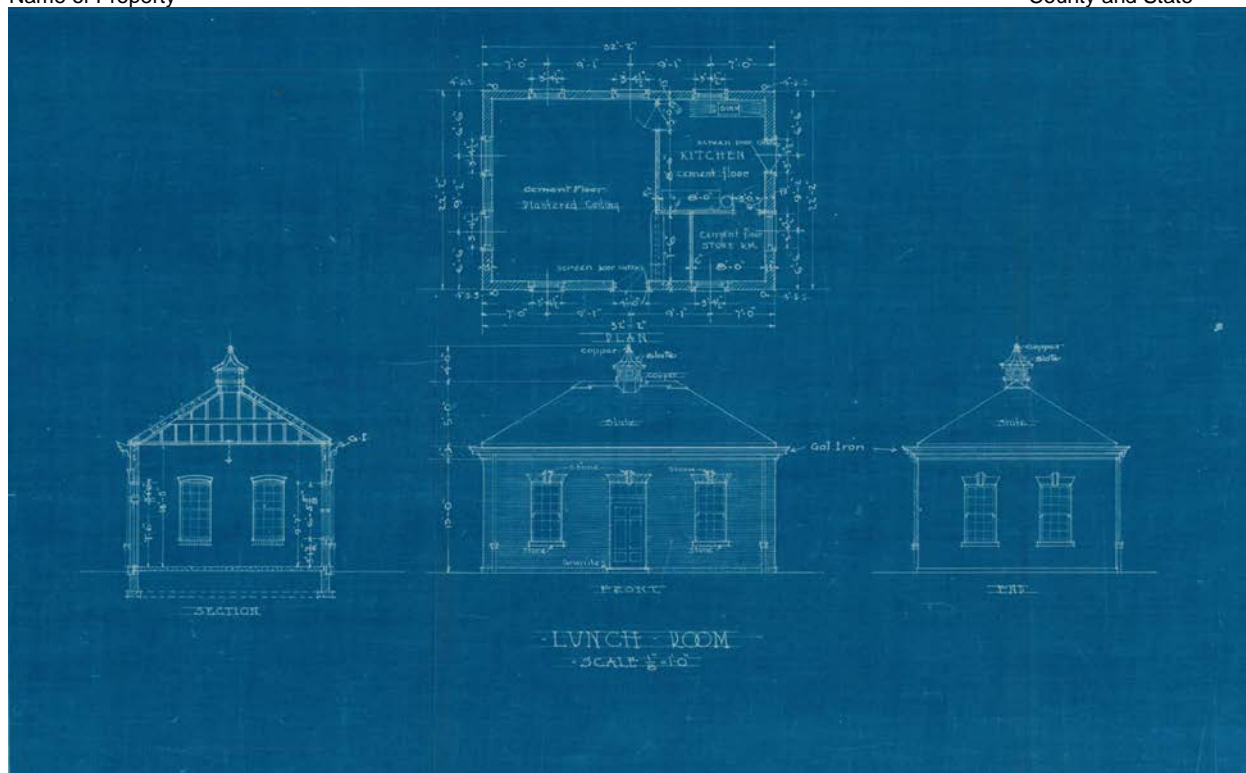
Lunch Room drawings, unsigned, 1916-1917

The one-story, painted brick Lunch Room Building is rectangular in plan, approximately 10 feet in height, and oriented to the southwest fronting the waterfront's edge. Its original main entry faced towards Maine Avenue, away from the water. The original slate-shingled hip roof of the 1916-1918 building is intact, complete with wood cornice and a centrally placed hexagonal-shaped cupola. The cupola, with slate-shingled cheeks, has wood louvers on each side for ventilation and is also topped with a slate-shingled roof. Smaller air vents pierce the main roof in several places.

The building's northeast elevation, which served as its main elevation at the time of construction, is the only fully exposed elevation of the original 1916-1918 structure; the rest of the building was altered by the 1946 one-story addition that wraps around the northwest and southwest elevations and the infill construction (hyphen) that joins the building to the Oyster Shucking Shed directly to the southeast. The northeast elevation is formed by brick in a stretcher bond, now painted white. The original door opening at the center of this elevation has been infilled with brick and is no longer in use; its double limestone keystone is still intact. A single window opening is set to either side. The window openings feature a brick lintel highlighted by double limestone keystones, a sill that appears to be limestone, and are fitted with non-original Plexiglas set into the original wood frames. Non-original metal security bars have been added to the openings.¹ A multitude of utility wires, conduits, power lines, and utility boxes, obstruct much of the original construction. Round metal downspouts have been added near the corners on all elevations.

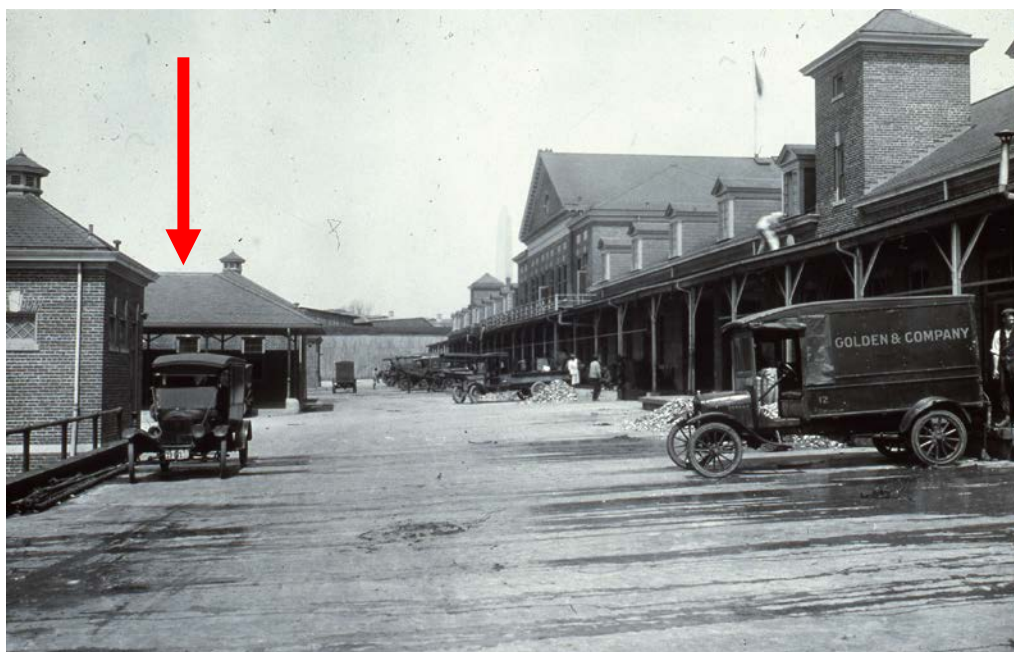
Circa 1918-1930, looking northwest showing unenclosed Oyster Shucking Shed in front of the Lunch Room, Historical Society of Washington

The Oyster Shucking Shed was constructed from 1916-1918 as an open-air metal structure. By 1931, this shed was enclosed. The hipped slate-shingled roof features wide overhanging eaves on three elevations, and exposed wood rafter ends. The eave on the northeast slope of the roof, facing towards Maine Avenue, does not overhang like the eaves at the other elevations. A large duct pierces the roof and runs through one of the window openings on the southeast elevation. The site's slight change in grade downward towards the water's edge exposes a heavy rounded concrete water table at the base of the building. This water table is most prominent at the building's southwest corner. The upper portion of the building's three visible elevations are sheathed in wood panels with the lower portions composed of a combination of masonry and clay tile. The original metal shed structure, composed of a hipped roof of supported by steel I-beams, is visible at the corners of the building's exterior; however, today, owing to the structural failure of the original steel members, the building's "walls" are the actual means of support for the hipped roof. The fenestration includes window openings filled with various sized and oriented six-light wood windows. These windows are set within the upper portion of the building's elevations. The window openings have wood surrounds and all but one (on the southeast elevation) have been boarded up or fitted with metal vents. The building's entry, on the southeast elevation, provides access to a fish cleaning room and is fitted with a rudimentary double-leaf wood door. A single door opening on the southwest elevation, facing towards the water, contains a single-leaf metal door.
