HISTORIC PRESERVATION REVIEW BOARD
APPLICATION FOR HISTORIC LANDMARK OR HISTORIC DISTRICT DESIGNATION

Property name Procurement Building GSA Regional Office Building (ROB)

Address 301 7th Street, SW

National Register of Historic Places Registration Form

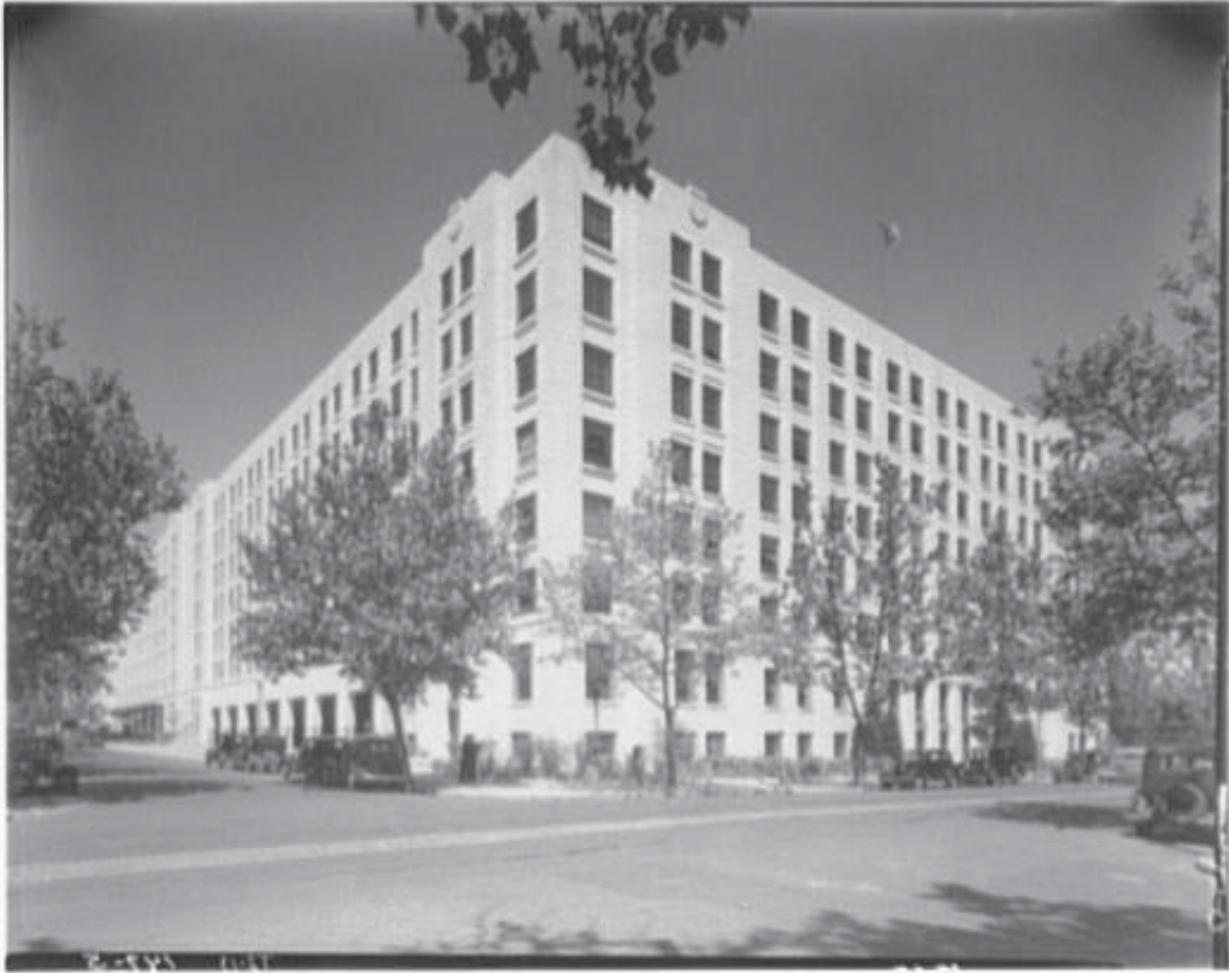
Procurement building of Treasury Department, c.1920-1950, Treasury Department, Courtesy of: Library of Congress.

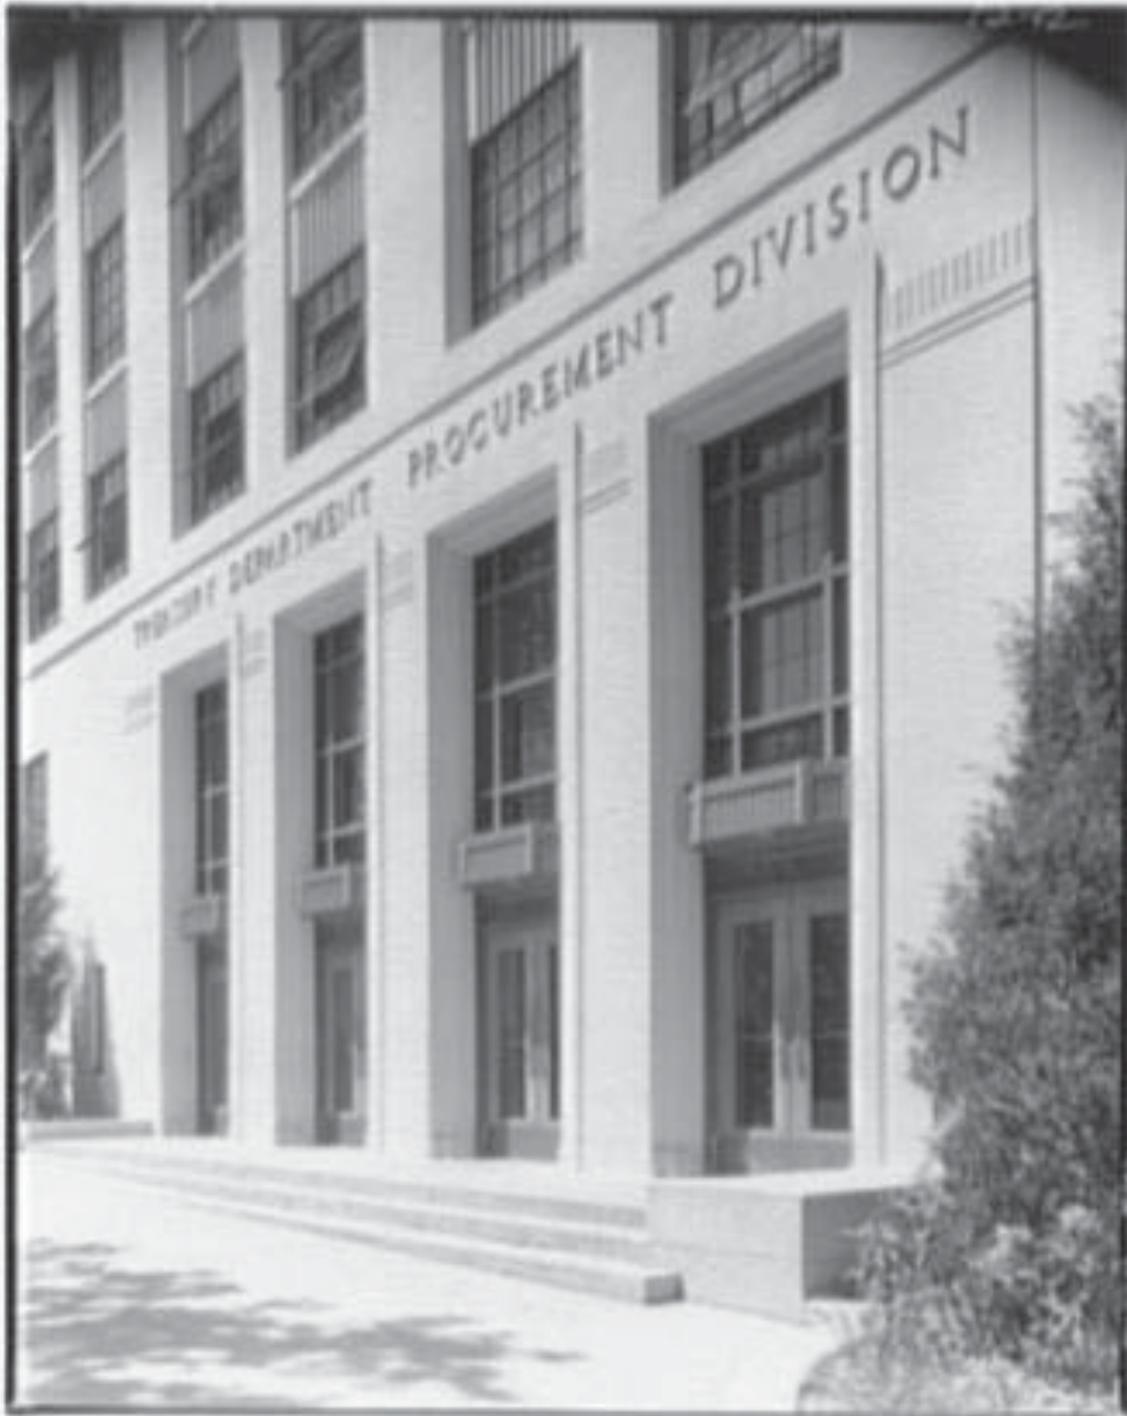
Entrance to Procurement building of Treasury Department, c.1920-1950, Treasury Department, Courtesy of: Library of Congress.

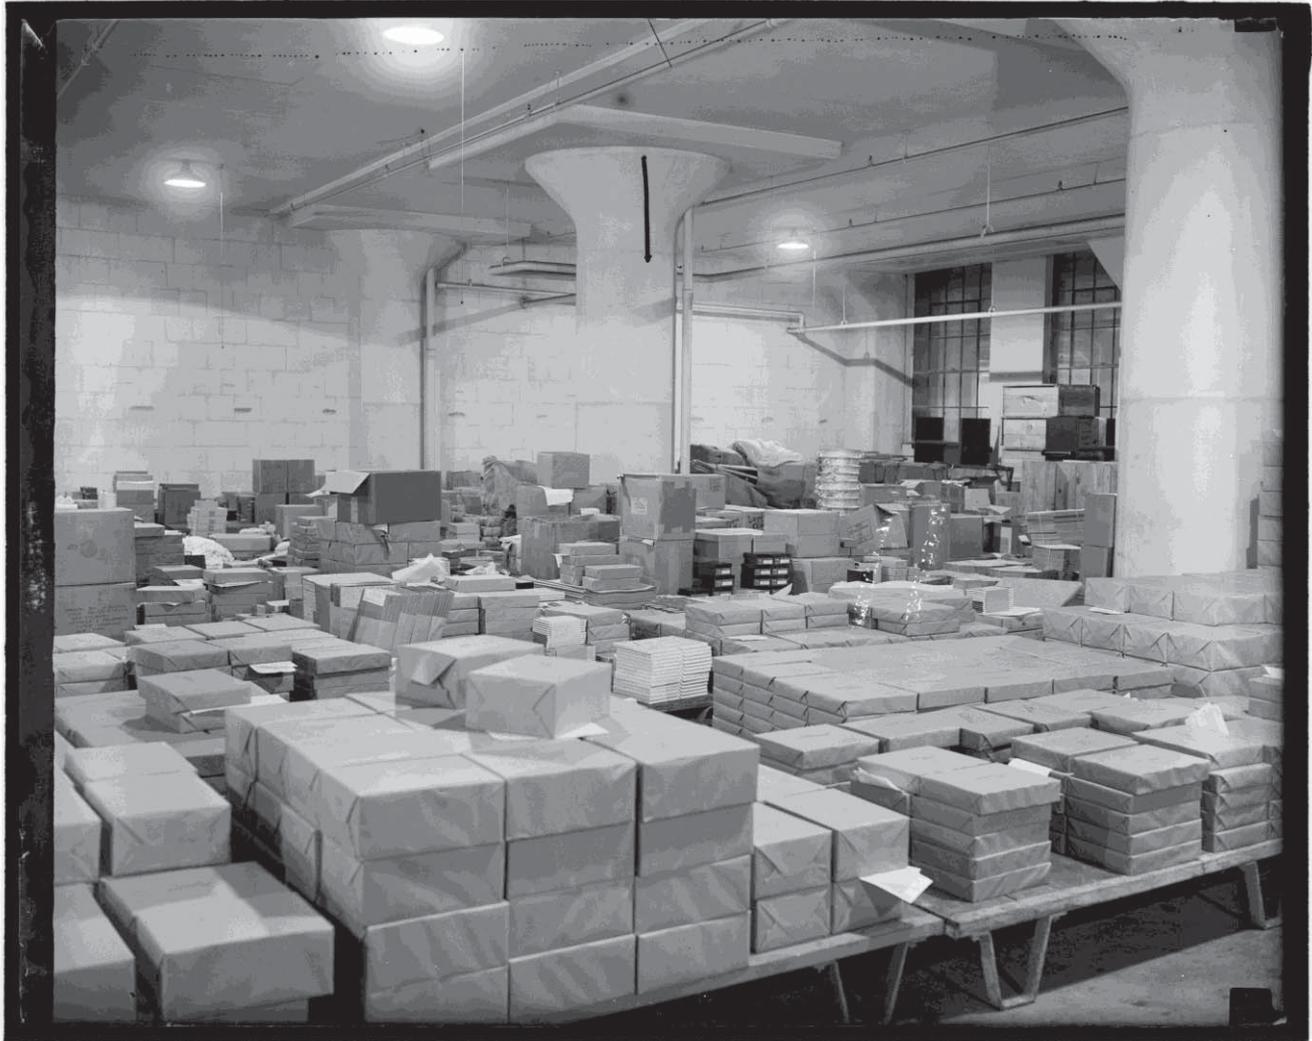
Warehouse Procurement Division Treasury Department, Interior, c.1937, Courtesy of: Library of Congress.

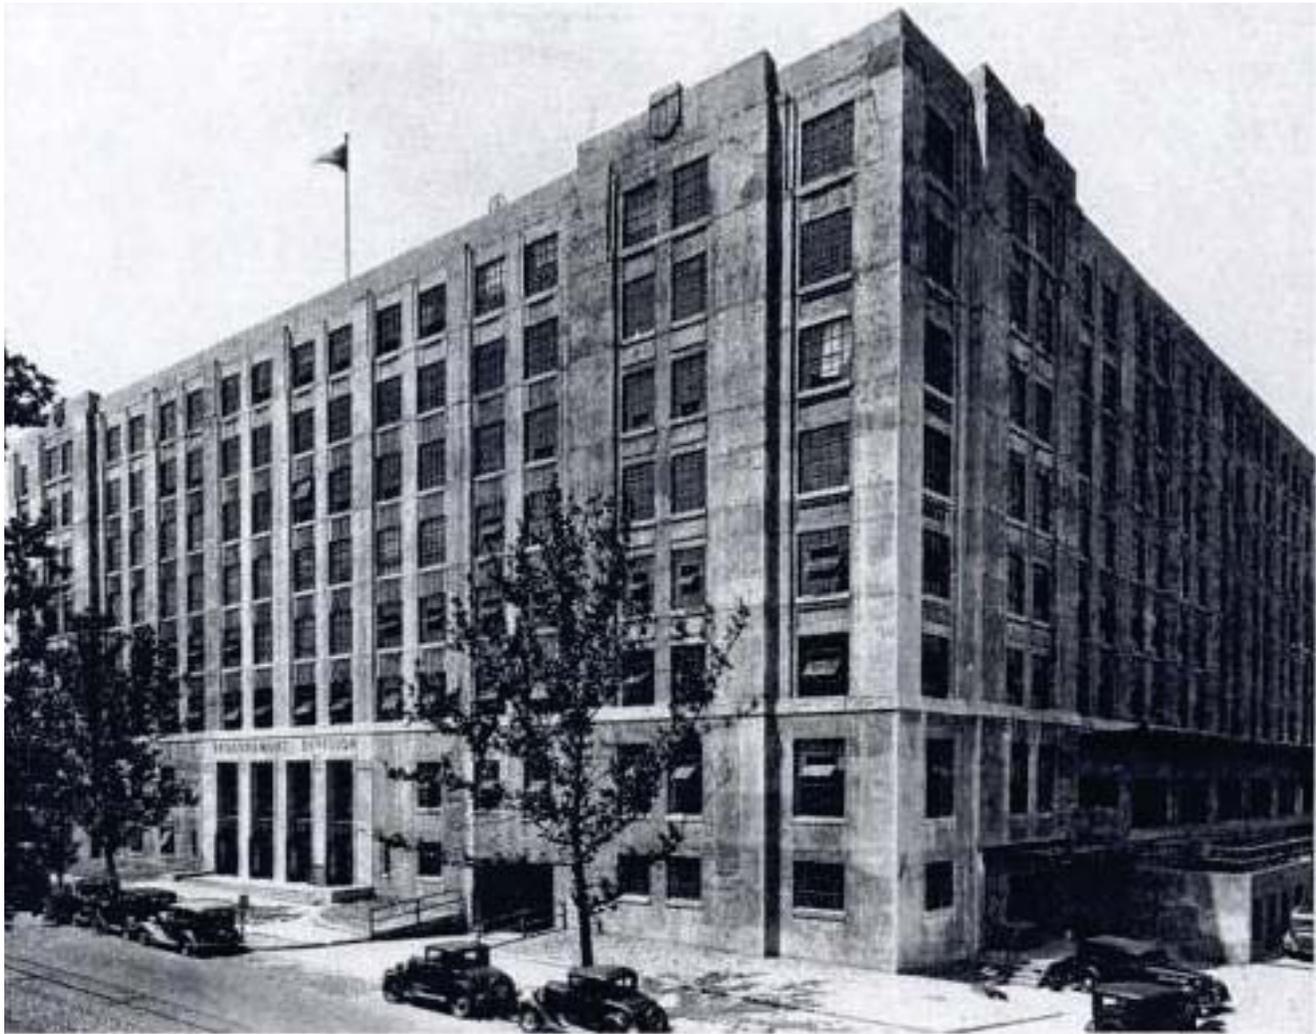
Procurement Building, c.1930, National Archives Records Administration, from *Architects to the Nation: The Rise and Decline of the Supervising Architect's Office* (Lee, 2000)
