ANACOSTIA HISTORIC DISTRICT DESIGN GUIDELINES

D.C. HISTORIC PRESERVATION REVIEW BOARD

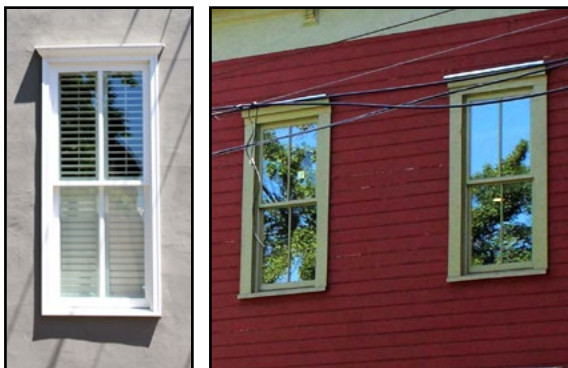
COMPATIBLE

These examples have successfully replicated the glazing and material of the historic windows.

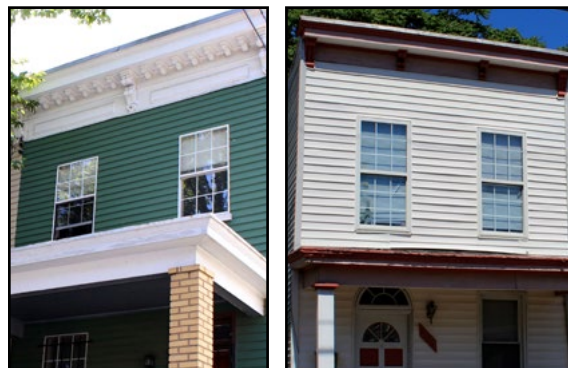
INCOMPATIBLE

Lacking depth, their original surrounds, and glazing configurations, these replacement windows diminish the character of their buildings.

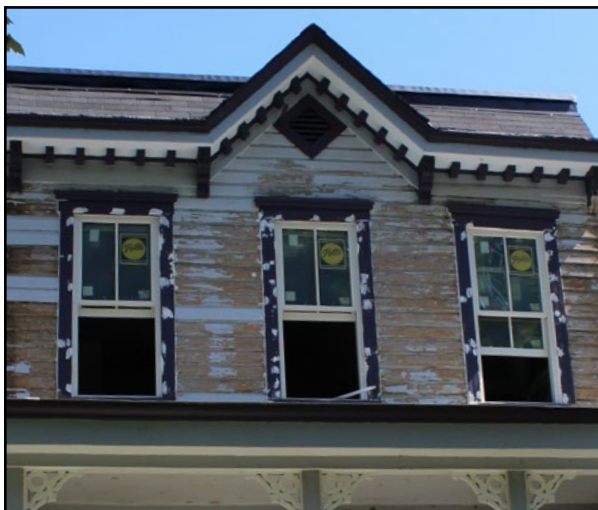
Windows here are being replaced to match their historic appearance and glazing pattern.

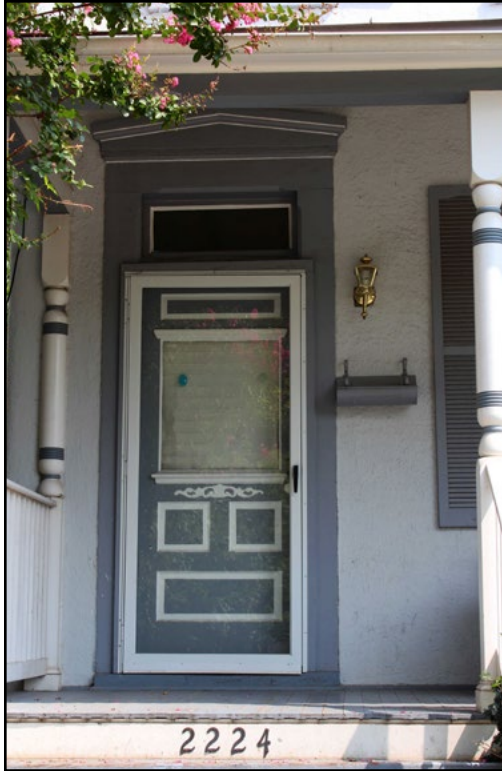
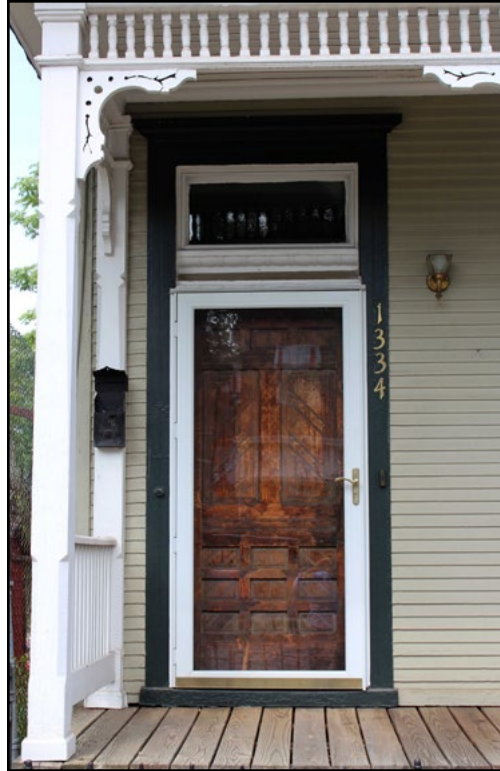
The addition of glazed storm doors allowed these original doors to be seen and protected and improves their energy efficiency.

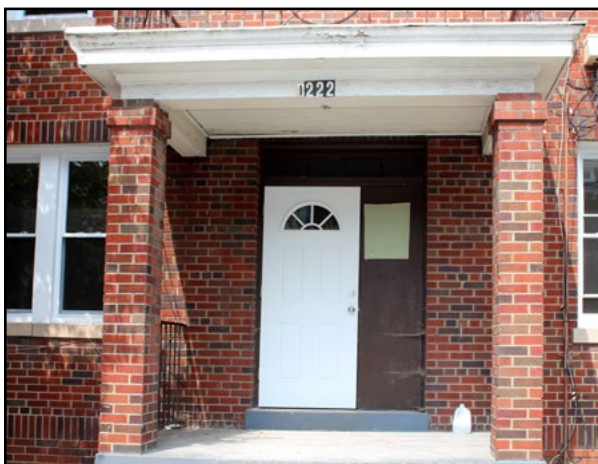
Fanlight-style doors are not appropriate replacements.

Doors with an integral arched window or fanlight are not a traditional type and should not be used on portions of a building that could be seen from the street. Fully or predominantly glazed doors are similarly incompatible.

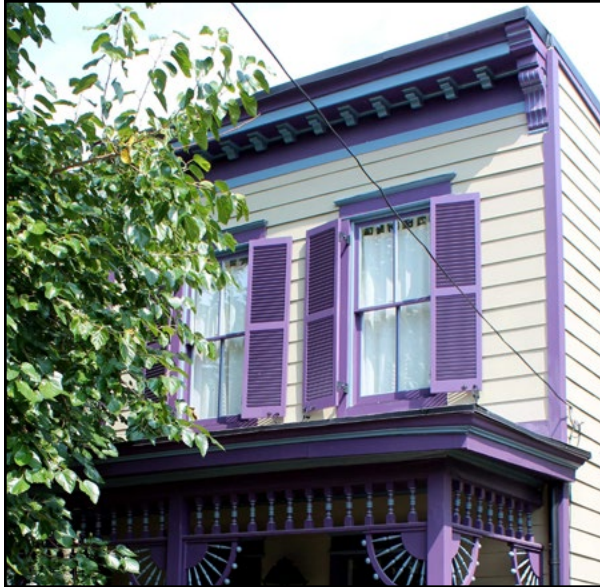
Compatible, operable louvered wood shutters

The windows of Italianate, Cottage, and Queen Anne-style buildings also sometimes featured shutters. If replacement shutters are being considered, operable louvered wood shutters should be used. If operable windows cannot be used, the shutters should be sized to correspond to the width of the window and hung in such a way as to appear operable. Fixed vinyl shutters are not appropriate for historic properties.

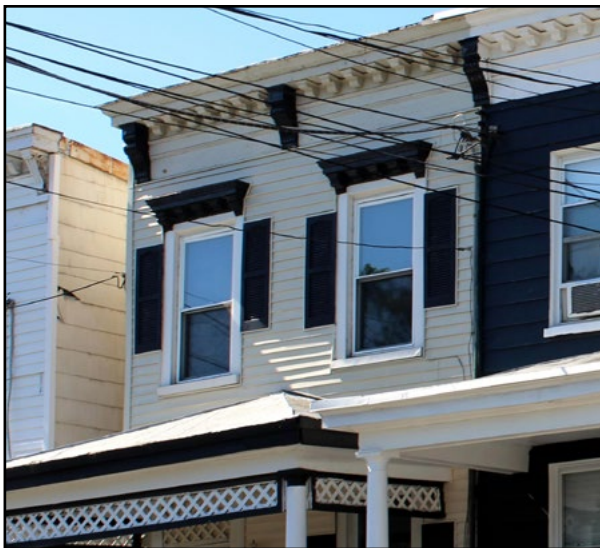
These incompatible, fixed vinyl shutters do not match the height or width of their corresponding windows.

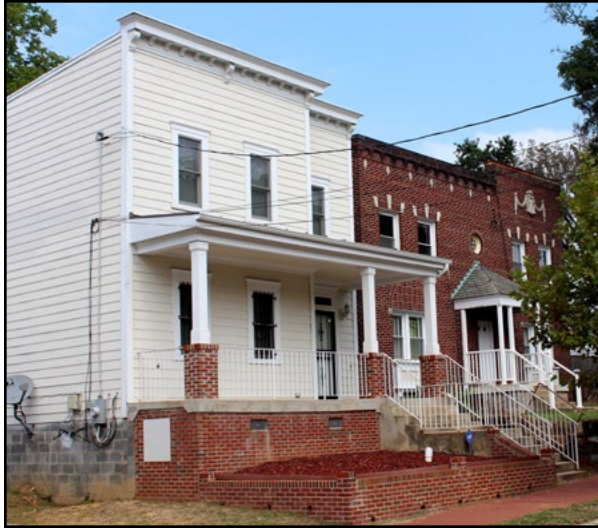
Fiber-cement siding was used on this new building.

Few substitute products are appropriate for use on historic frame buildings, and repair or in-kind replacement should be undertaken on primary elevations. Fiber-cement siding may be used on new construction, additions, outbuildings, and on rear walls of historic houses. It may also be applied to side walls fewer than three feet distant from neighboring buildings or in areas that are not prominently visible or easy to access for maintenance. The profiles available in fiber-cement are limited, however, and the thickness is noticeably much less than that of traditional wood siding.

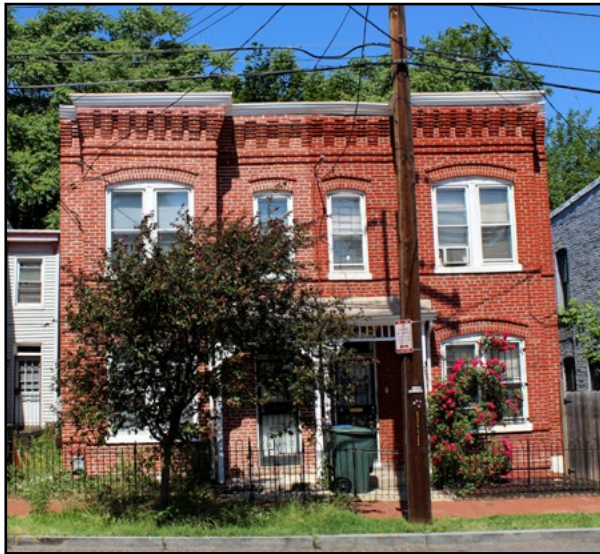
The house on the left was recently repointed. The mortar successfully reproduced the composition and color of the original.

When masonry walls are repointed, old mortar should be removed with hand tools and not with a saw or grinder, which may damage the surface of the brick. Replacement mortar should be of the same consistency and color as the original mortar, typically made principally of lime and sand. Mortar must be softer than the surrounding brick, allowing it to absorb stresses along the wall surface, therefore protecting the brick from damage. It is important to identify the exact color and composition of the historic mortar before

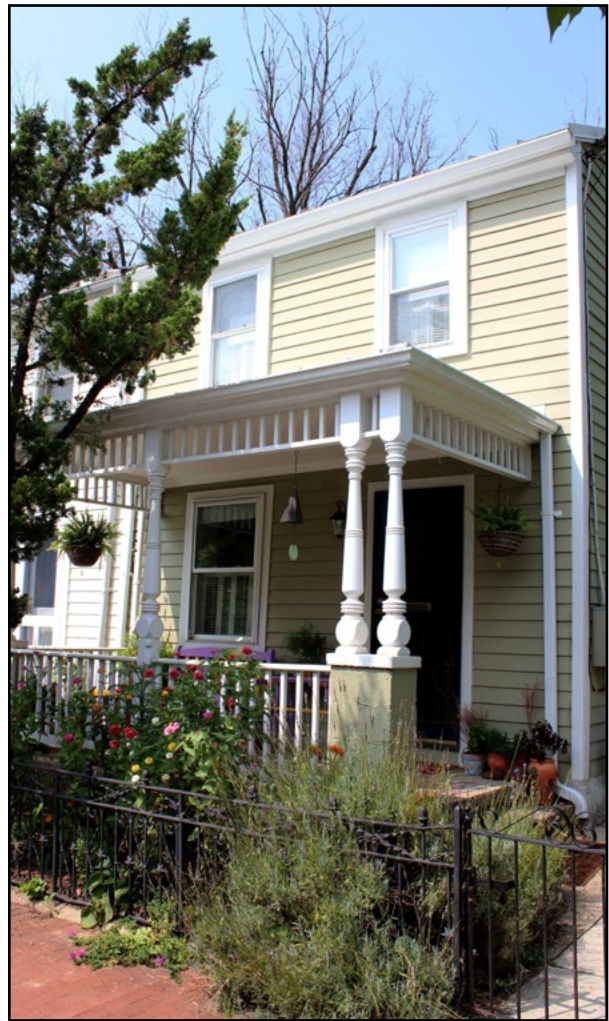
This porch of this house features a spindlework frieze, elaborately turned posts, and masonry piers.

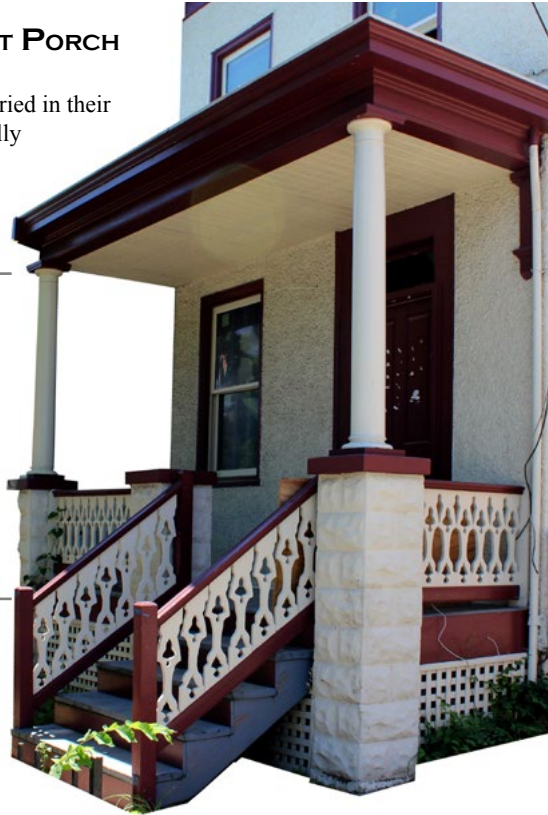
ANATOMY OF A FRONT PORCH

STAIRS & FLOORING Porch floors were usually composed of wood decking, or in some cases concrete slabs. Stairs generally matched the design and material of the porch and flooring.

CEILING The ceilings of porches were usually flat or sloped and covered in painted beadboard.

Porches consisted of several primary components: the decking or floor, the supporting piers and apron, the stairs and railing, the supporting posts or columns, and the roof. These components could be found in a variety of materials including wood, brick, metal, stone and concrete. Such parts are not necessarily interchangeable; it is important to carefully consider the compatibility of porch elements with the style and period of a particular house.

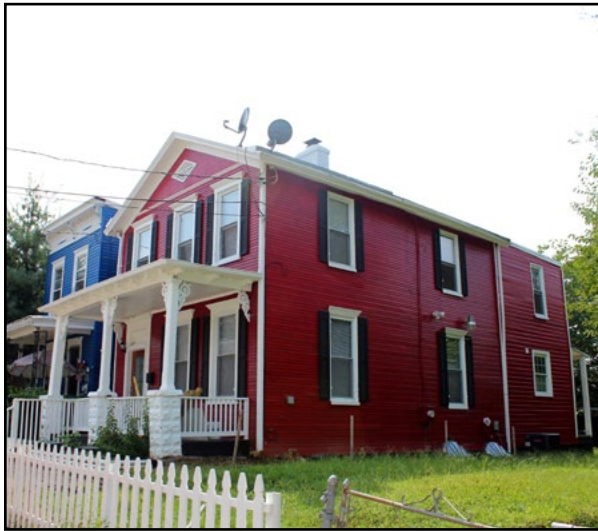
In this compatible rear addition, altering the profile of the siding, the roofline, and the window size allowed the addition to be clearly defined from the original building.

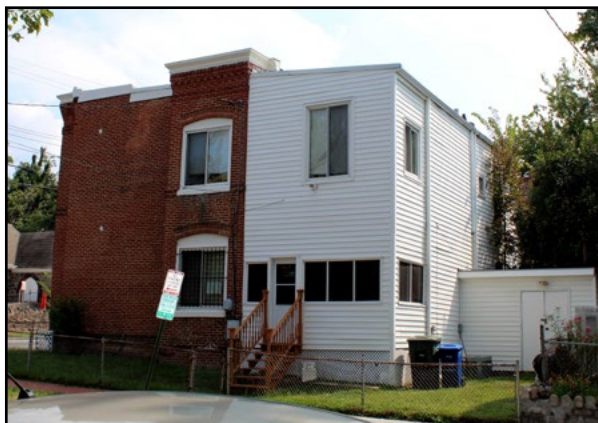
The prominence and projection of this incompatible addition visually competes with the original building. The addition's side wall should have been aligned with that of the house, set behind the bay.
