ANACOSTIA HISTORIC DISTRICT DESIGN GUIDELINES

D.C. HISTORIC PRESERVATION REVIEW BOARD

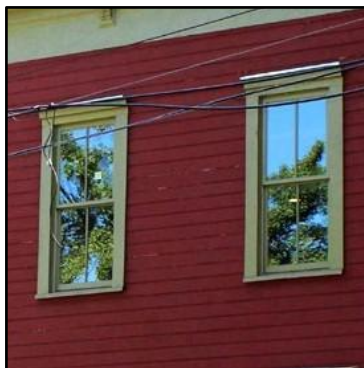
COMPATIBLE

These examples have successfully replicated the glazing and material of the historic windows.

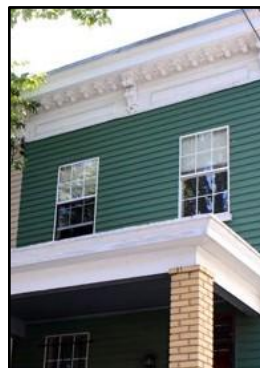
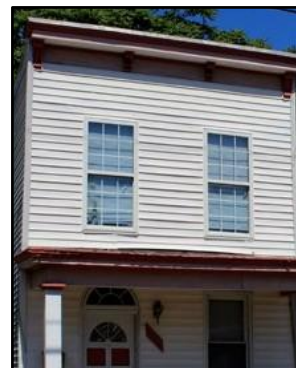
INCOMPATIBLE

Lacking depth, their original surrounds, and glazing configurations, these replacement windows diminish the character of their buildings.

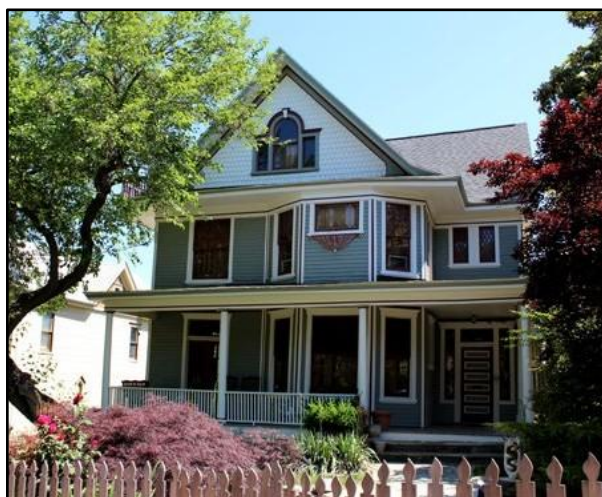
Queen Anne-style buildings often featured a greater variety of window shapes & glazing.

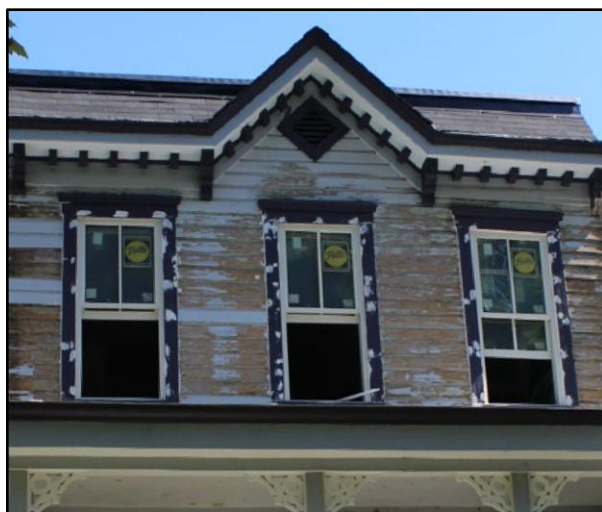
Windows here are being replaced to match their historic appearance and glazing pattern.

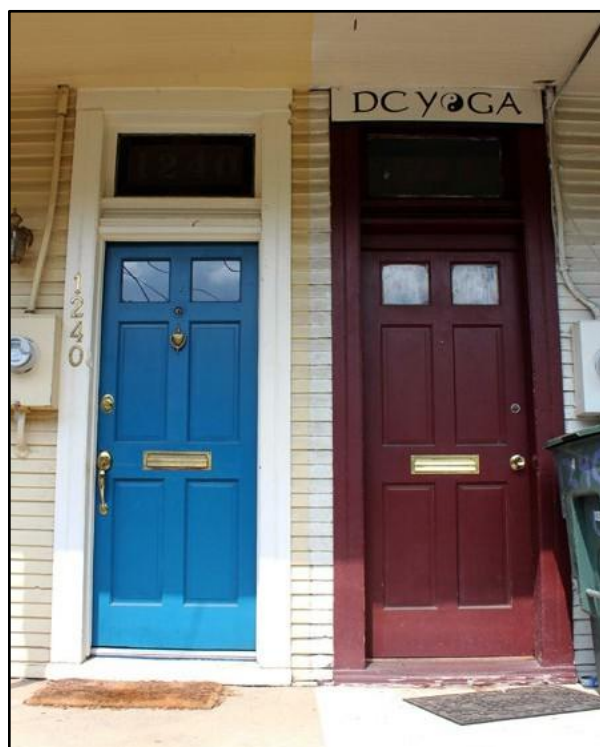
Historic wood doors in Anacostia generally had 4- or 5-paneled configurations and sometimes incorporated glazing on the upper panels.

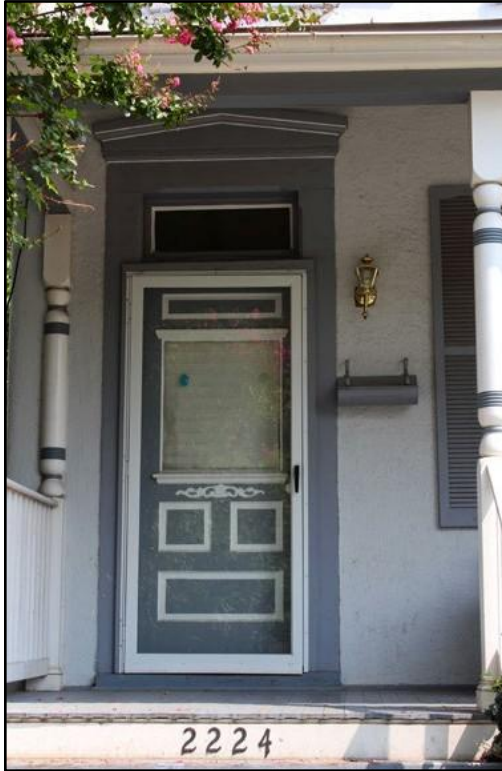
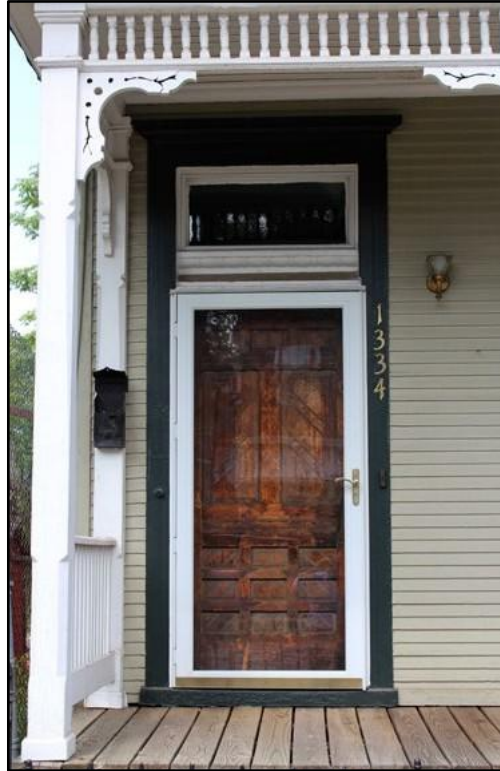
The addition of glazed storm doors allowed these original doors to be seen and protected and improves their energy efficiency.

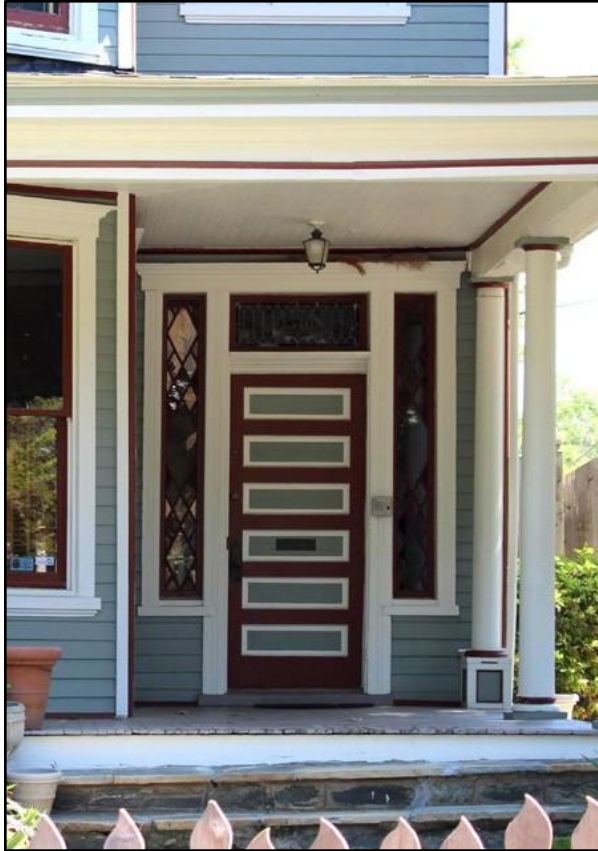
Original doors, transoms, and sidelights should be preserved as important character-defining features.

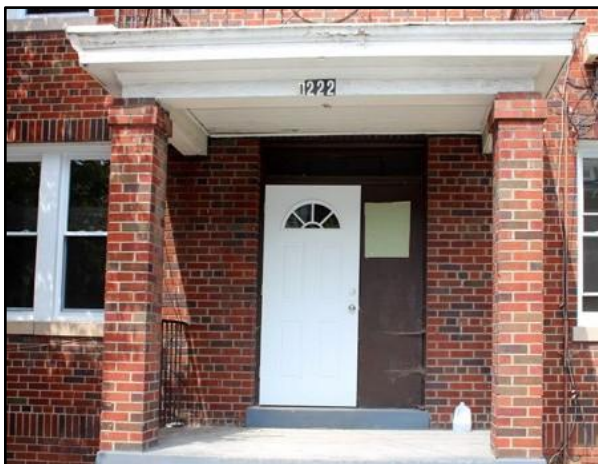
Fanlight-style doors are not appropriate replacements.

Doors with an integral arched window or fanlight are not a traditional type and should not be used on portions of a building that could be seen from the street. Fully or predominantly glazed doors are similarly incompatible.

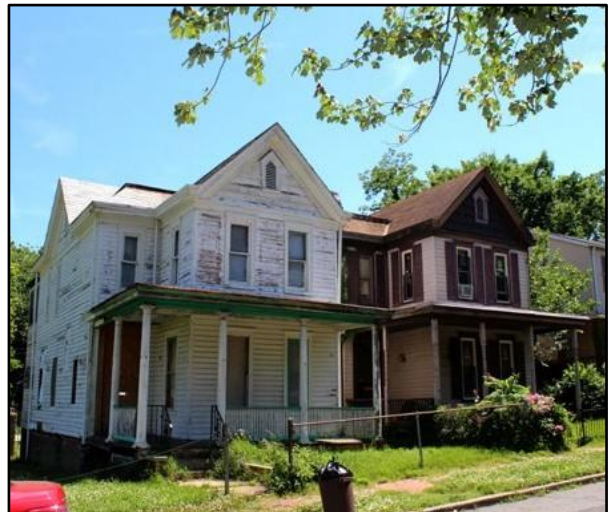
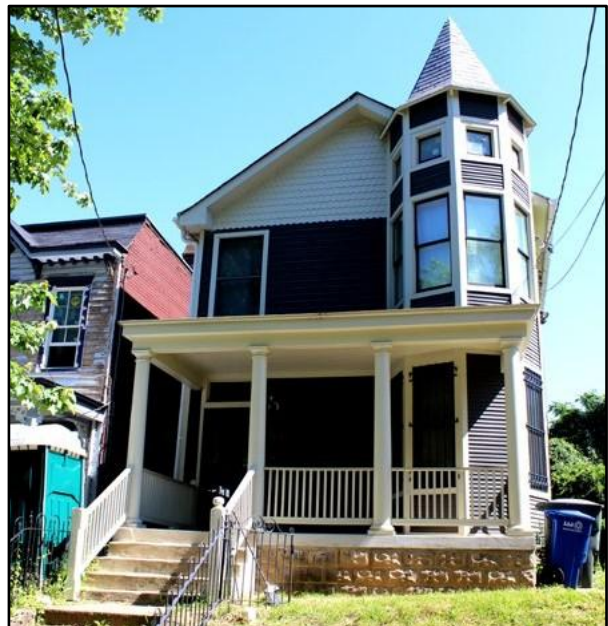
Detached houses with gabled roofs are found throughout Anacostia. Such houses occasionally incorporated towers or cross gables.

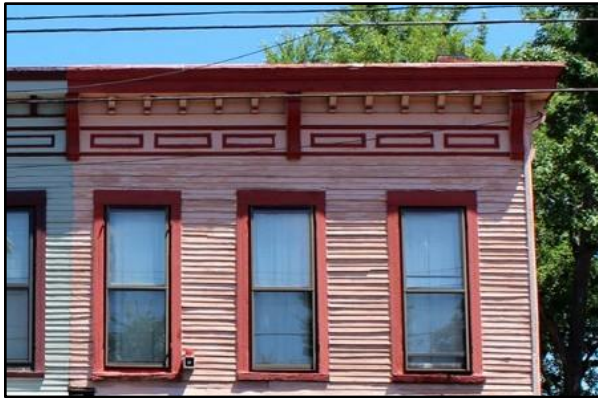
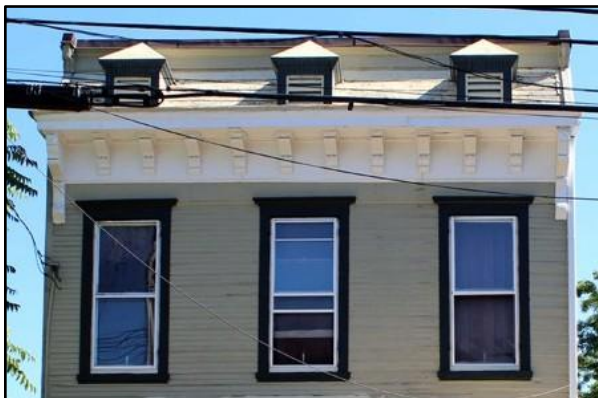
Decorative wood cornices or pent roofs were often used to embellish façades and conceal sloping roofs.

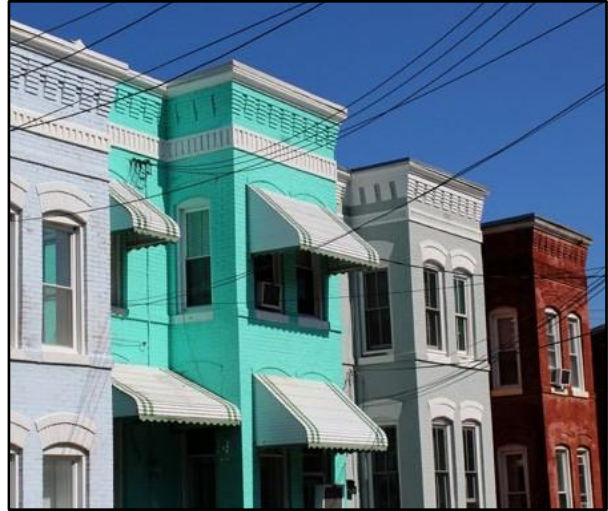
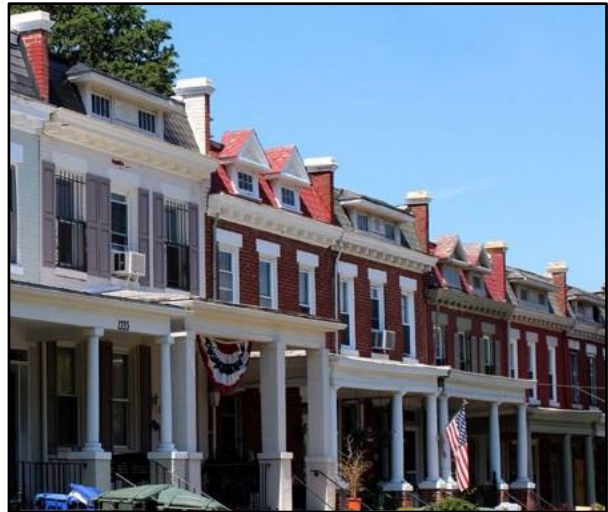
Corbelled brick details and dormers enlivened and united rows of houses.

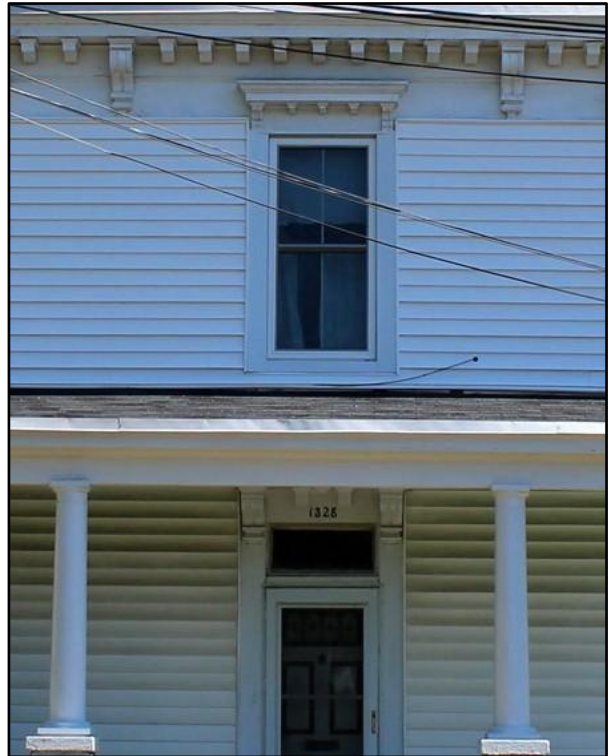
Above: Window and door surrounds often reproduce elements found elsewhere on the building on a smaller scale.

The architectural details found in roofs, cornices, and porches were often carried into window and door surrounds. Frequently, decorative hoods would reproduce on a smaller scale the brackets and dentils found at the eave.

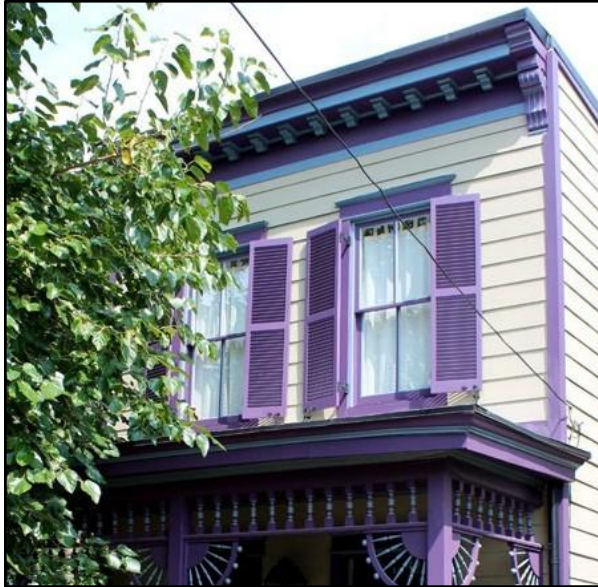
Compatible, operable louvered wood shutters

The windows of Italianate, Cottage, and Queen Anne-style buildings also sometimes featured shutters. If replacement shutters are being considered, operable louvered wood shutters should be used. If operable windows cannot be used, the shutters should be sized to correspond to the width of the window and hung in such a way as to appear operable. Fixed vinyl shutters are not appropriate for historic properties.

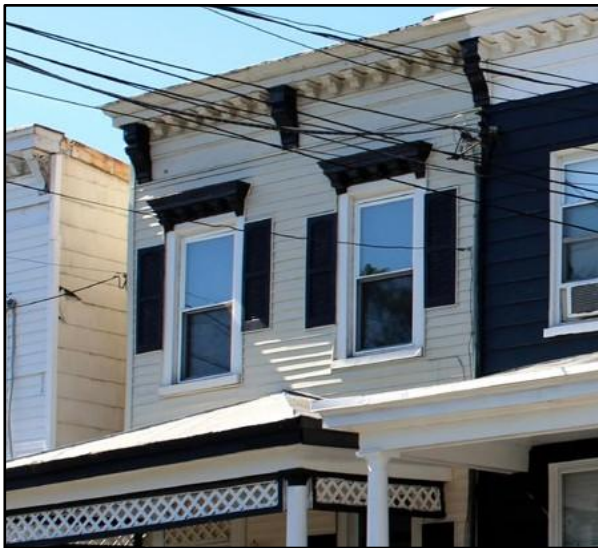
These incompatible, fixed vinyl shutters do not match the height or width of their corresponding windows.

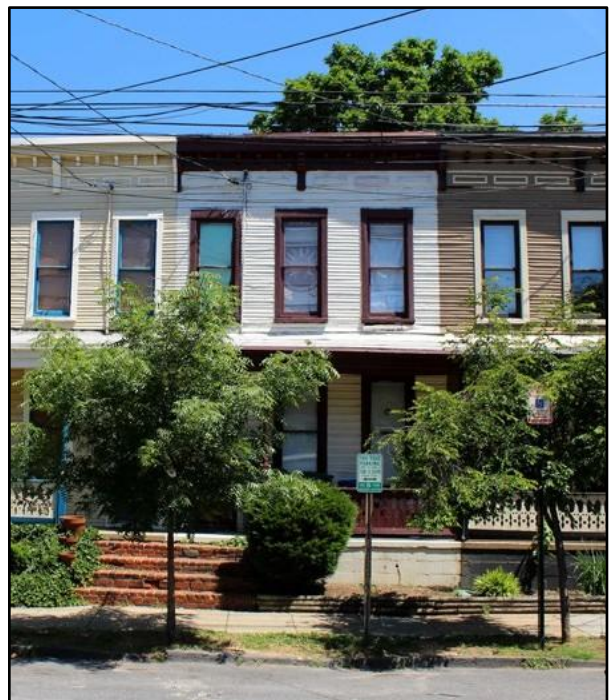
Primary, street-facing elevations typically featured the most expensive and decorative finishes and features.

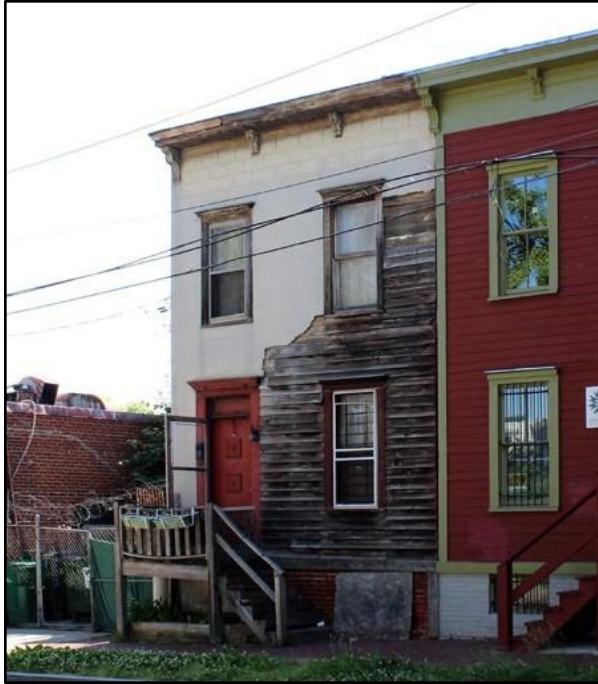
Here, stucco was applied directly atop the earlier cladding.

Throughout the 20th century, it was a common occurrence for replacement materials to be applied directly atop the existing siding. These materials, including vinyl and aluminum siding, stucco, and formstone veneer, served to encase and preserve the original siding. It is often possible to remove the later cladding and restore the original, repairing or reusing the existing materials.

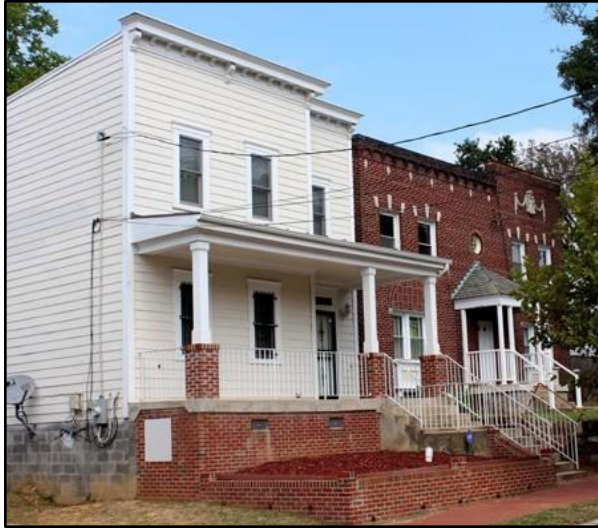
Fiber-cement siding was used on this new building.

Few substitute products are appropriate for use on historic frame buildings, and repair or in-kind replacement should be undertaken on primary elevations. Fiber-cement siding may be used on new construction, additions, outbuildings, and on rear walls of historic houses. It may also be applied to side walls fewer than three feet distant from neighboring buildings or in areas that are not prominently visible or easy to access for maintenance. The profiles available in fiber-cement are limited, however, and the thickness is noticeably much less than that of traditional wood siding.

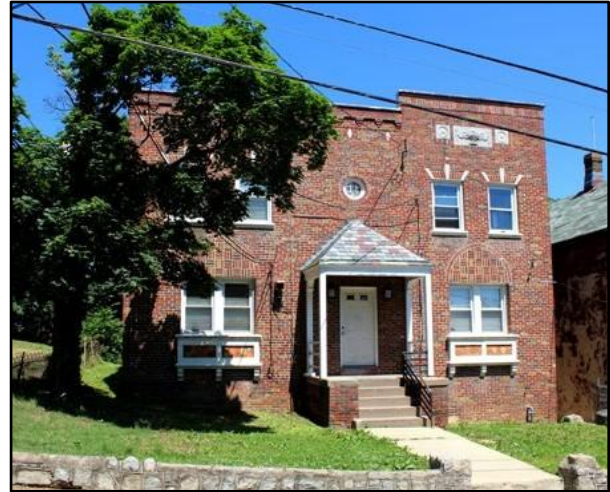
The façade of this small apartment building incorporated a mix of masonry materials and patterns.

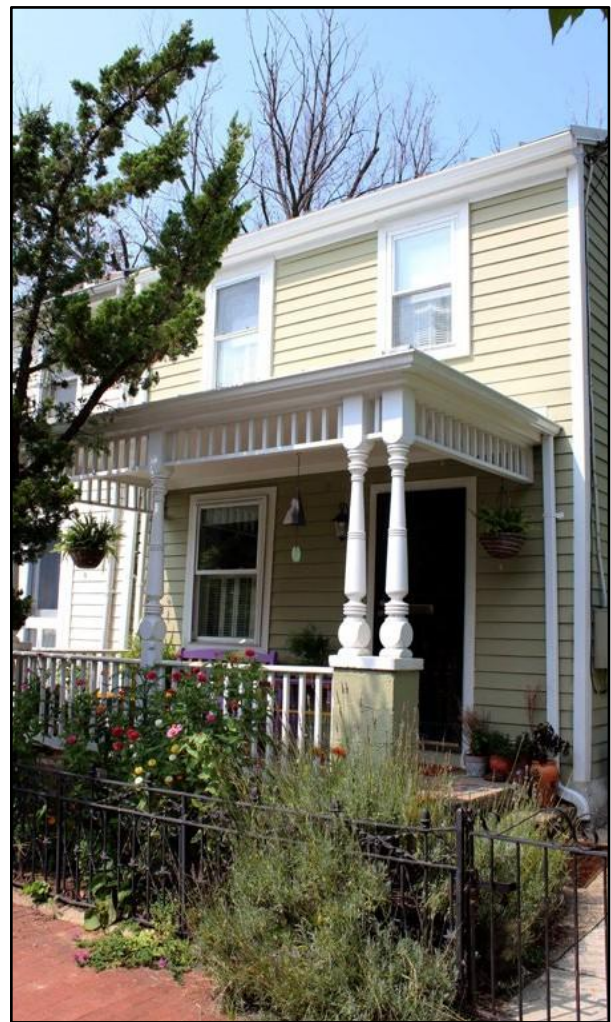
This porch of this house features a spindlework frieze, elaborately turned posts, and masonry piers.

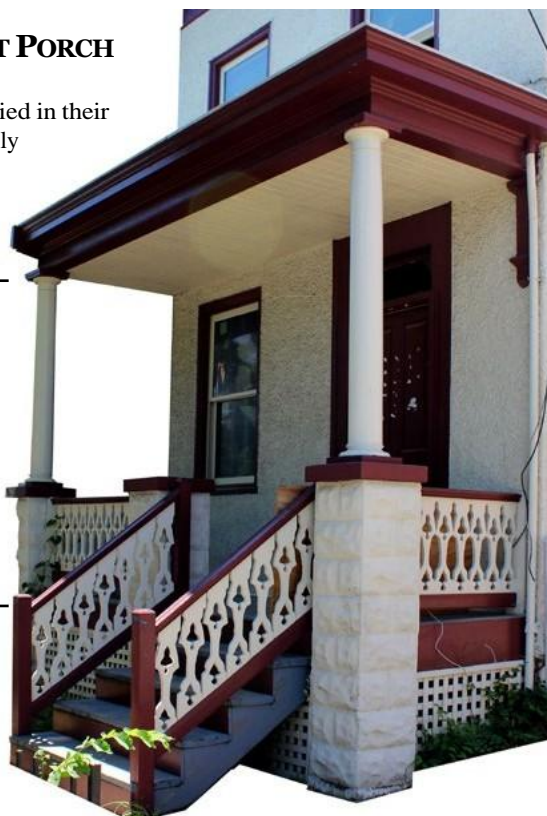
CEILING The ceilings of porches were usually flat or sloped and covered in painted beadboard.

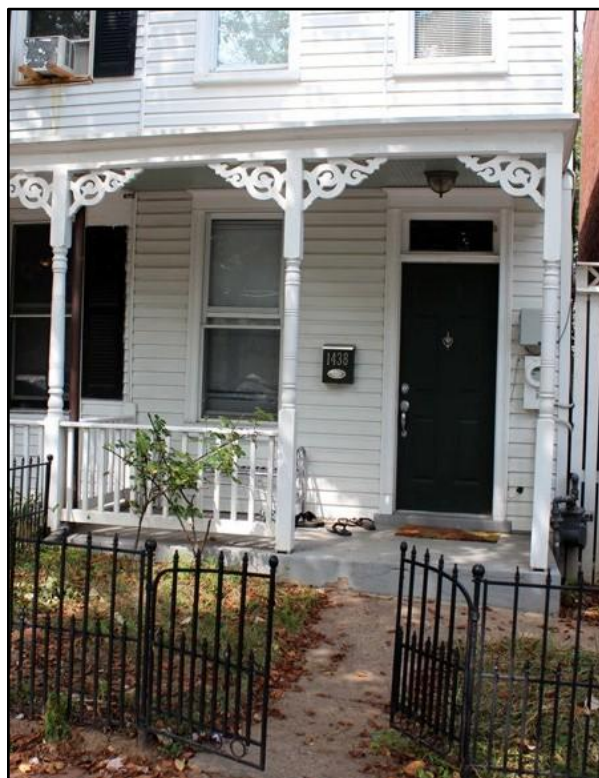
Railings were usually painted, with low grip rails and square-section balusters. Both turned and splat-type balusters were also occasionally used. Balustrades had a horizontal bottom rail supporting the balusters inches above the deck. Most porch roofs were flat or shallowly hipped, with beadboard ceilings. Detailing on porches ranged from plain to quite elaborate, in character with the size and ornamentation of their corresponding houses.

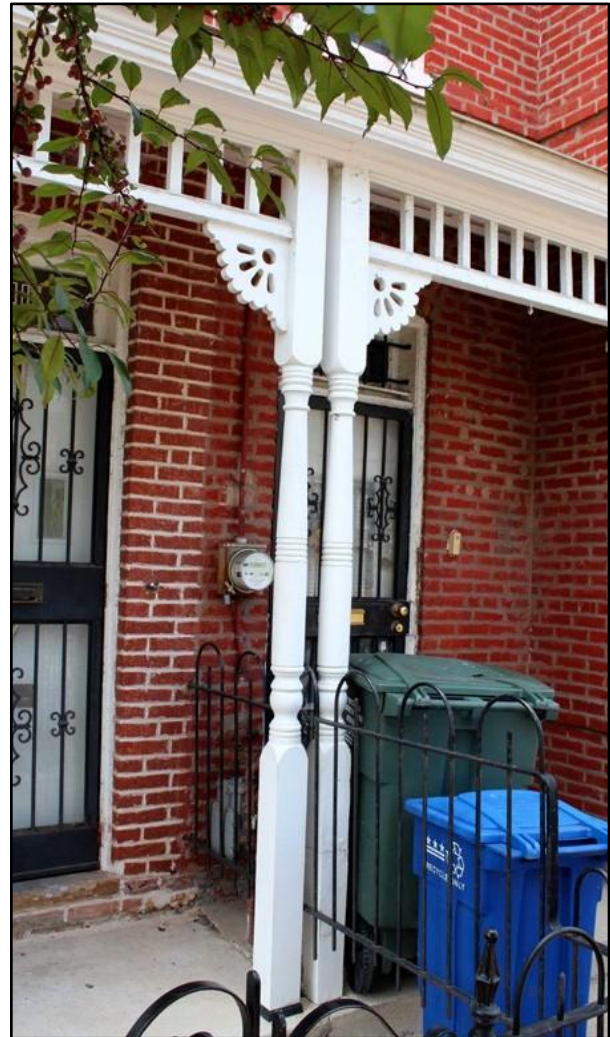
The elements on the left are modern replacements. They were replicated to match existing components on the adjoining house.

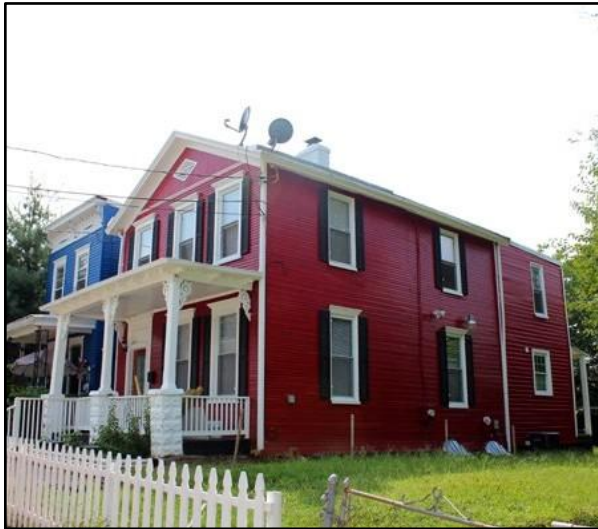
In this compatible rear addition, altering the profile of the siding, the roofline, and the window size allowed the addition to be clearly defined from the original building.

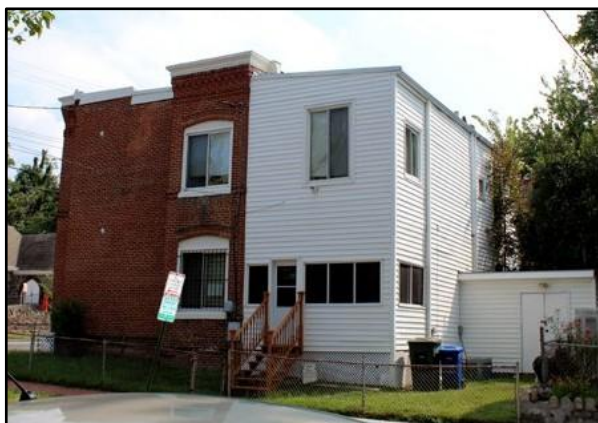
The prominence and projection of this incompatible addition visually competes with the original building. The addition's side wall should have been aligned with that of the house, set behind the bay.

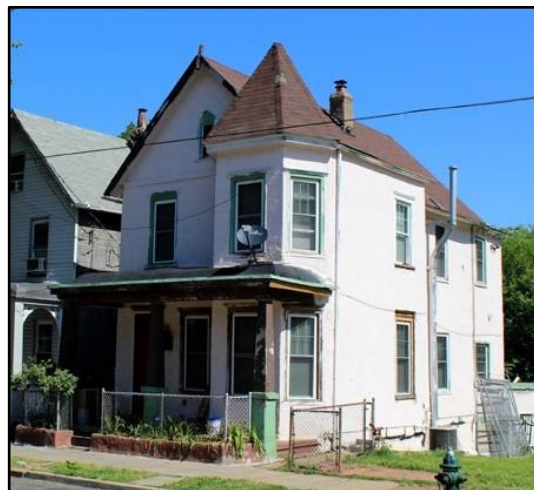
Satellite dishes and other appurtenances should not be mounted on the fronts of buildings or other prominent locations such as porches, mansard roofs, turrets, etc.

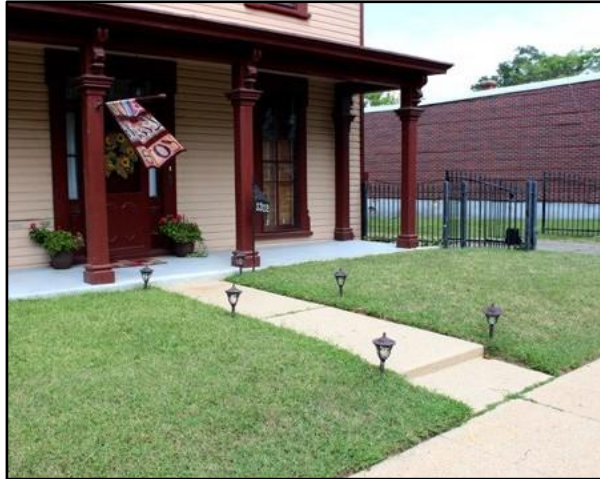
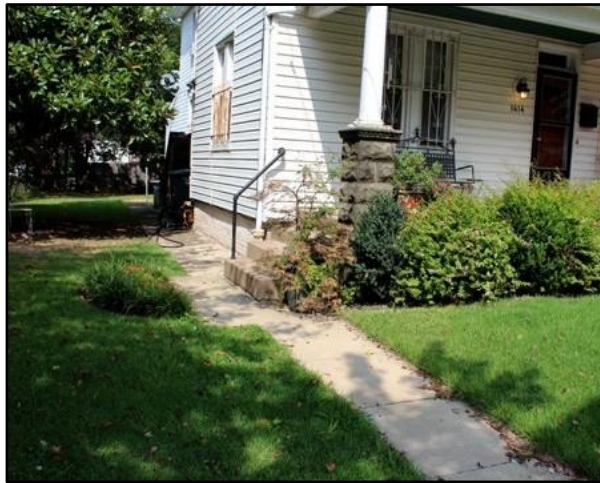
A narrow, direct sidewalk is the preferred type.

door, although some branch off at a right angle to run around one side of a house and to the rear of a property. Walks were historically no more than three feet wide in this neighborhood and should remain as narrow as possible while permitting necessary passage.

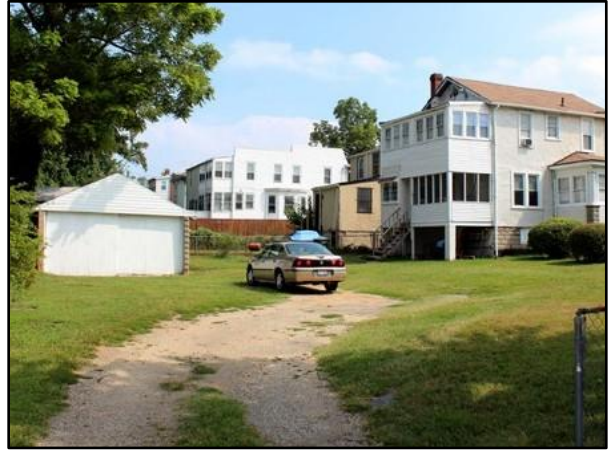
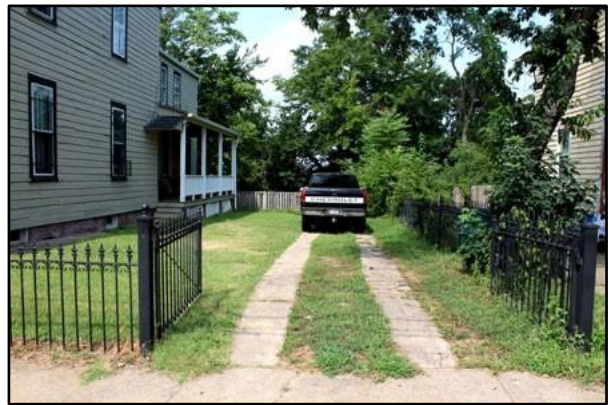
Gravel (above) or parallel tracks of concrete divided by turf (below) were common historically.

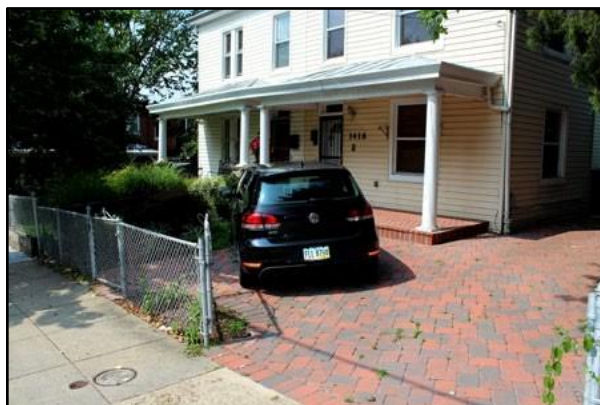
Parking spaces should never be located in the front yard. The extensive paving used to create this drive is not compatible with the character of the original landscape.

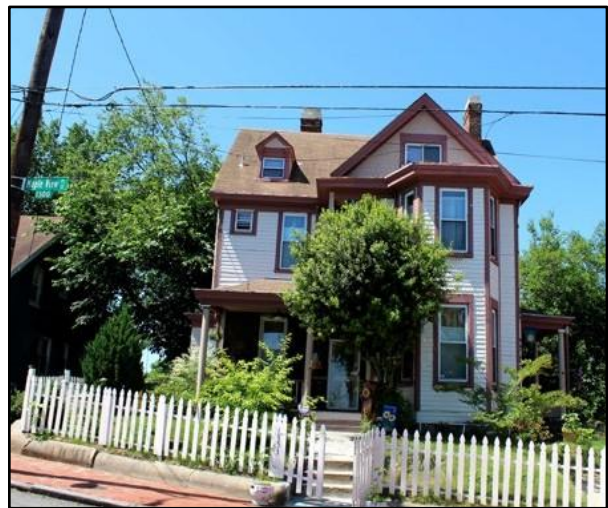
Painted wood picket fences are the most compatible with Anacostia's frame houses. The texture, finish, and details of vinyl or other substitute materials are not compatible or acceptable as replacements for wood. Painted, pressure-treated wood may be an acceptable alternative to other durable woods such as cedar and redwood.

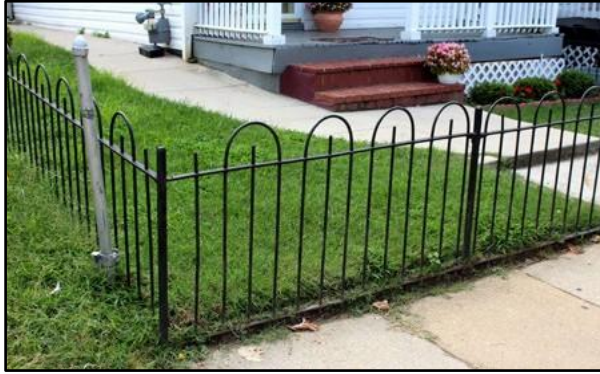
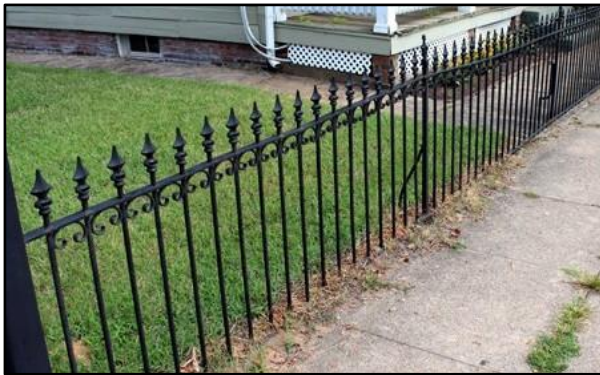
Examples of typical wrought-iron fence patterns

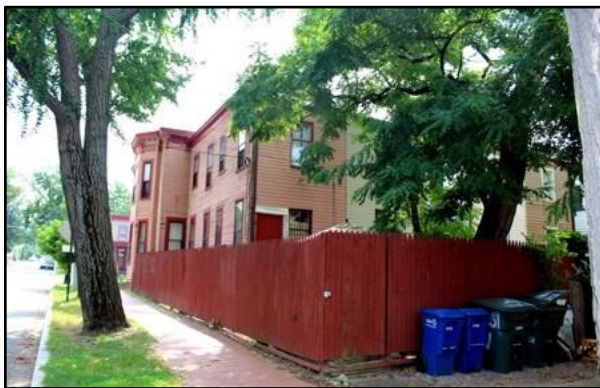
Plank fences can provide privacy for rear and side yards. Where fences face a public street, wood is the preferred material.

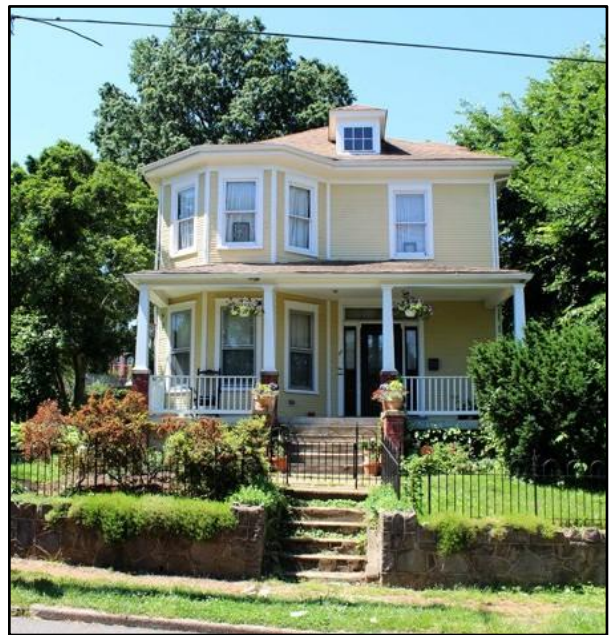
Retaining walls provide space for sidewalks, level lawns, and landscaping.

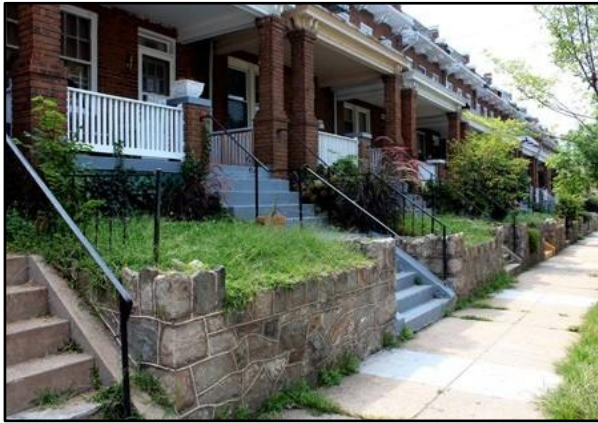
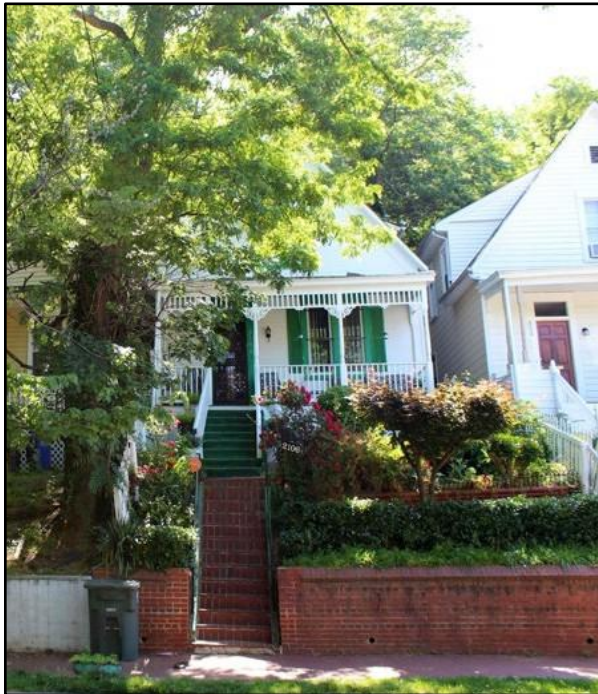
The design and material of new retaining walls should respond to the character of their associated houses.

For replacement walls, or those few instances where a new wall might be necessary, their design and placement should be based on an existing wall to be replaced, on original walls at nearby properties, or upon documentary or photographic evidence. In addition to the material of a wall, attention should be paid to the masonry coursing, to the profile and width of mortar joints, and to minimizing the height of the wall to only what is necessary to retain an existing grade.

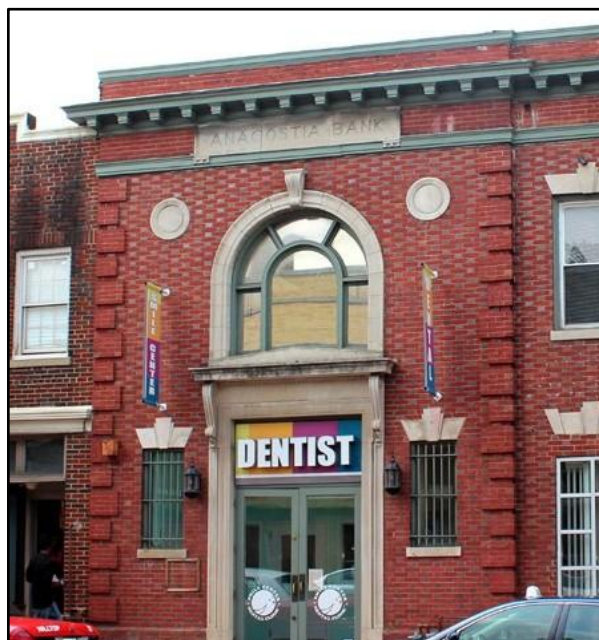
New signage on this historic bank building preserves its original architectural detailing and signage.
