# EASTERN MARKET

## Market Master's Office

April 2008

## Motivation and Goal of the Market Master's Office Conservation Report

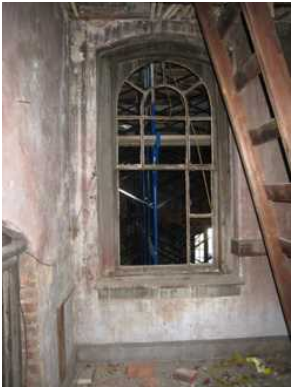
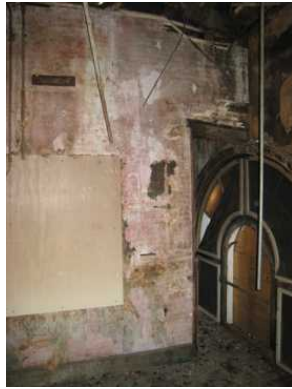
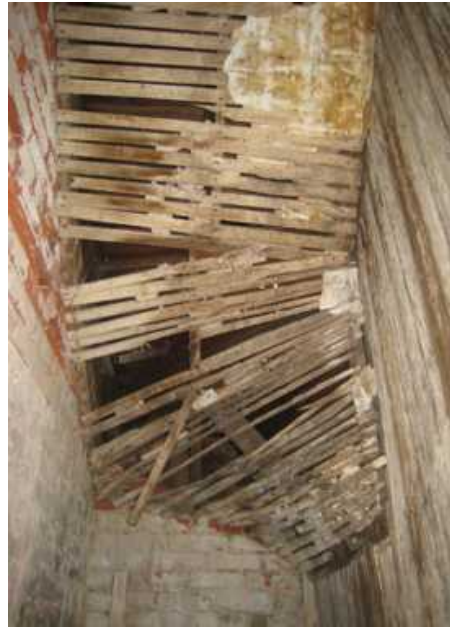
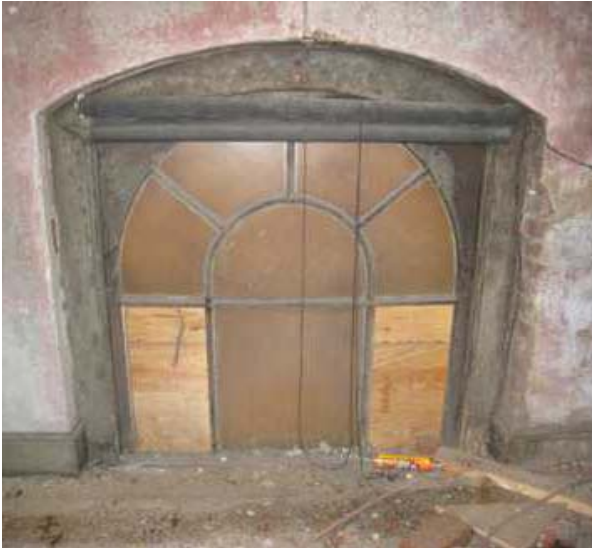
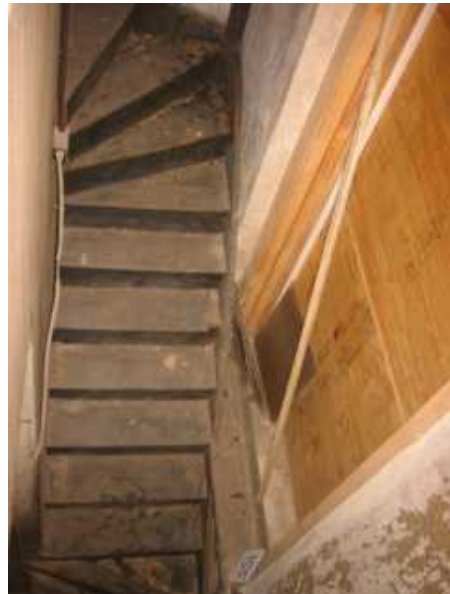
Measured drawings

- Visual examination of surfaces and finishes, including:
  - All surfaces and finishes on the second floor as visible from the interior of the space;
  - The partition and door enclosing the stair leading up to the second floor office;
  - The stair and its enclosure;
  - Interior surfaces and finishes for the windows in the exterior wall and the wall separating the office from the main market hall;
  - The knee wall and partition built above the knee wall at the stair on the second floor.

- Original configuration:
  - One room
  - No enclosures
  - High quality craftsmanship
- Condition of original materials:
  - Fair for walls, windows and floors
  - Poor for stair and ceilings

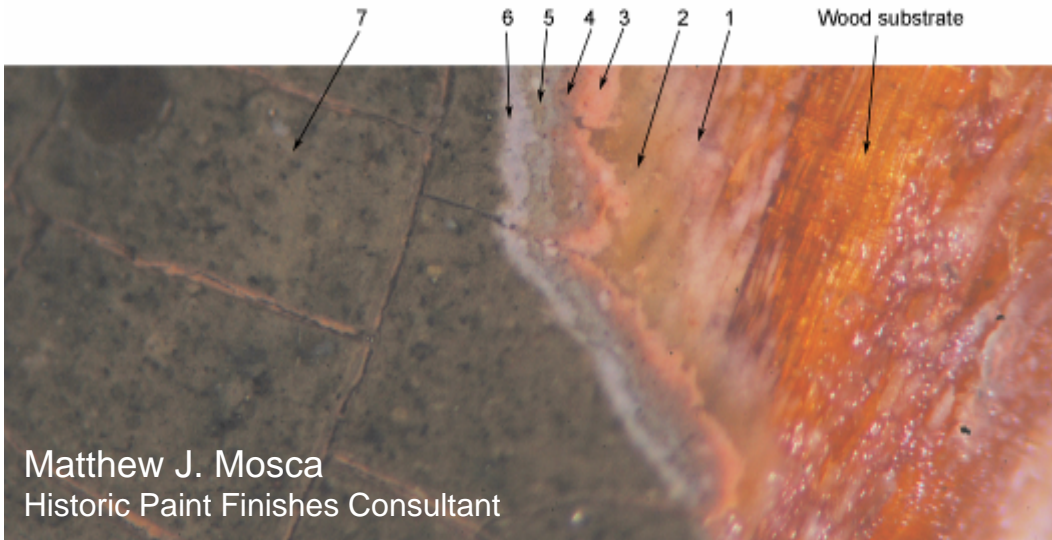
- Identification of the historic paint finish through stereoscopic and polarized-light microscopy, and microchemistry

Finish I: White primer not intended to be a finish layer (1), but left exposed in 1873 due to insufficient funds –oily coating (2).

Finish II: Yellowish pink layer (3) appears to be the first intended finish.

Finish III: Light pinkish brown layer (4).

Finish IV: This finish is a moderate grey enamel (5).

Finish V: This is the last finish (6) a light grey enamel. There is heavy surface particulate (7).

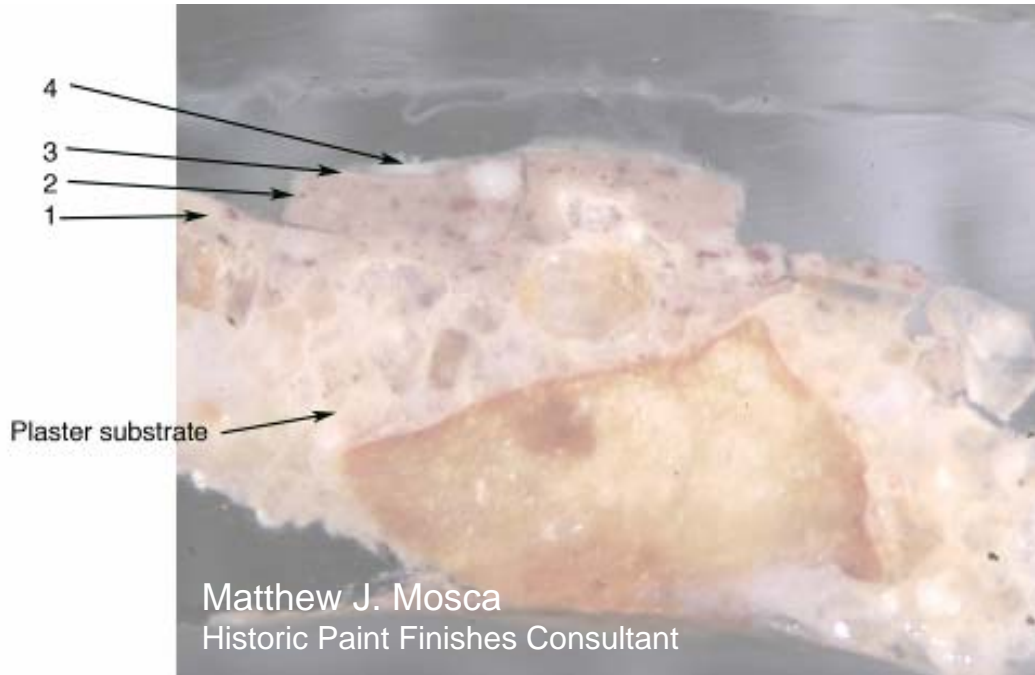
Finish 1: Pale grayish pink. Other plaster finishes not

Finish 2: Pale grayish pink. visible in this sample:

Finish 3: Pale grayish pink. Finish 5: Light yellow.

Finish 4: White.

Finish 6: Light blue.

Finish 7: Moderate red.

Finish 5: Grayish pink.

Wallpapers.
