**HISTORIC PRESERVATION REVIEW BOARD  
STAFF REPORT AND RECOMMENDATION**

Landmark/District:	U Street Historic District	(x) Agenda
Address:	941 Westminster Street NW	
Meeting Date:	March 25 <sup>th</sup> , 2023	(X) Alteration
Case Number:	HPA 23-321	(X) Permit

The applicant MCD Studio, on behalf of the owners Mark Schamel and Deborah Ritter request a permit revision to a roof deck on Westminster Street NW in the U Street Historic District.

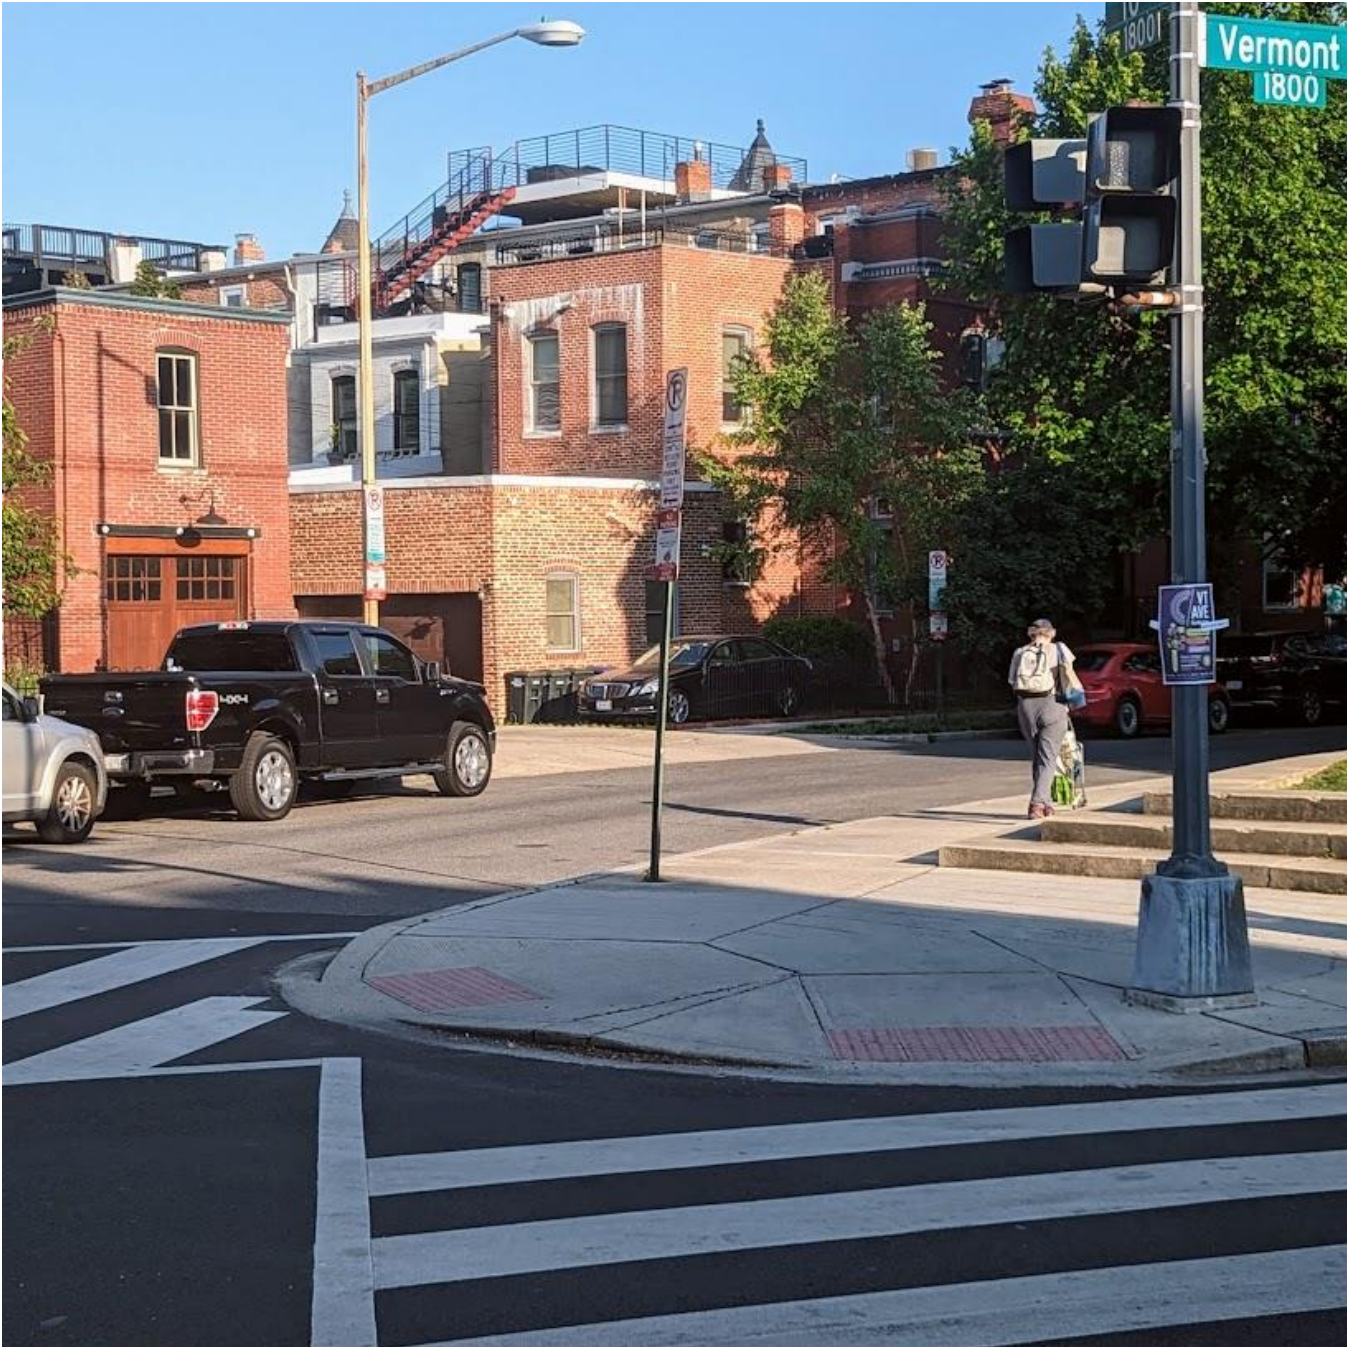
In March 2023, construction on the property was stopped for violating the approved scope of work. The construction installed the unpermitted straight-run staircase instead of the approved spiral stair. The applicant requests HPRB approval of the constructed straight-run staircase.

1: Installed Straight-run Staircase at Property

HPO recommends that the Board find the constructed straight-run stair to be incompatible in form for a location that is so visible from street view, and that a spiral stair is the most appropriate option. HPO recommends that the Board deny the permit, and direct the applicant to remove the straight run stair and install the previously-approved spiral stair.

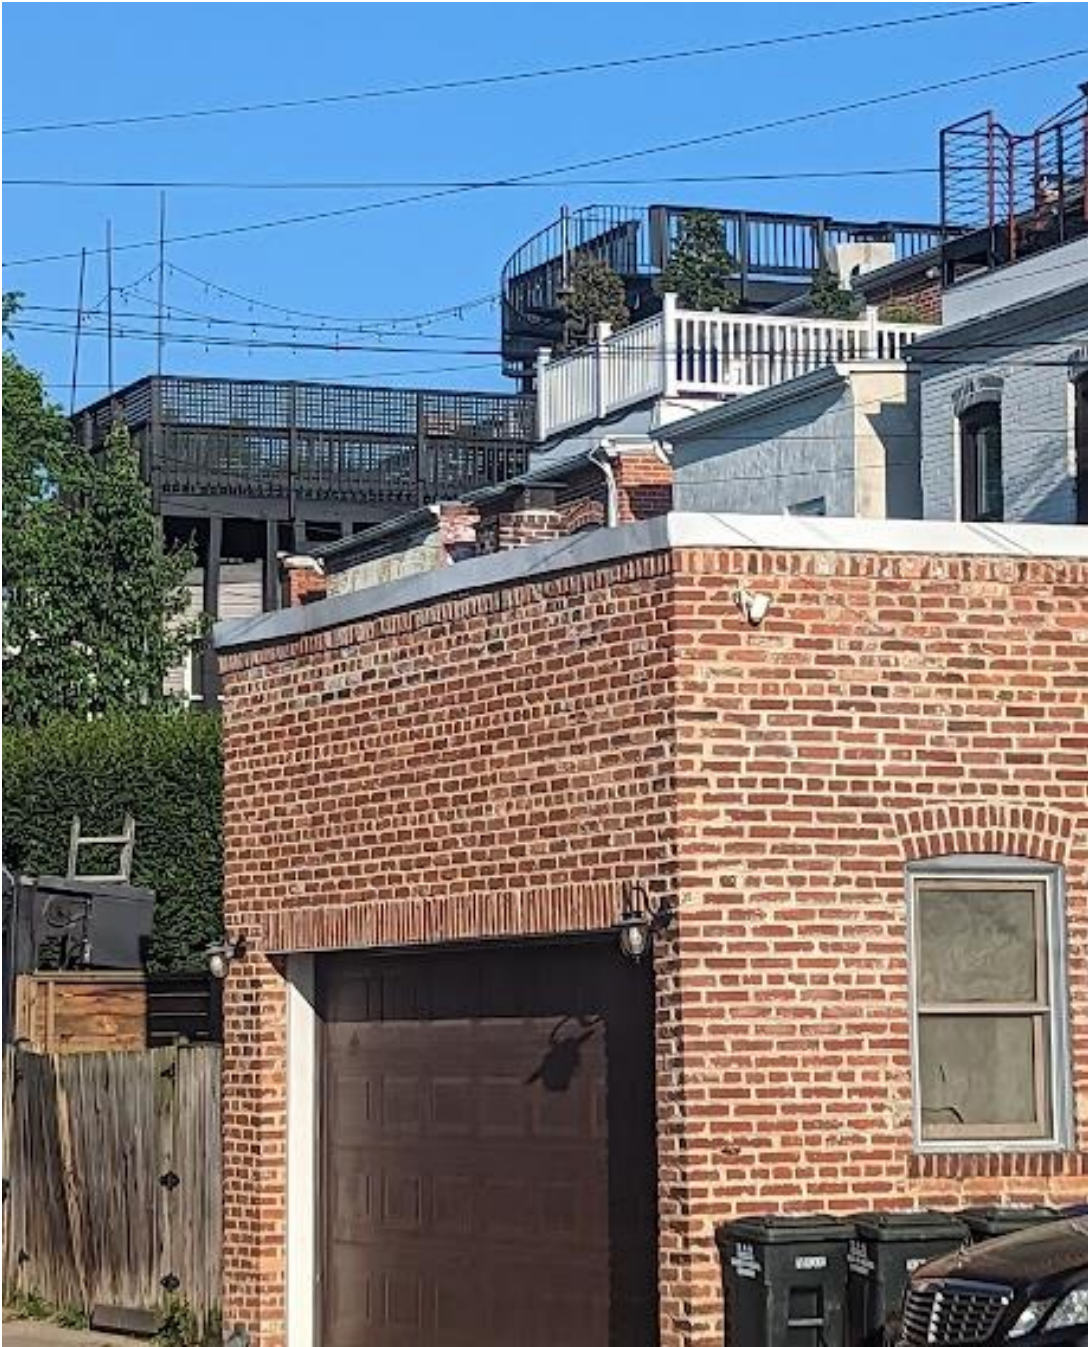
2: Existing Neighboring Roof Deck with Spiral Staircase
