**HISTORIC PRESERVATION REVIEW BOARD
STAFF REPORT AND RECOMMENDATION**

Property Address: **915 F Street NW** () Agenda
Landmark/District: **Equitable Co-Operative Building Association (Interior Landmark)** () Consent Calendar
() Denial Calendar
Meeting Date: **April 4, 2013** () Concept Review
H.P.A. Number: **#13-027** () Alteration
Staff Reviewer: **Brendan Meyer** () New Construction
() Demolition
() Subdivision

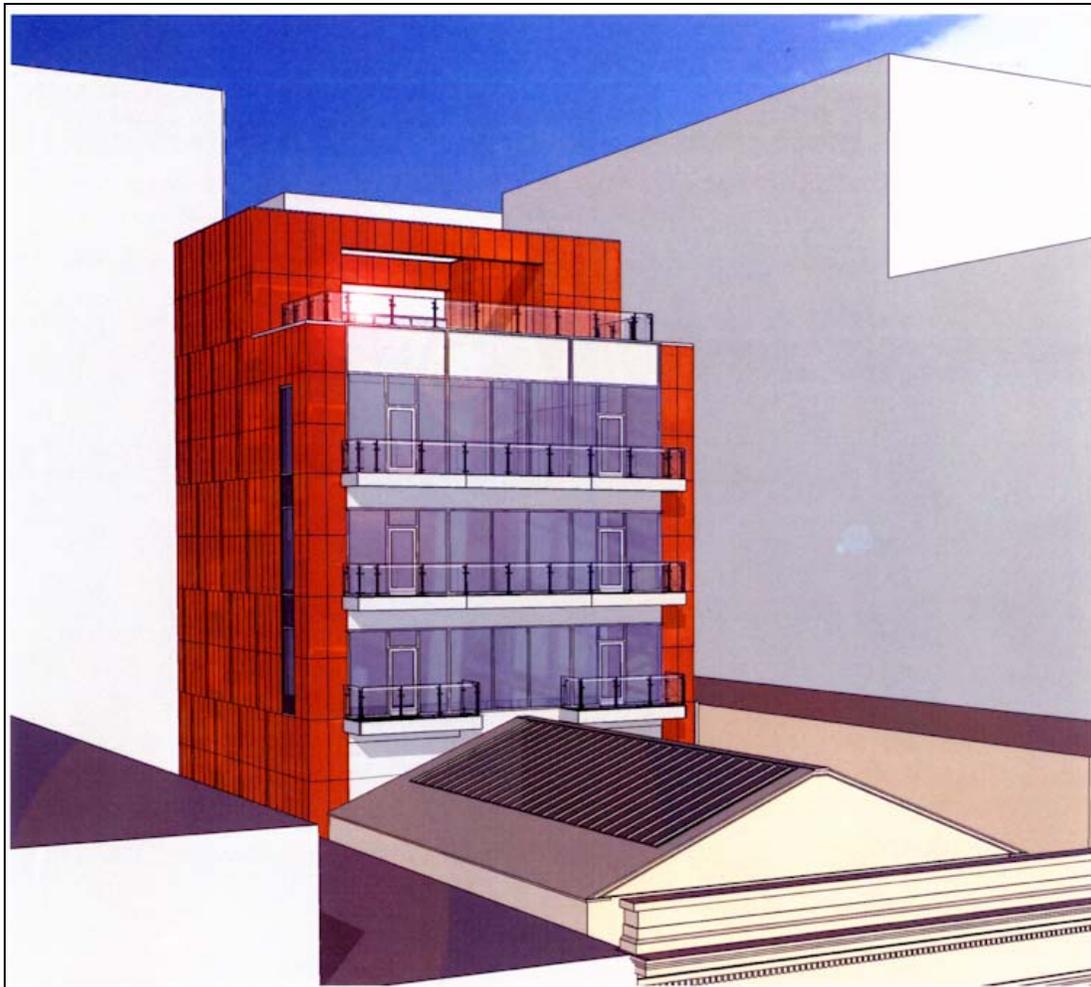
Figure 1 Rear addition at 915 F Street NW clad in glass and Cor-ten™ weathering steel

The applicant has selected a metal and glass cladding scheme for all elevations of the addition. The selected metal is a panelized weathering steel product called cor-ten that will install as unfinished steel but in 2-3 years oxidize to a stable layer of rust that acts as a barrier against destructive corrosion (Figure 1).

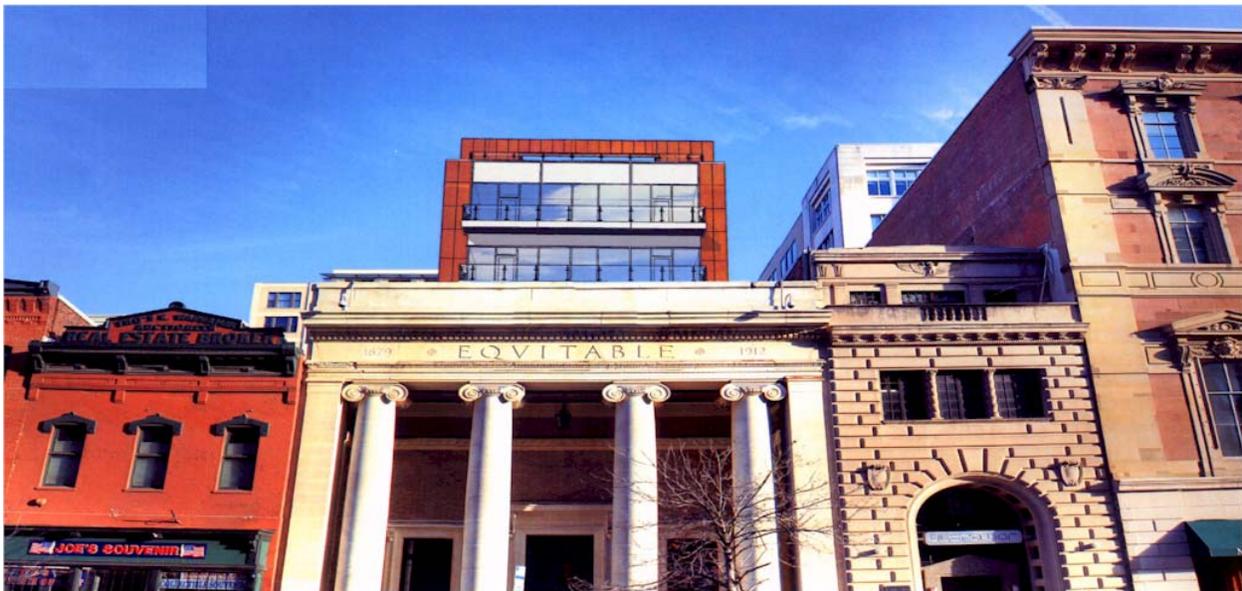
Figure 2. Proposed view from F Street NW showing existing taller buildings on either side of the proposed addition.

The height of the addition, including penthouse, has been reduced from 105 feet to 98 feet above alley level. It would be set back 69 feet from the façade, preserving the existing skylight that is integral to the integrity of the historically designated banking hall (Figure 2).
