HISTORIC PRESERVATION REVIEW BOARD STAFF REPORT AND RECOMMENDATION

Landmark/District: Georgetown Historic District

Address: 1212 and 1214 28th Street NW

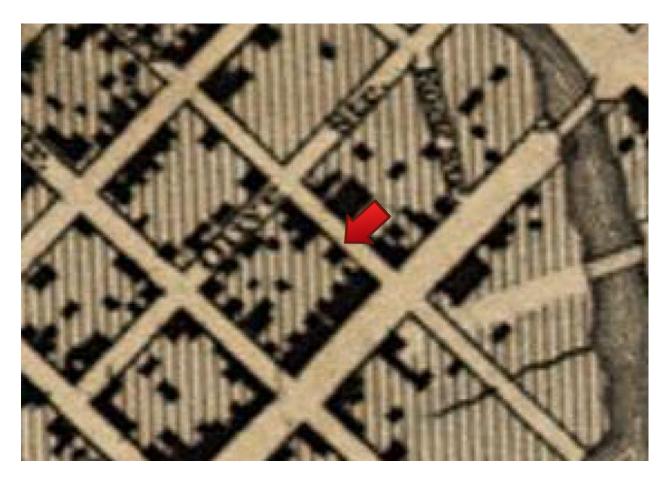
Above: A detail of the Albert Boschke's 1861 "Topographical map of the District of Columbia". The arrow indicates the location of 1210 and 1212 28th Street NW.

² The 1861 Boschke map and the 1888 Sanborn atlas depict no ell. The 1903 Sanborn atlas shows a one-story square-plan addition, but that may have been an error, as no such structure appears in the 1894 Hopkins atlas or the 1907 Baist.

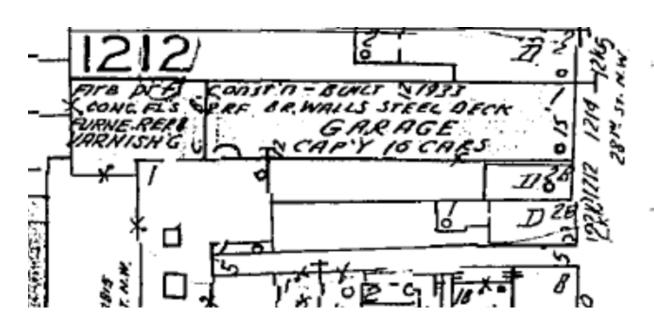
Below: A detail from the Sanborn insurance atlas of 1959 showing the garage at 1214 28th.

Two abutting buildings would be joined. One, 1214 28th Street, was constructed in 1933 as a commercial garage and was later renovated with a second story. The garage was built to the depth of its lot (or at least added onto to reach that depth by 1937).
