**HISTORIC PRESERVATION REVIEW BOARD
STAFF REPORT AND RECOMMENDATION**

Landmark/District:	Anacostia Historic District	(x) Agenda
Address:	1321-1325 Maple View Place SE	
Meeting Date:	February 2, 2017	(x) New construction
Case Number:	17-129	(x) Subdivision
Staff Reviewer:	Tim Dennée	(x) Concept

The applicant, property owner Chughtai Family Properties LLC (with architect Stephen duPont), requests the Board's review of a concept to subdivide two lots (976 and 877 in Square 5803) into four lots of record and to build upon them four two-story frame houses, each with an accessory apartment in the basement.

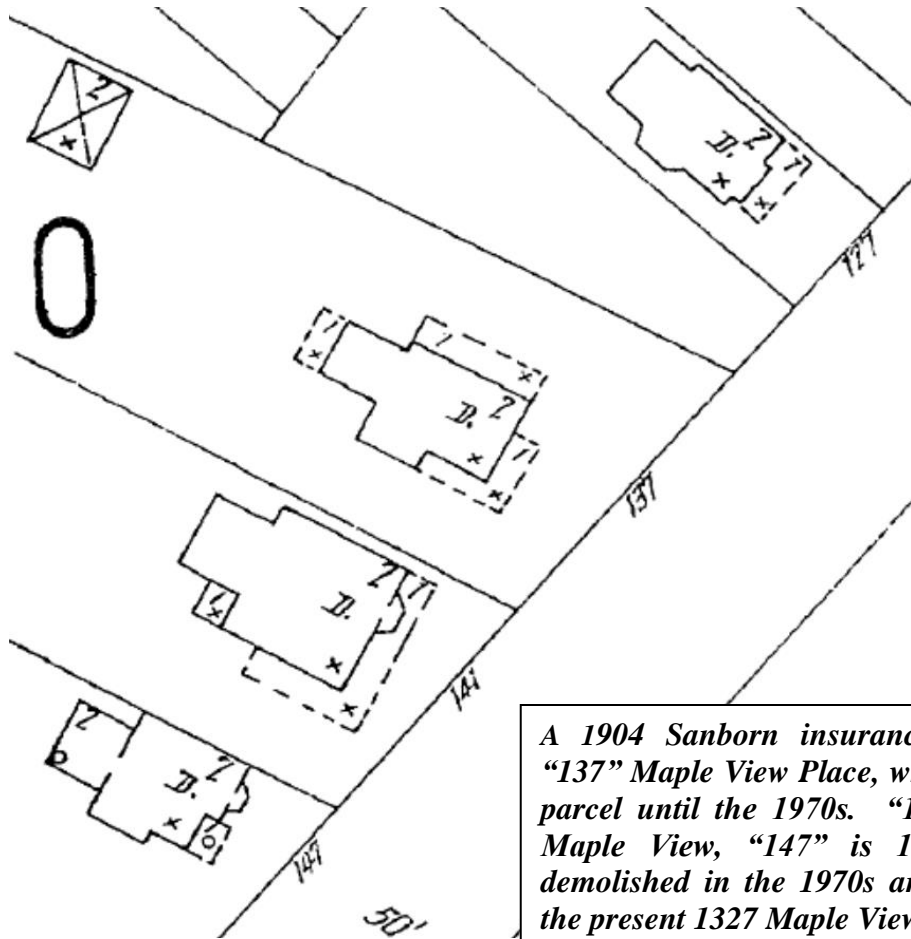
A 1904 Sanborn insurance map detail depicting “137” Maple View Place, which stood on the present parcel until the 1970s. “127” is the present 1319 Maple View, “147” is 1333. “141” was also demolished in the 1970s and was later replaced by the present 1327 Maple View.

The original (1886) subdivisions and early resubdivisions of Griswold’s Addition do not provide much guidance, as the lots were most often about 25 feet wide, although some were as little as 20 feet, and others slightly more than 30. In this particular location, a larger parcel was further subdivided in 1894 and 1903. 1319 Maple View and the houses to its west were placed on 22-foot-wide lots, although 1317 straddles two such lots. The land overlapping the subject lots were left large—40, 60 and 75 feet—and then resubdivided to their present extent when 1327 was built in 1991.
