**HISTORIC PRESERVATION REVIEW BOARD
STAFF REPORT AND RECOMMENDATION**

Landmark/District: **Anacostia Historic District** (x) Agenda
Address: **1326 Valley Place SE**

Meeting Date: **October 23, 2014** (x) Addition
Case Number: **14-717** (x) Alterations

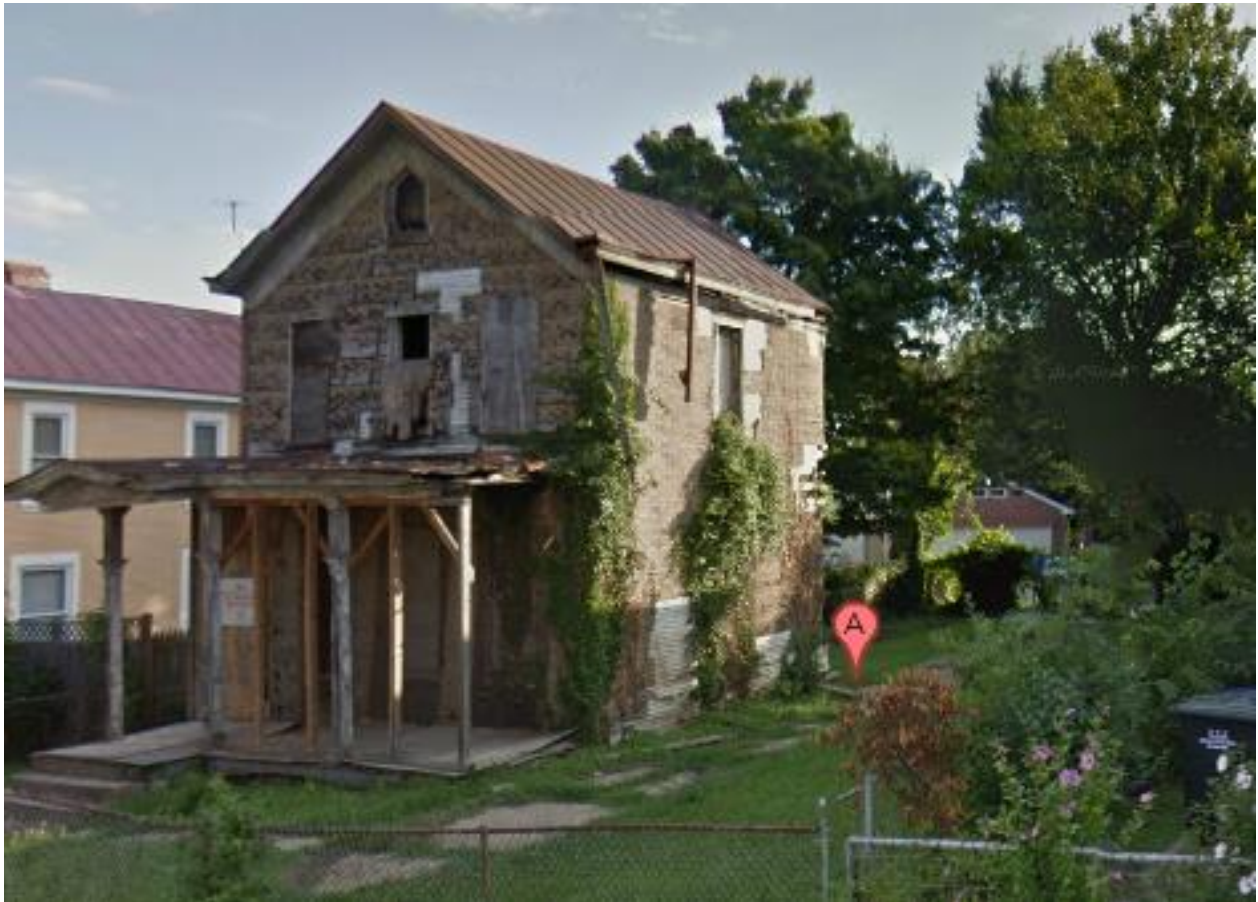
Would skylights be visible on the side of the house? Yes.

Skylights

- *the main block be constructed to its original depth, be sided with wood siding to match the original profile and exposure, and have fenestration generally consistent in size and proportions; and*
- *there be no skylights installed on the principal roof.*
