**HISTORIC PRESERVATION REVIEW BOARD
STAFF REPORT AND RECOMMENDATION**

Landmark/District:	Anacostia Historic District	(x) Consent Calendar
Address:	1326 Valley Place SE	
Meeting Date:	January 24, 2019	(x) Alteration
Case Number:	19-132	(x) Concept

The applicant, property owner the L’Enfant Trust (with Cunningham Quill Architects), requests the Board’s review of a permit application to reconstruct and add a two-story rear addition to this two-story, frame structure.

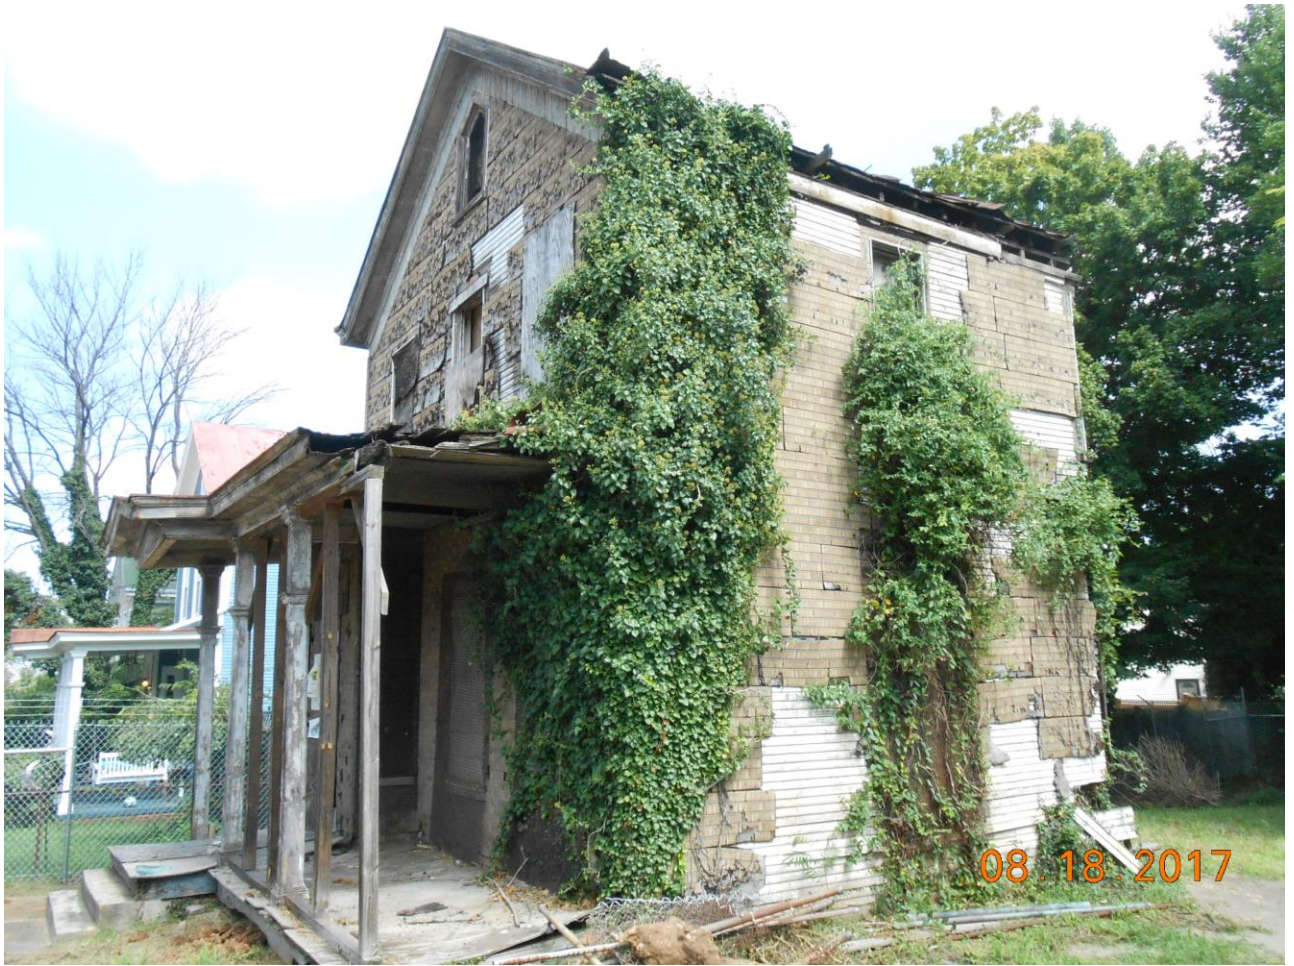
Like the others on the row, the main entrance of 1326 projects beyond the main plane of the façade. The east side of the project has a narrow, vertical window opening. Each of the houses in this row had there a seven-over-seven double-hung window with multi-colored lights. When the 2014 concept was reviewed, this window was still largely intact, but deteriorated. Its present condition cannot be evaluated from the street, as there is presently a steel mesh over the opening. If it is still present and restorable, then it should be restored.
