## HISTORIC PRESERVATION REVIEW BOARD STAFF REPORT AND RECOMMENDATION

Landmark/District:	<b>Anacostia Historic District</b>	<input checked="" type="checkbox"/> Agenda
Address:	<b>2249 14<sup>th</sup> Street SE</b>	<input type="checkbox"/> Consent
		<input checked="" type="checkbox"/> Concept
Meeting Date:	<b>January 28, 2021</b>	<input checked="" type="checkbox"/> Alteration
Case Number:	<b>21-127</b>	<input type="checkbox"/> New Construction
		<input type="checkbox"/> Demolition
		<input type="checkbox"/> Subdivision

Applicant David Johnson seeks concept review for construction of a two-story, frame, Italianate-style house on a vacant lot in the Anacostia Historic District.

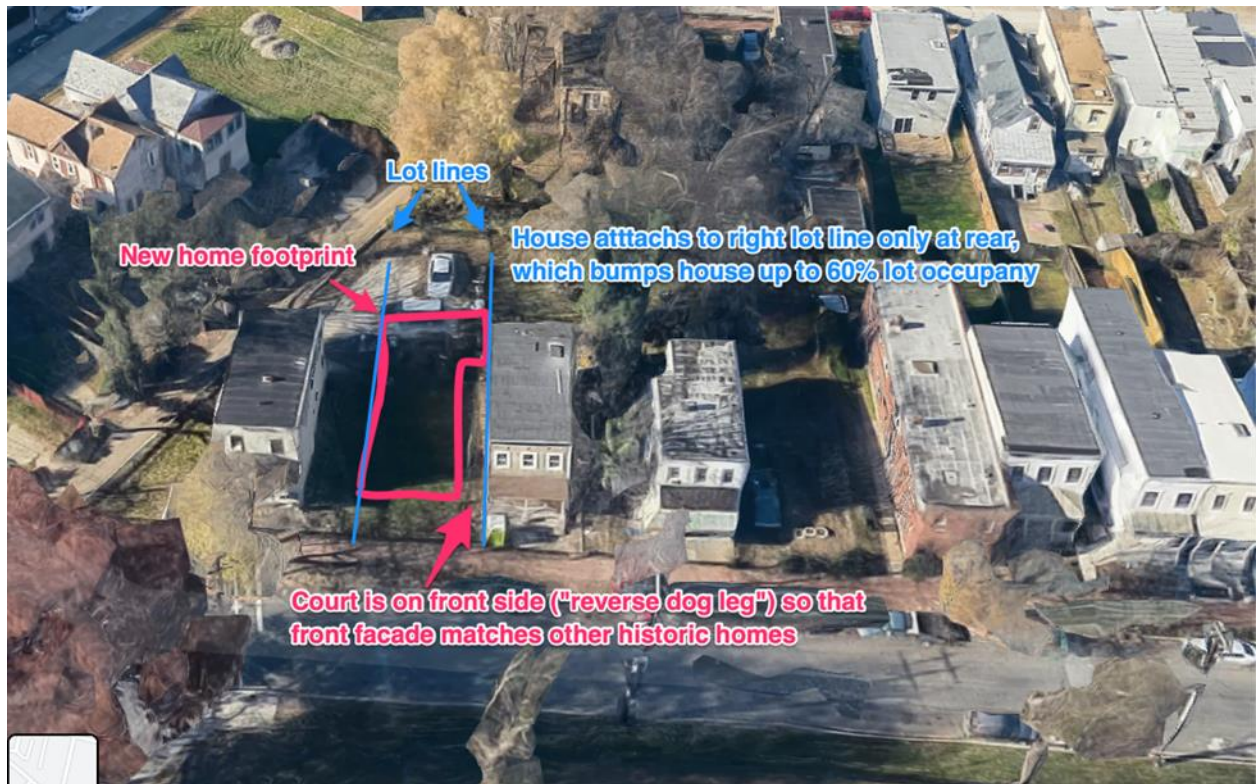
The plans call for construction of a two-story wood framed single family house, extending 22'10" in width, with a 5' side yard, and 24'5 in height. The house would be clad in HardiPlank lap siding with 2/2 punched windows and have a full-width front porch with turned posts and brackets, all features that would relate it to similar, neighboring historic homes. The house would be capped by a flat roof and sit on a concrete foundation. The rear elevation would have a sliding patio door with wood steps under two large ganged windows on the second floor.

The basic form, materials and stylistic detailing for the house are generally compatible for new construction in the Anacostia Historic District, however, several revisions are needed. These include raising the height of the front of the building by 24"-30" and converting the flat roof and side profile of the house to have a sloping roof. Raising the height at the front would not only improve the vertical proportions of the façade but would also allow the first and second floor windows to be slightly elongated to improve their vertical proportions. The use of a small transom above the front door, aligned with the tops of the first-floor windows, should also be investigated, and the front porch columns spaced so that the center column doesn't fall in front of a window. The porch roof should either be hipped or the ends of the present shed roof should be covered with panels or flush boards rather than lapped clapboards. Finally, any portion of the foundation that will be visible from the street should be finished in brick rather than exposed concrete.
