# HISTORIC PRESERVATION REVIEW BOARD STAFF REPORT AND RECOMMENDATION

Landmark/District: **Capitol Hill Historic District** (x) Agenda 434 10<sup>th</sup> Street, S.E. ( ) Consent Address: 6B (x) Concept ANC:

Applicant Syga Thomas seeks concept review for a new three story above raised basement structure at a property in the Capitol Hill Historic District.

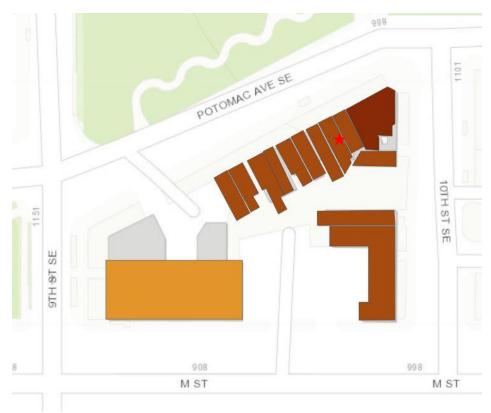
Block plan from HistoryQuest showing three open lots where matching row was demolished.  $1107\ 10^{th}$  St SE marked with red star

The structure originally located at 1107 10<sup>th</sup> St SE was built in 1889 for J. D. McGuire. Designed by Glenn Brown and built by A. J. Fisher, this was one of ten built under the same permit (919-927 Potomac Ave SE, 1103-1111 10<sup>th</sup> St SE). Although demolished, we can see from the rest of the matching row that this would have originally been a two-story brick building with jack arched window openings and a stepped brick dentil cornice.

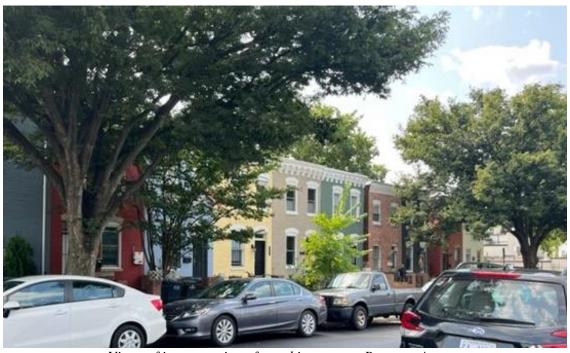
Views of intact portion of matching row on Potomac Avenue
