HISTORIC PRESERVATION REVIEW BOARD STAFF REPORT AND RECOMMENDATION

Property Address: 3401 Lowell Street, NW X Agenda

Landmark/District: Cleveland Park Historic District Consent Calendar

H.P.A. Number: **19-270**

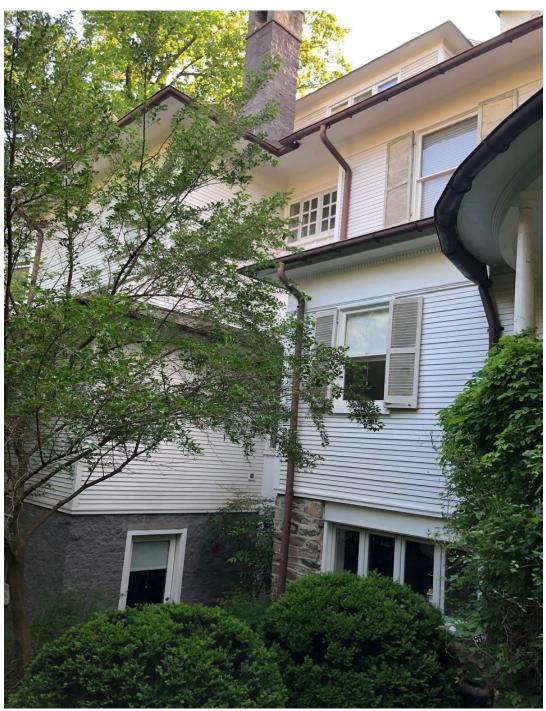
This rear addition in Cleveland Park projects past the side wall of the original house using a recessed hyphen to differentiate between the two.

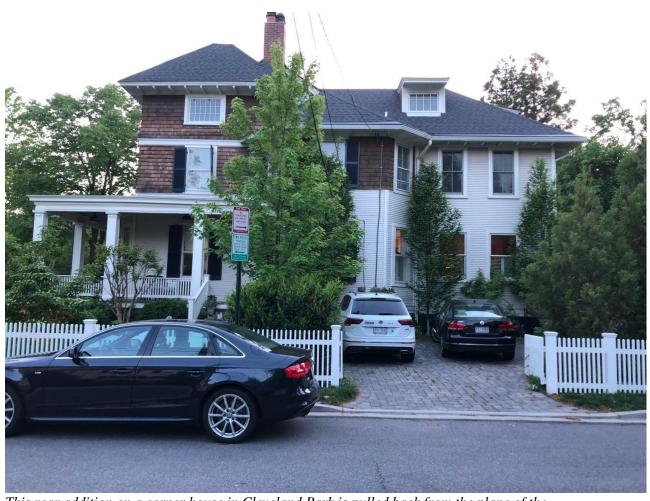
This rear addition on a corner house in Cleveland Park is pulled back from the plane of the original side elevation to achieve a subordinate relationship to the house.
