**HISTORIC PRESERVATION REVIEW BOARD  
STAFF REPORT AND RECOMMENDATION**

Landmark/District:	<b>Engine Company No. 19</b>	<input checked="" type="checkbox"/> Agenda
Address:	<b>2813 Pennsylvania Avenue, SE</b>	<input type="checkbox"/> Consent
Meeting Date:	<b>April 28, 2011</b>	<input type="checkbox"/> New Construction
Case Number:	<b>HPA #11-081</b>	<input type="checkbox"/> Addition
		<input checked="" type="checkbox"/> Alterations
Staff Reviewer:	<b>Tim Dennée</b>	<input checked="" type="checkbox"/> Concept

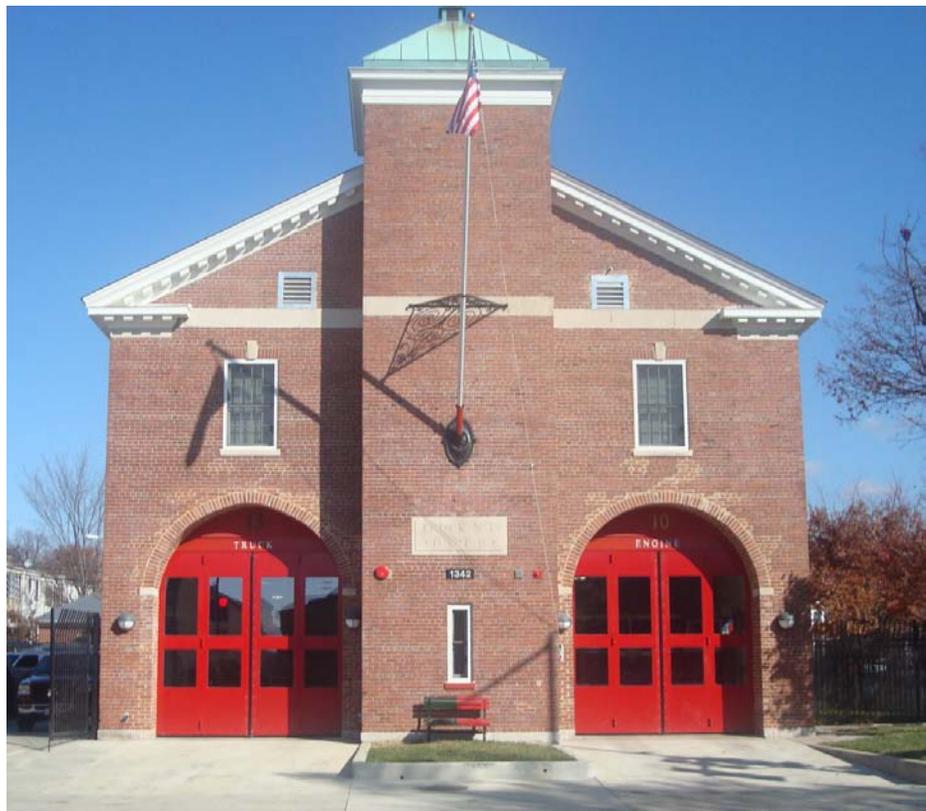
*Engine 10/Truck 13*

As it happened, the reconstruction of the brick arches at Engine 10 proved sufficiently challenging in itself, even with the detailed drawings, with the left arch noticeably pointed. As each project comes forward, we all must be increasingly careful to ensure a successful outcome, not leaving the results to chance. Creating a form for a rustic stone arch and maintaining the arch despite the irregularity of the stone is more challenging than working with a material with as regular a module as brick.

In February 2010, the Board reviewed the widening of the vehicle-bay doors at Engine Company 10, 1342 Florida Avenue, NE. Given the character of that building and the detailed drawings presented, the Board decided that the openings could be widened compatibly beneath semicircular arches. The Board discussed at the time, however, that the anticipated reconstruction of stonemasonry openings at other firehouses would constitute more of a challenge to compatibility, likely needing review by the Mayor's Agent.

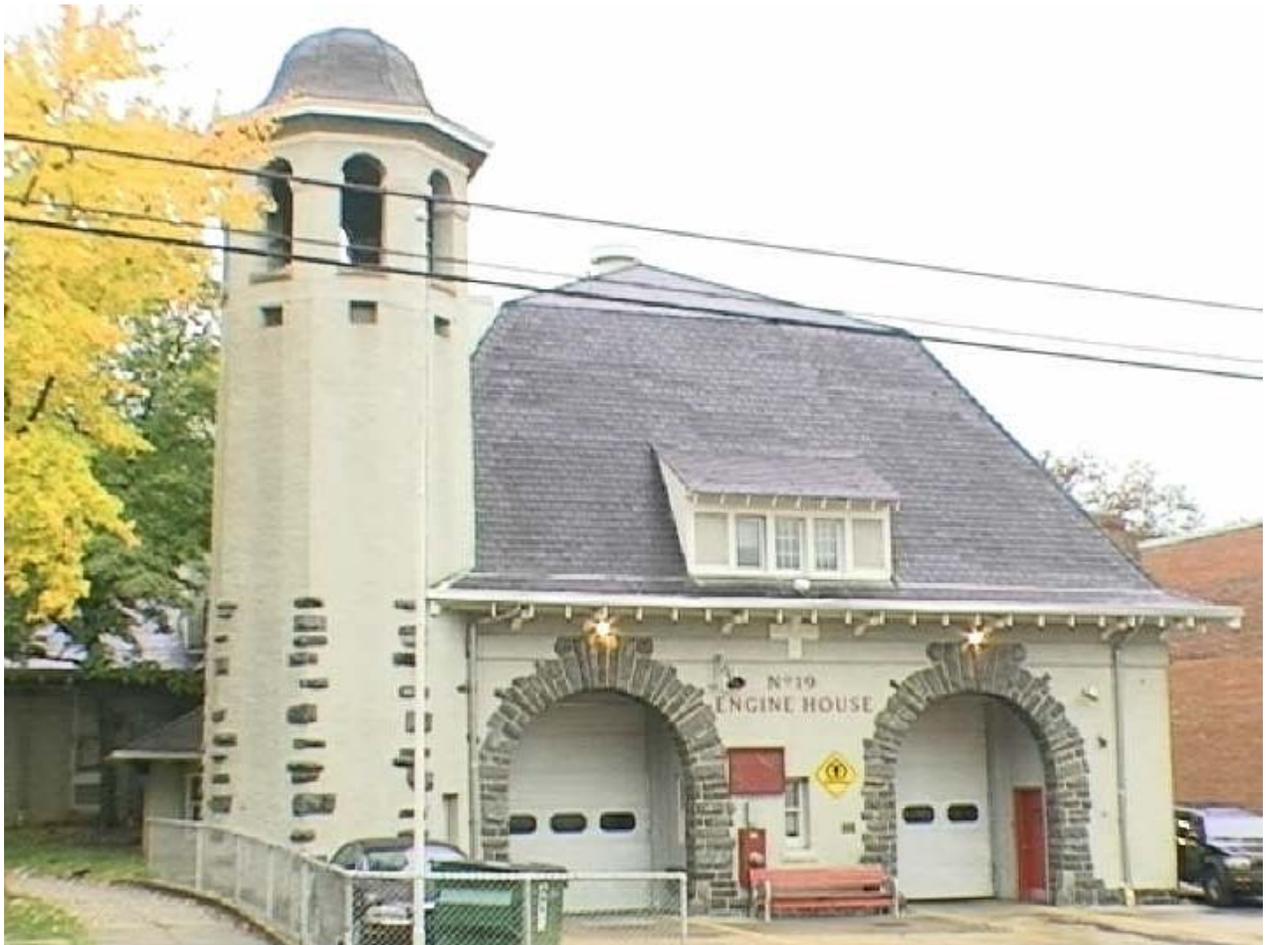
*Engine Company No. 19*

Unlike the coursed ashlar fronts of many of its contemporaries, the suburban Engine 19 is principally of stuccoed brick, with fieldstone arches and quoins, which may allow for some wiggle room in reconstructing the openings without visibly pulling apart the whole facade. The watchroom between the doors would have to be demolished, as the building's corner tower forms an outward constraint that forces the doors to be widened only inward, toward each other, if the façade's symmetry is to be retained.
