HISTORIC PRESERVATION REVIEW BOARD STAFF REPORT AND RECOMMENDATION

Property Address: 1421 Corcoran Street, NW

Landmark/District: 14th Street Historic District

H.P.A. Number: **15-139**

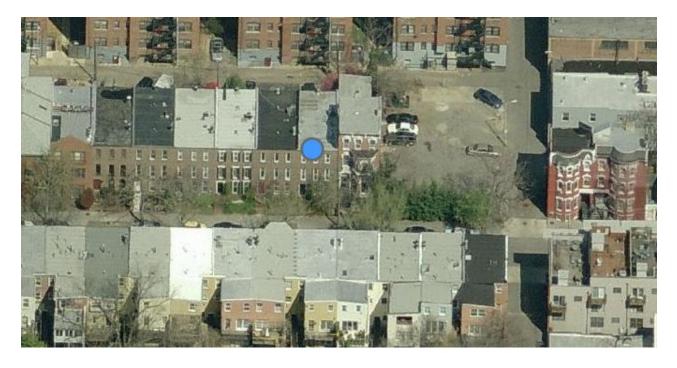
1421 Corcoran Street is a three-story, flat-front, slab-on-grade brick rowhouse, which is the end unit in a row of six constructed in the 1970s. The house is adjacent to a brick, bay-fronted Victorian rowhouse to the east. The subject property does not contribute to the 14th Street Historic District based on its date of construction outside the district's period of significance (1855-1940).
