**HISTORIC PRESERVATION REVIEW BOARD  
STAFF REPORT AND RECOMMENDATION**

Property Address: **1523 Church Street, NW**  
Landmark/District: **14<sup>th</sup> Street Historic District**

Meeting Date: **January 24, 2019**  
H.P.A. Number: **19-077**

Landis Construction, representing owners Dell and Saun Robinson, seek conceptual design review for construction of a two-story rear addition, a roof top stair addition and deck, replacement windows and doors, replacement of the front stairs, and excavation of the front yard to provide access to a basement apartment.

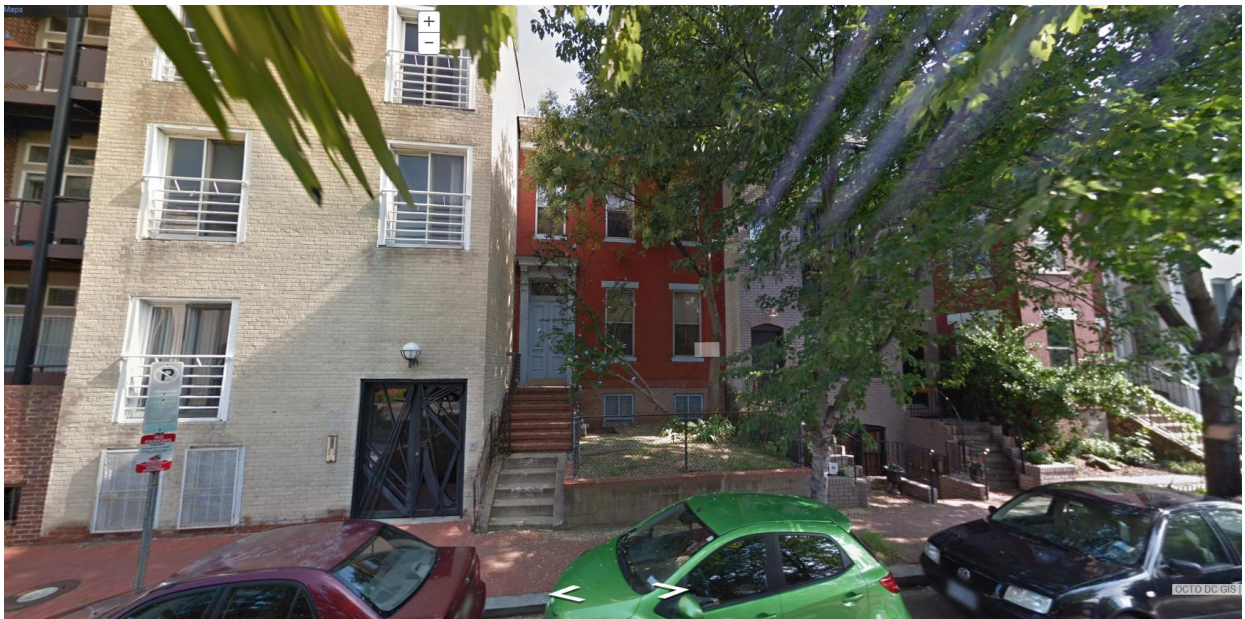
*1523 Church Street, NW (red brick house at center)*

1523 Church Street is a two-story, flat-front brick house set above a partially-raised basement. It was constructed in 1875 and retains its original elevated front yard, although the retaining wall and front stairs to the house are not original.

The house is immediately adjacent to a non-contributing 1950s apartment building to the west that extends out to the edge of the sidewalk and a non-contributing (possibly refaced historic building) to the east. An assortment of contributing rowhouses extends further to the east. A large surface parking lot for St. Luke's Church is located immediately across the street.
