**HISTORIC PRESERVATION REVIEW BOARD  
STAFF REPORT AND RECOMMENDATION**

Property Address: **1618 14<sup>th</sup> Street, NW**  
Landmark/District: **14<sup>th</sup> Street Historic District**

Meeting Date: **November 20, 2014**  
H.P.A. Number: **15-064**  
Staff Reviewer: **Steve Callcott**

Owner Stephen Jaffe, represented by attorney Larry Kirsch and structural engineer Peter A. Neubauer, seeks a permit to raze a corner commercial building at 1618 14<sup>th</sup> Street, NW at the corner of 14<sup>th</sup> and Corcoran Streets, NW in the 14<sup>th</sup> Street Historic District.

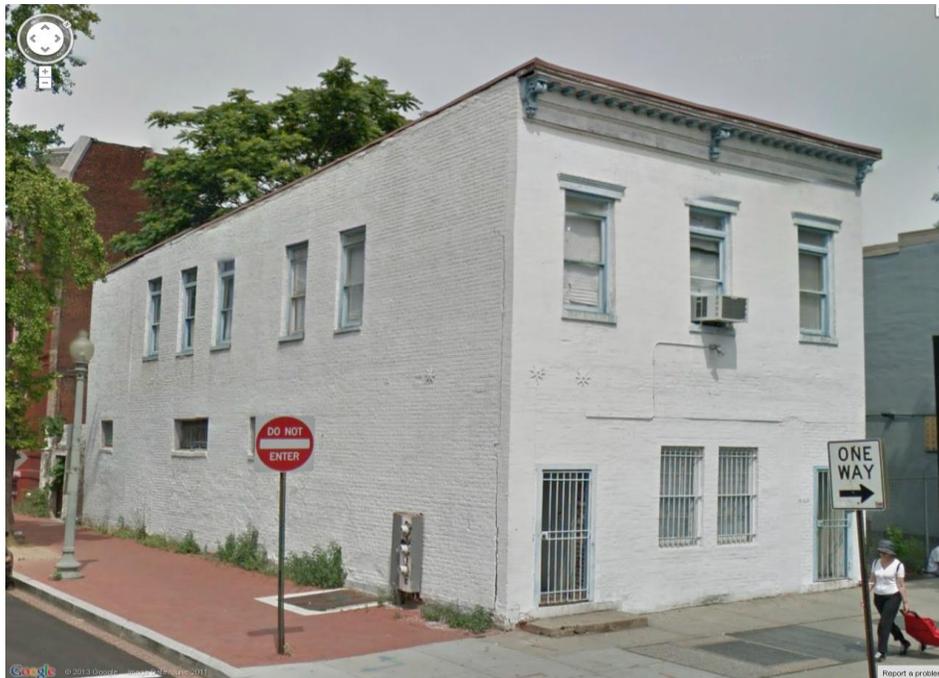
1618 14<sup>th</sup> Street, NW is two-story corner commercial building. The building is 25' wide x 58' deep occupying a 74' deep lot. It has a pressed brick façade and common brick side and rear walls resting on a brick foundation. The first floor façade once featured a one-story projecting bay and transom windows over the doors, since bricked in, with three double hung windows on the second floor; the façade is capped by an Italianate bracketed wood cornice. The side elevation has three small windows on the first floor and five double hung windows on the second.
