HISTORIC PRESERVATION REVIEW BOARD STAFF REPORT AND RECOMMENDATION

Property Address: **1618 14th Street, NW**
Landmark/District: **14th Street Historic District**

Meeting Date: **December 18, 2014**
H.P.A. Number: **15-064**
Staff Reviewer: **Steve Callcott**

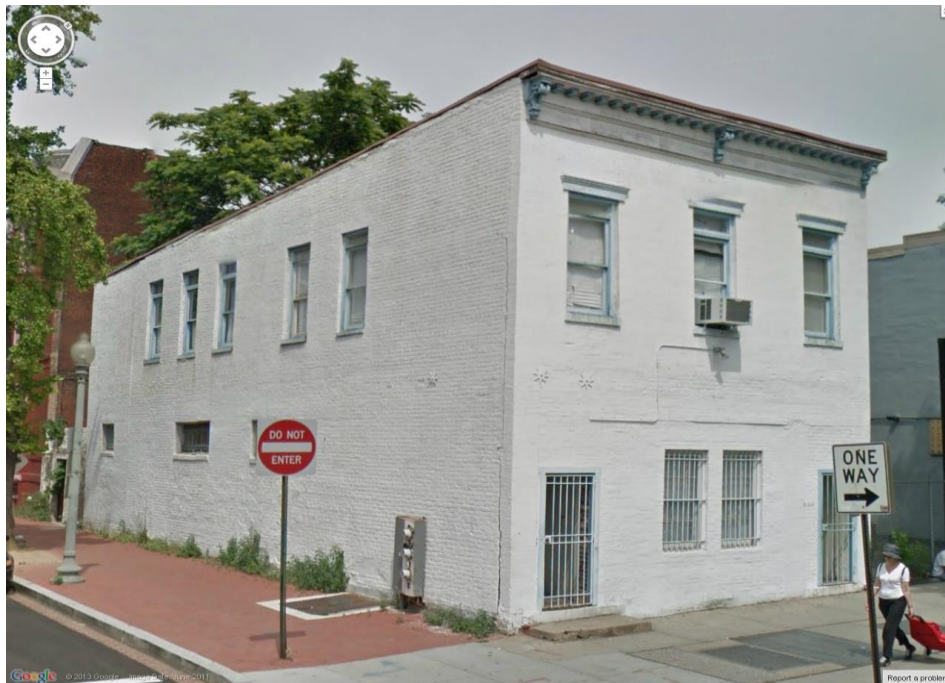
Owner Stephen Jaffe, represented by attorney Larry Kirsch and structural engineer Peter A. Neubauer, seeks a permit to raze a corner commercial building at 1618 14th Street, NW at the corner of 14th and Corcoran Streets, NW in the 14th Street Historic District.

1618 14th Street, NW is two-story corner commercial building. The building is 25' wide x 58' deep occupying a 74' deep lot. It has a pressed brick façade and common brick side and rear walls resting on a brick foundation. The first floor façade once featured a one-story projecting bay and transom windows over the doors, since bricked in, with three double hung windows on the second floor; the façade is capped by an Italianate bracketed wood cornice. The side elevation has three small windows on the first floor and five double hung windows on the second.
