**HISTORIC PRESERVATION REVIEW BOARD
STAFF REPORT AND RECOMMENDATION**

Landmark/District: **Park View Christian Church** (x) Agenda
Address: **625-633 Park Road NW**

Meeting Date: **July 23, 2015** (x) Alteration
Case Number: **14-522**

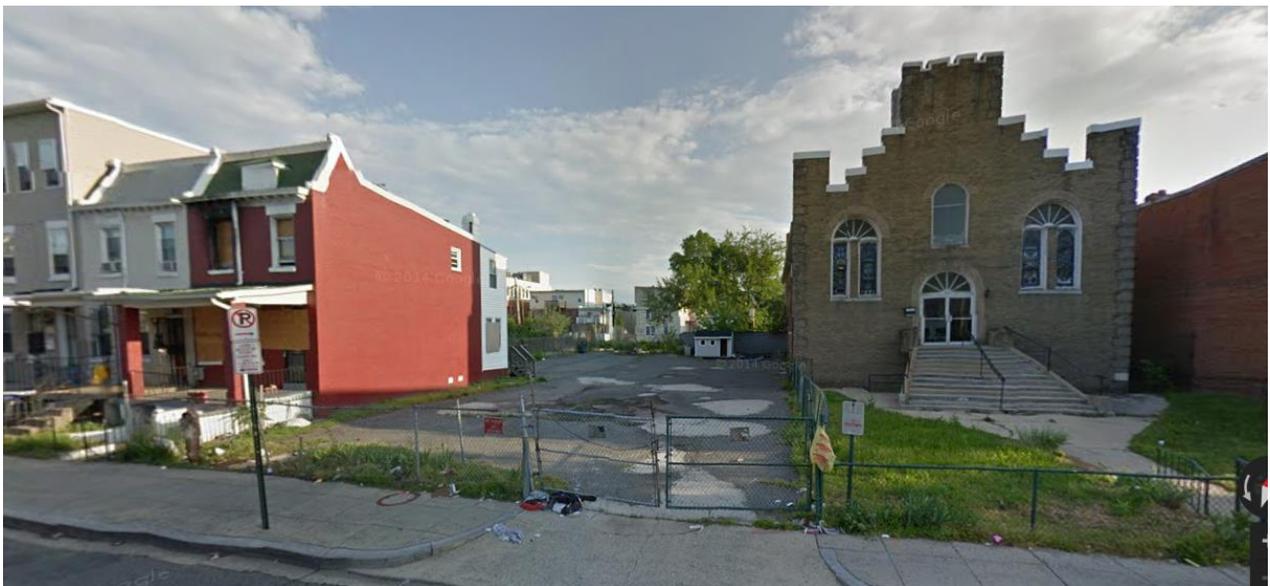
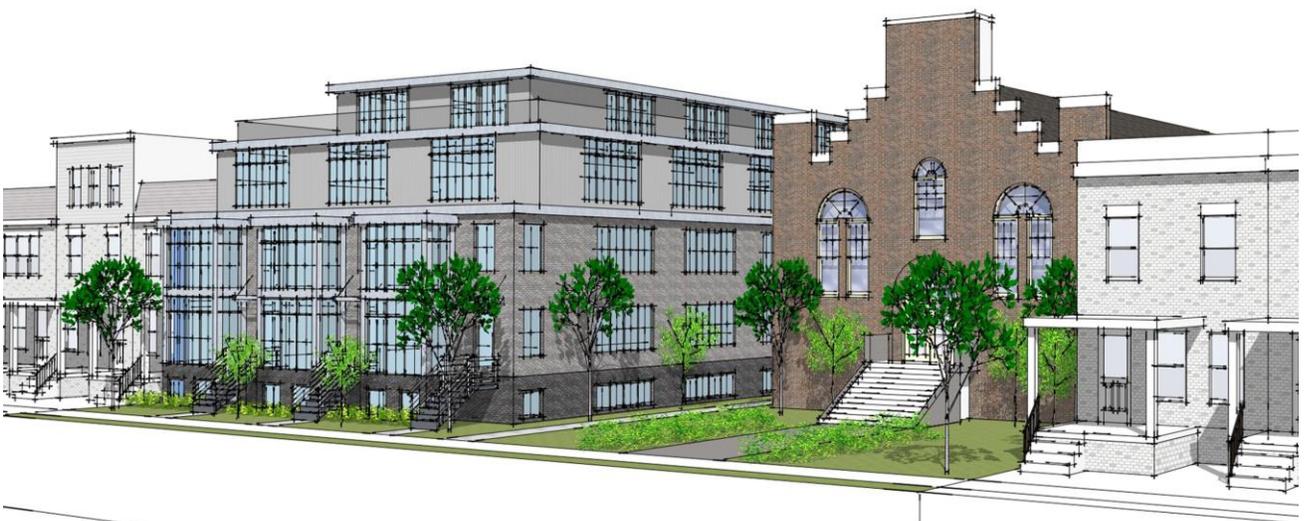
The 2014 concept.

In July 2014, the Board approved the concept's site plan, height and general massing as compatible with the character of the landmark, but it expressed a preference for further setback of the building, so that its front wall would align with those of the rowhouses immediately to the west. The Board requested a preservation plan for the church building that would address the condition, significance and feasibility of salvaging the windows, especially the stained-glass ones, as well as the maintenance and repair of the masonry. The Board also asked for more detail, with particular attention to: repairs, replacements and alterations of the front steps and entrances; window repairs and replacements; any areaways or alterations to basement windows; the design of proper, efficient and unobtrusive roof drainage; the concealment of mechanical and electrical equipment; and the landscaping of the front yard.
