**HISTORIC PRESERVATION REVIEW BOARD  
STAFF REPORT AND RECOMMENDATION**

Landmark/District:	<b>Mount Pleasant Historic District</b>	(x) Agenda
Address:	<b>1614 Kilbourne Place NW</b>	
Meeting Date:	<b>September 22, 2022</b>	(x) Alteration/Addition
Case Number:	<b>22-365</b>	(x) Revised concept

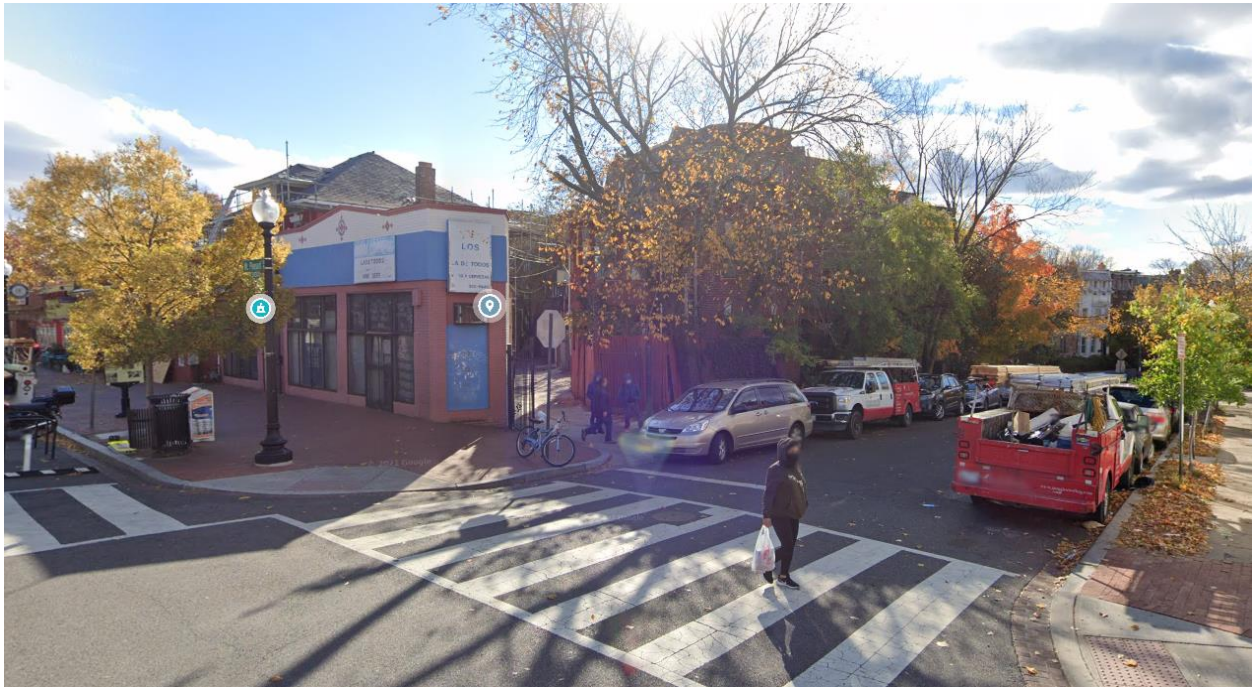
A deck is still proposed atop the primary roof, in a location probably better suited for the mechanical equipment. The applicant has presented photos of a mockup, but the railing will likely be slightly higher, as the deck will presumably be superimposed on the roof. A one-to-one setback does not render the deck entirely invisible—without considering the furnishings that might be placed upon the finished deck. As expected, the deck would be visible from Mount Pleasant Street to the east. Seeing it over 3170 Mount Pleasant Street seems less an issue than from the intersection of Mount Pleasant and Kilbourne, below, although the house’s bay projection will cut off most views from this angle (while, as we see in the photo below, trees are not an adequate year-round screen for such appurtenances).
