**HISTORIC PRESERVATION REVIEW BOARD  
STAFF REPORT AND RECOMMENDATION**

Landmark/District: **Mount Pleasant Historic District** (x) Agenda  
Address: **1815 Lamont Street NW** ( ) Consent

Meeting Date: **November 20, 2014** (x) Alteration/addition  
Case Number: **15-004**

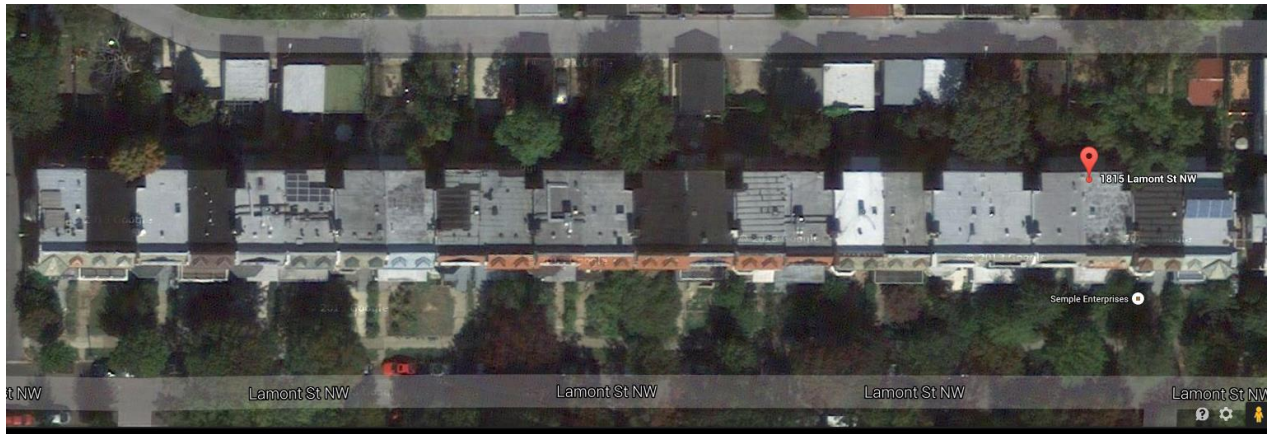
*Above: The row as seen from directly above (north is up).*

This porch-fronted row is nearly intact, with no additions to speak of, only the enclosure of some of the two-story sleeping porches and the unusual third-story porches at the inside corners of the short ells. The Board has, however, twice approved concepts for a sizeable addition behind the long-vacant 1855 Lamont, at the western end of the row, and that project should soon have a permit.

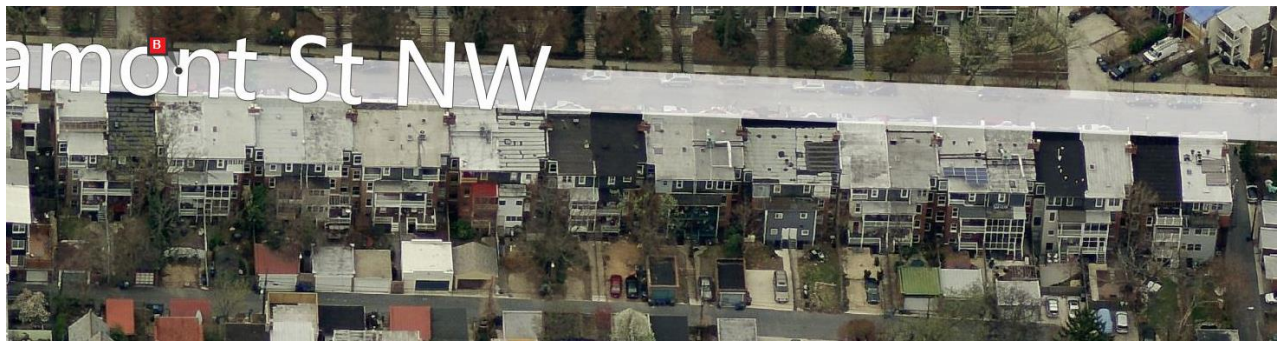
*Below: An aerial photo of the rear of the row (north is down).*

The addition would be a full three stories tall and 23 feet wide, stretching from side lot line to side lot line, necessitating the demolition of the three-story ell and the two-story rear porch. The addition would be deeper as well, replacing the 8.4-foot-deep ell and six-foot-deep porch with a seventeen-foot-deep envelope, plus a one-story eight-by-twelve-foot projection detailed as an enclosed porch (the dimensions given on the site plan on Sheet A-0 are not accurate; the side elevation/section on Sheet A-4 best compares the proposal with the present ell and porch). The landings for an exterior spiral stair add to the bulk.
