**HISTORIC PRESERVATION REVIEW BOARD
STAFF REPORT AND RECOMMENDATION**

| Address: | 3118-3120 16th Street NW | |
| Case Number: | 16-312 | (x) Alteration |

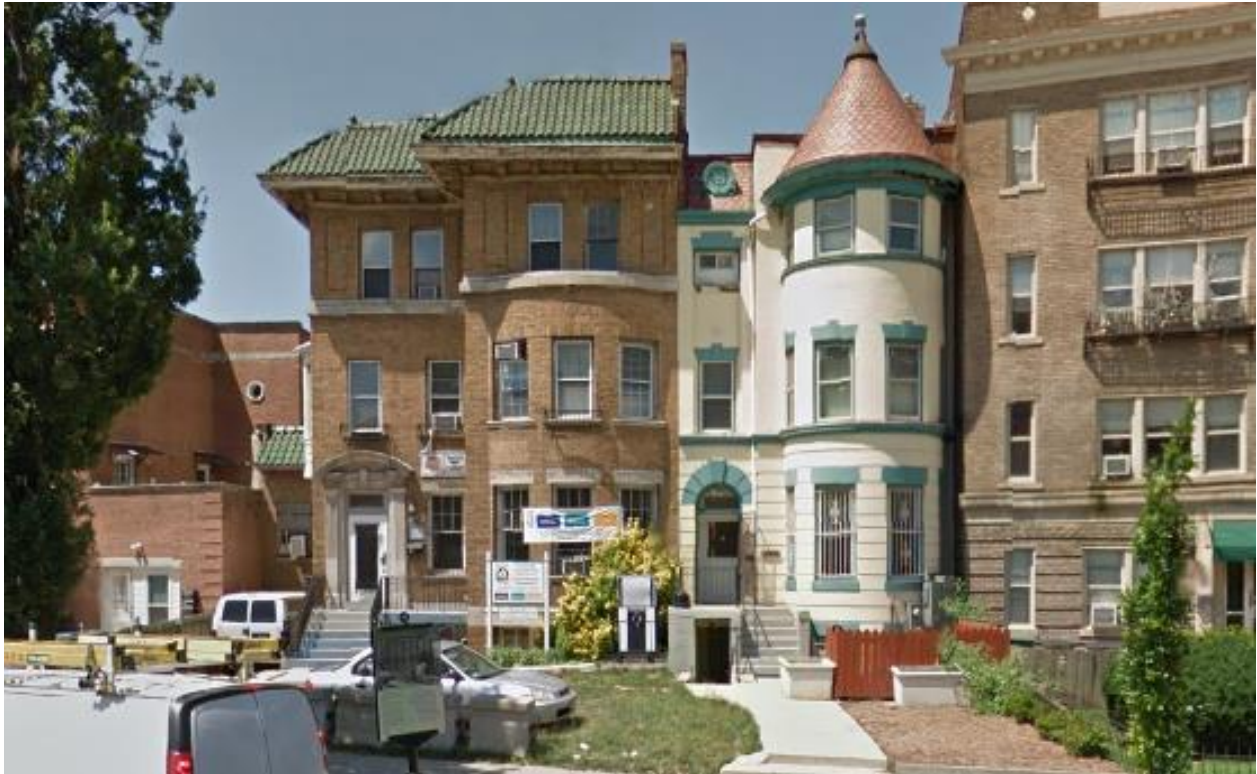
It appears that the extent of demolition has increased. The north wall at the third floor rear wing of 3118 is now proposed for removal. One may interpret the south side wing of 3118 to be mostly disappearing, too, although the drawings are ambiguous. The question of overall demolition is not settled, because it will ultimately depend on what is to occur in the third dimension, i.e., to the floors. Some of the walls to be removed appear to be bearing the loads of floor joists and rafters. Eventual permit drawings should show these being retained, supported by new structure, because the loss of substantial floor framing or the loss of the south wing or more of the rear could tip the project over into constituting demolition of the buildings "in significant part."

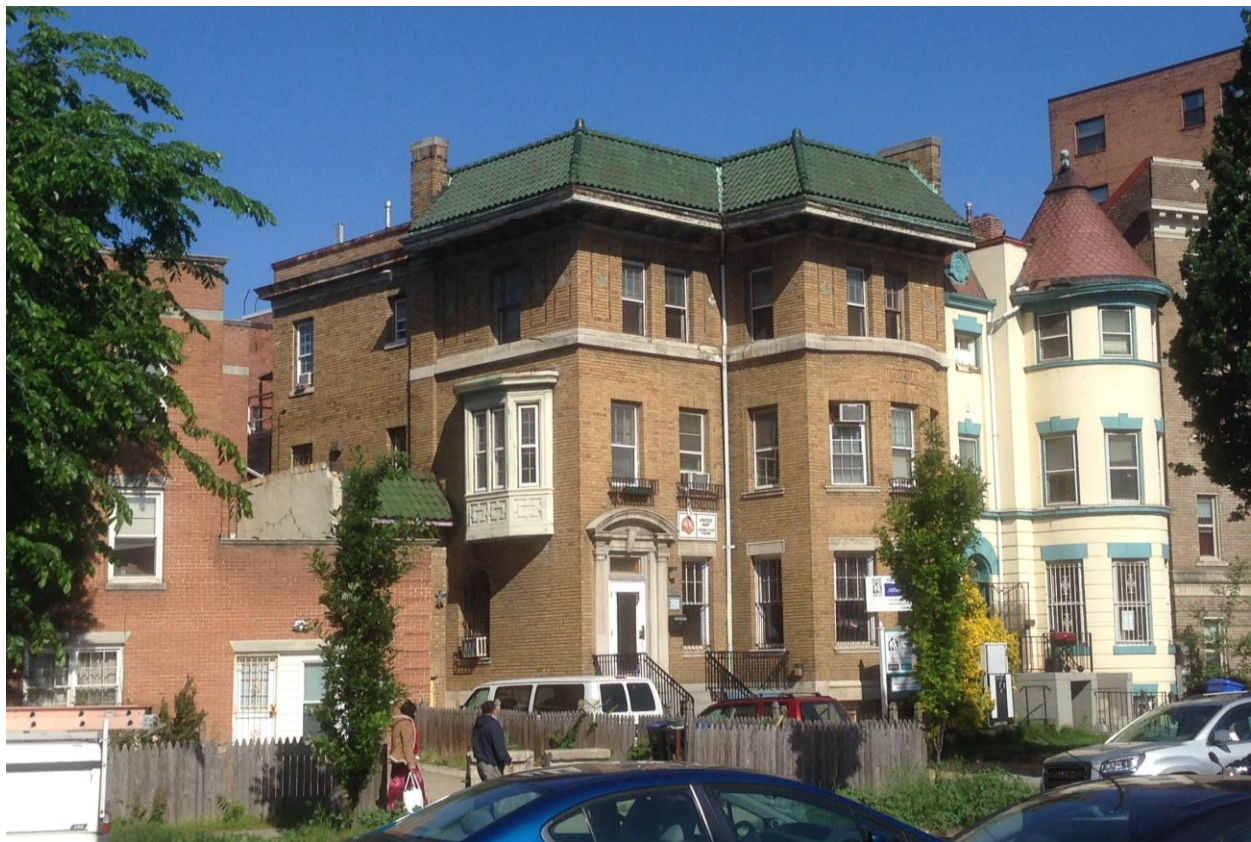
The addition atop the little south-side wing of 3118 has been revised in a couple of significant ways. There is more glazing, but it has not quite taken on the character of a side porch. The roof, now a slate-clad hip, is not characteristic of a side porch. When the Board requested that the tile roof not be continued onto the side addition, it was not merely a matter of differentiating new construction from old. Continuing the roof, but in slate, is a jarring incompatibility. The staff understood the Board’s direction to mean that the addition roof should be detached from the main roof, i.e., that it be lower and flatter.

Of course, the effect of lowering the roof in this proposal would be to further expose to view the roof addition and air-conditioning equipment. The present roof is meant principally as a screen.

The perspective drawings suggest that, directly facing the facades, one would see only a little of the addition over 3120. But the actual degree of visibility from that vantage point is going to have to be guesstimated by a flag test. It is more difficult to enforce compliance of an addition allowed to be “a little” visible, than one that is conditioned on not being visible from the street. But the addition is likely to be conspicuous when seen as below, depending on the design of the side addition.

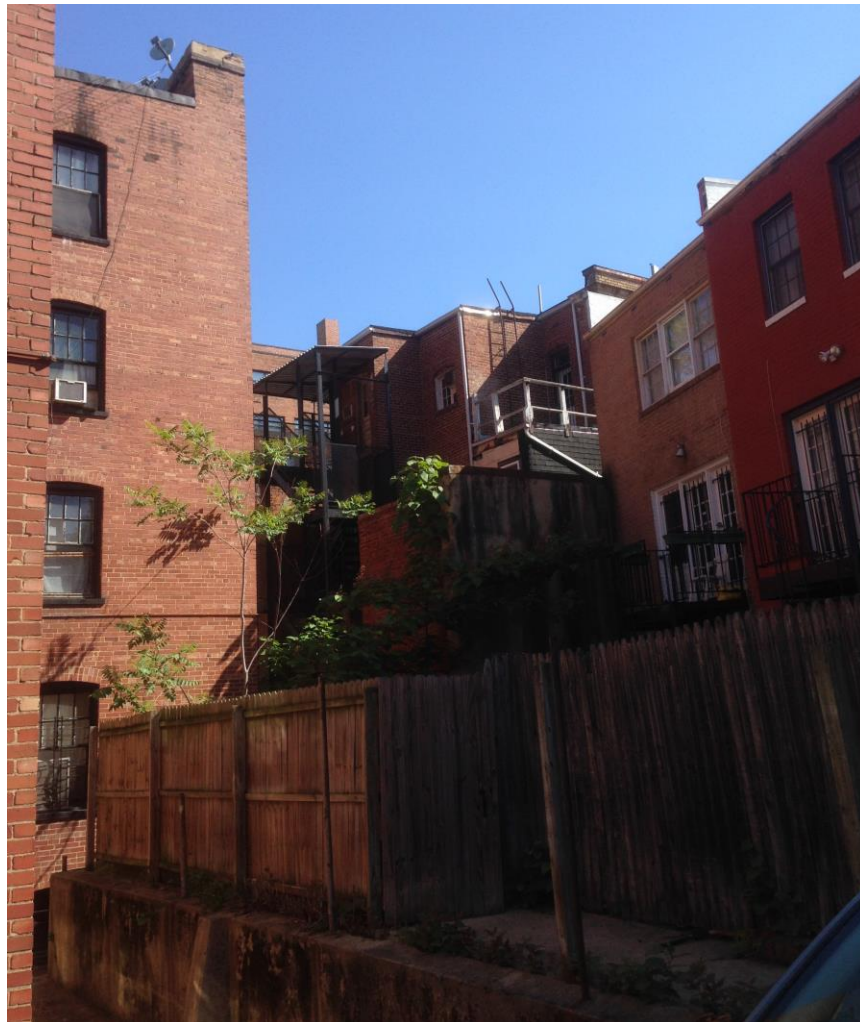
The rear egress stairs remain the same. The rear elevation has changed, reflecting the new massing of the side addition and the extended roof addition. The two buildings have been distinguished from each other more. As with its façade, the rear of the side addition to 3118 should better balance integration with and distinction from the main mass. A porch-like front manages to be a part of the larger building, but a clearly subordinate part. The rear of the side addition makes it a thing unto itself.

The extent of fiber-cement siding to be employed – the reconstructed third floor and new fourth story on 3118 -- is unfortunate and not compatible even for a rear addition of such a high style house. While the Board has traditionally given greater flexibility of the treatment of secondary elevations, it should be noted that these buildings are visible from Irving Street through a parking lot shared by the homes to the east (see photo on the next page). Historically, a fairly high-style building might have received a minor, shed-like frame addition. Here, the siding is proportionally too extensive and visually splits 3118 in half. It is also too bad that the brick of 3120 would be painted in order to blend with the siding, because painting brick is typically not the best treatment, and the monolithic color emphasizes the rear wing's narrow verticality. There should be a proportional balance struck on both buildings. Dividing the building horizontally into thirds, with the upper third distinguished materially, is almost certainly the most successful route.
