**HISTORIC PRESERVATION REVIEW BOARD
STAFF REPORT AND RECOMMENDATION**

Landmark/District:	Mount Pleasant Historic District	(x) Agenda
Address:	3118 Mount Pleasant Street NW	
Meeting Date:	September 23, 2021	(x) Alteration/Addition
Case Number:	21-501	(x) Concept

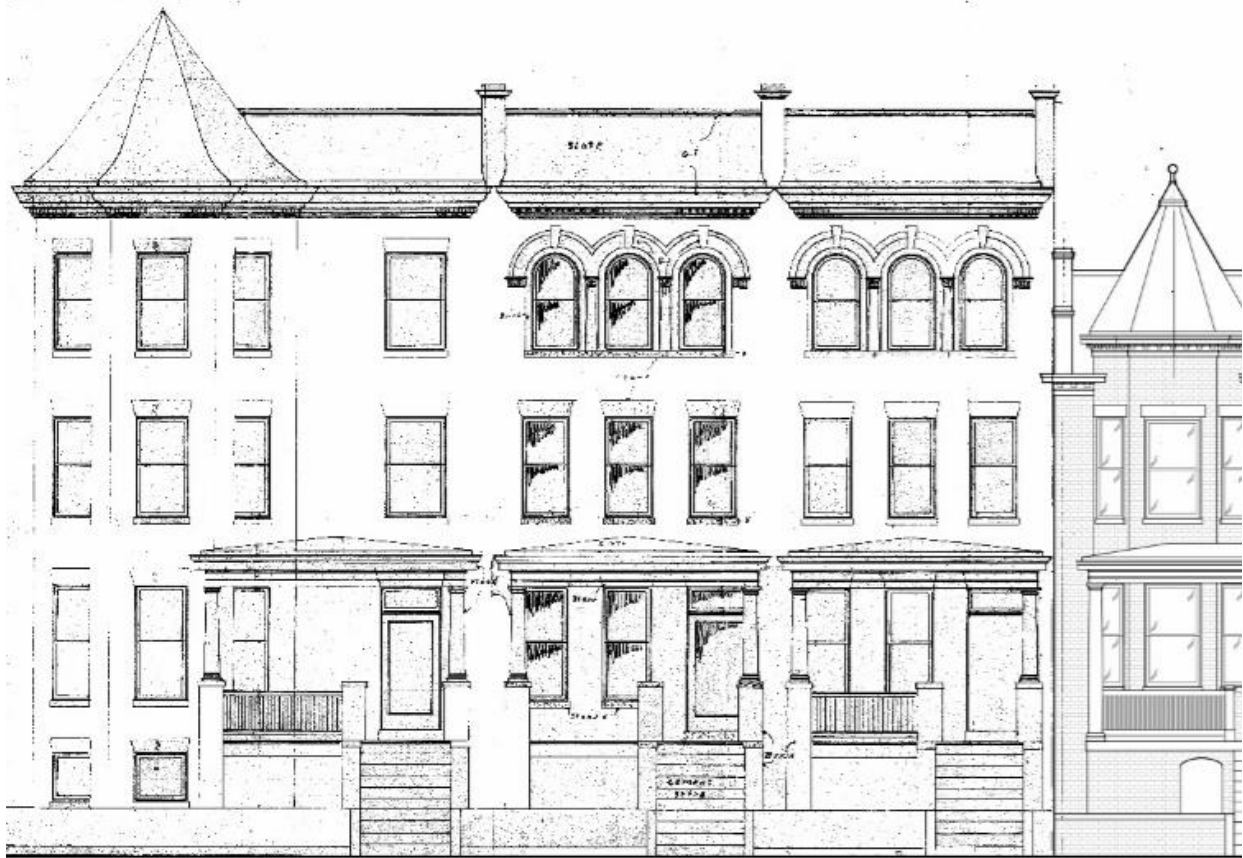
Elevation Three Houses
For Mr. H. Monte
100 West
Mt. Pleasant Street, N.Y.

Scale 1/4" = 1'-0"
