**HISTORIC PRESERVATION REVIEW BOARD
STAFF REPORT AND RECOMMENDATION**

Landmark/District: **Mount Pleasant Historic District** (x) Agenda
Address: **3212 19th Street NW**

Meeting Date: **May 25, 2023** (x) Alteration
Case Number: **23-329 and 23-330** (x) Permit

The applicant, property owner Natalie Bonanno, requests the Board’s review of an after-the-fact permit application to add stone pavers to the leadwalk, main-entry steps and front porch and to replace two dormer windows.

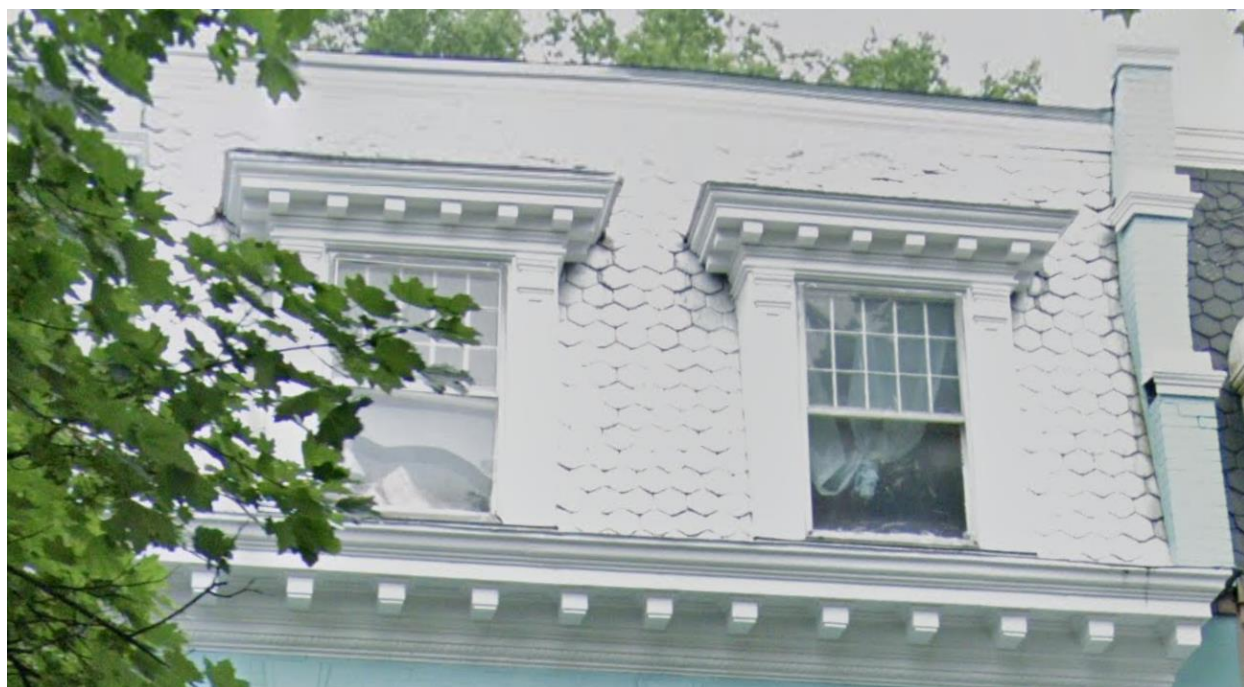
Based upon photos going back two decades, the original dormer windows were divided-light, with configurations appropriate to the shape of the openings. The sash in the rectangular openings with flat or hipped roofs was fifteen lights over one, as appear in Google Streetview photos of this property as recently as June 2019, more than a year after the property was purchased by the applicant. The applicant had obtained a permit for window replacements in September 2018, and it called for fifteen-over-one windows at the attic, as one would expect, but one-over-one windows were installed.¹

HPO recommends that the Board not recommend approval of a permit for the dormer windows and the paving as is, but support the windows being replaced with compatible fifteen-over-one windows, and the stone being removed from at least the walk and steps.
