**HISTORIC PRESERVATION REVIEW BOARD  
STAFF REPORT AND RECOMMENDATION**

Property Address:	<b>523 Cedar Street, NW</b>	<b>X</b>	Agenda
Landmark/District:	<b>Takoma Park Historic District</b>		Consent Calendar
Meeting Date:	<b>June 30, 2022</b>	<b>X</b>	Concept Review
H.P.A. Number:	<b>22-242</b>		Alteration
Staff Reviewer:	<b>Steve Callcott</b>	<b>X</b>	New Construction
			Demolition
			Subdivision

Applicants Rachel and Angeloe Wilson, with plans prepared by MWB Architects, seek concept review for construction of a three-story frame house on a vacant lot in the Takoma Park Historic District.

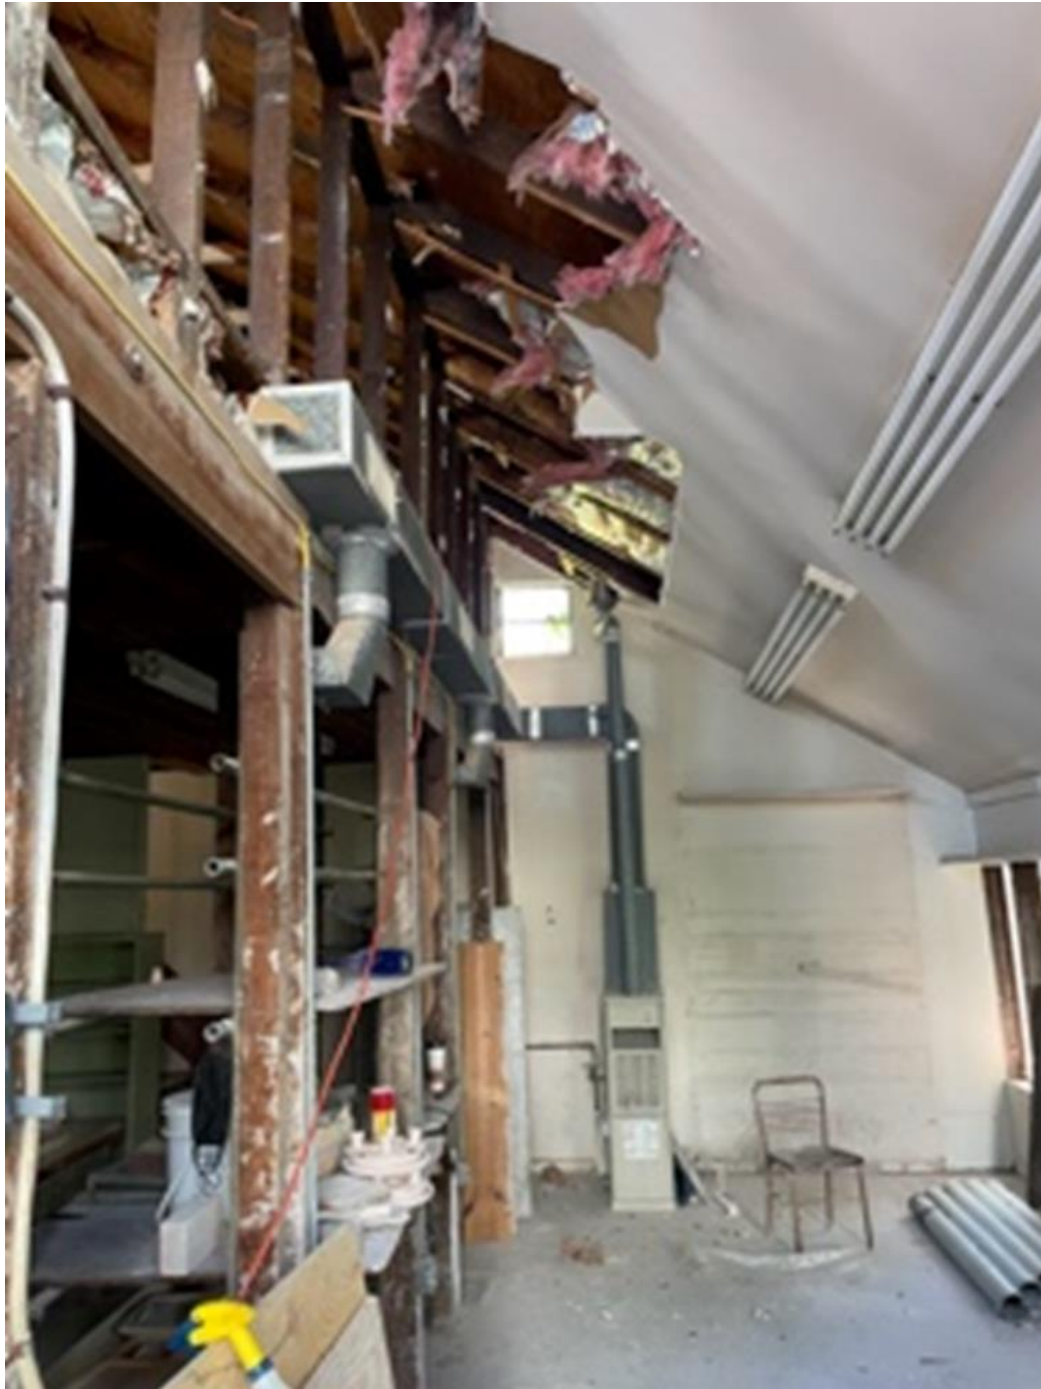
*Interior of outbuilding at 515 Cedar showing older wall framing and newer roof framing. The older framing elements are of different sizes, possibly indicating that they were reclaimed and reused.*

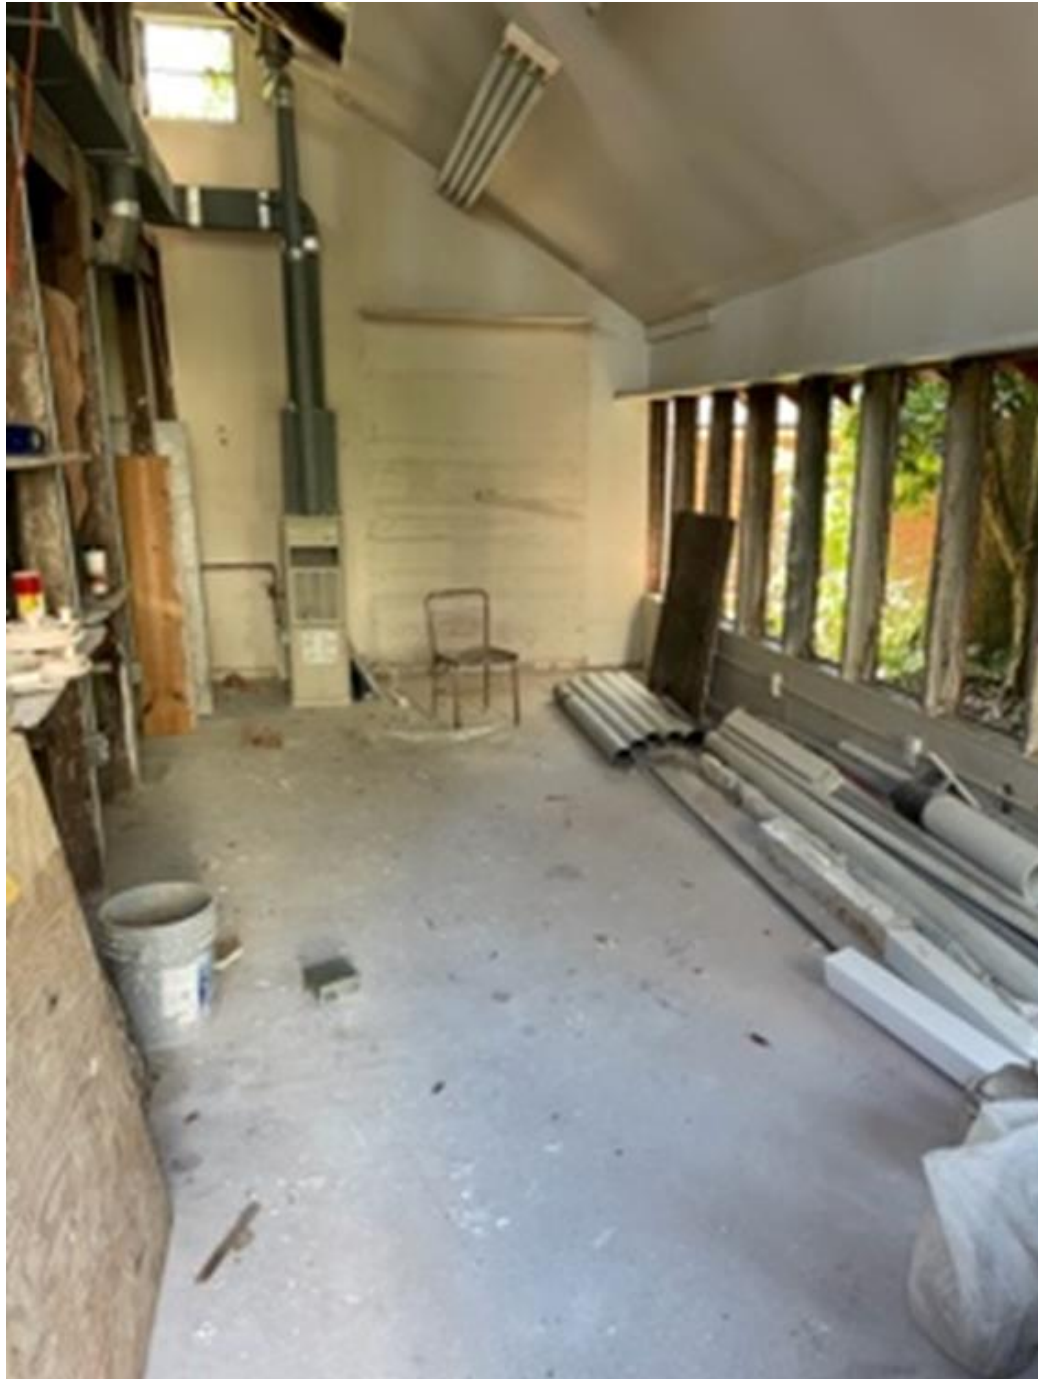
*Modern concrete floor and foundation of 515 Cedar outbuilding*
