**HISTORIC PRESERVATION REVIEW BOARD
STAFF REPORT AND RECOMMENDATION**

Landmark/District: **Walter Reed Army Medical Center** (x) Agenda
Address: **1010 Butternut Street/6099 Georgia
Avenue NW**

Meeting Date: **August 3, 2023** (x) Alteration/additions
Case Number: **23-369** (x) Revised concept

The applicant, Walter Reed MF Partners LLC, lessee, requests the Board’s review of design development of a project to convert Building 12 to use as a hardware store, including additions (solarium, elevator shaft, third-story connector) and site work (paving, walks, fencing, planting).

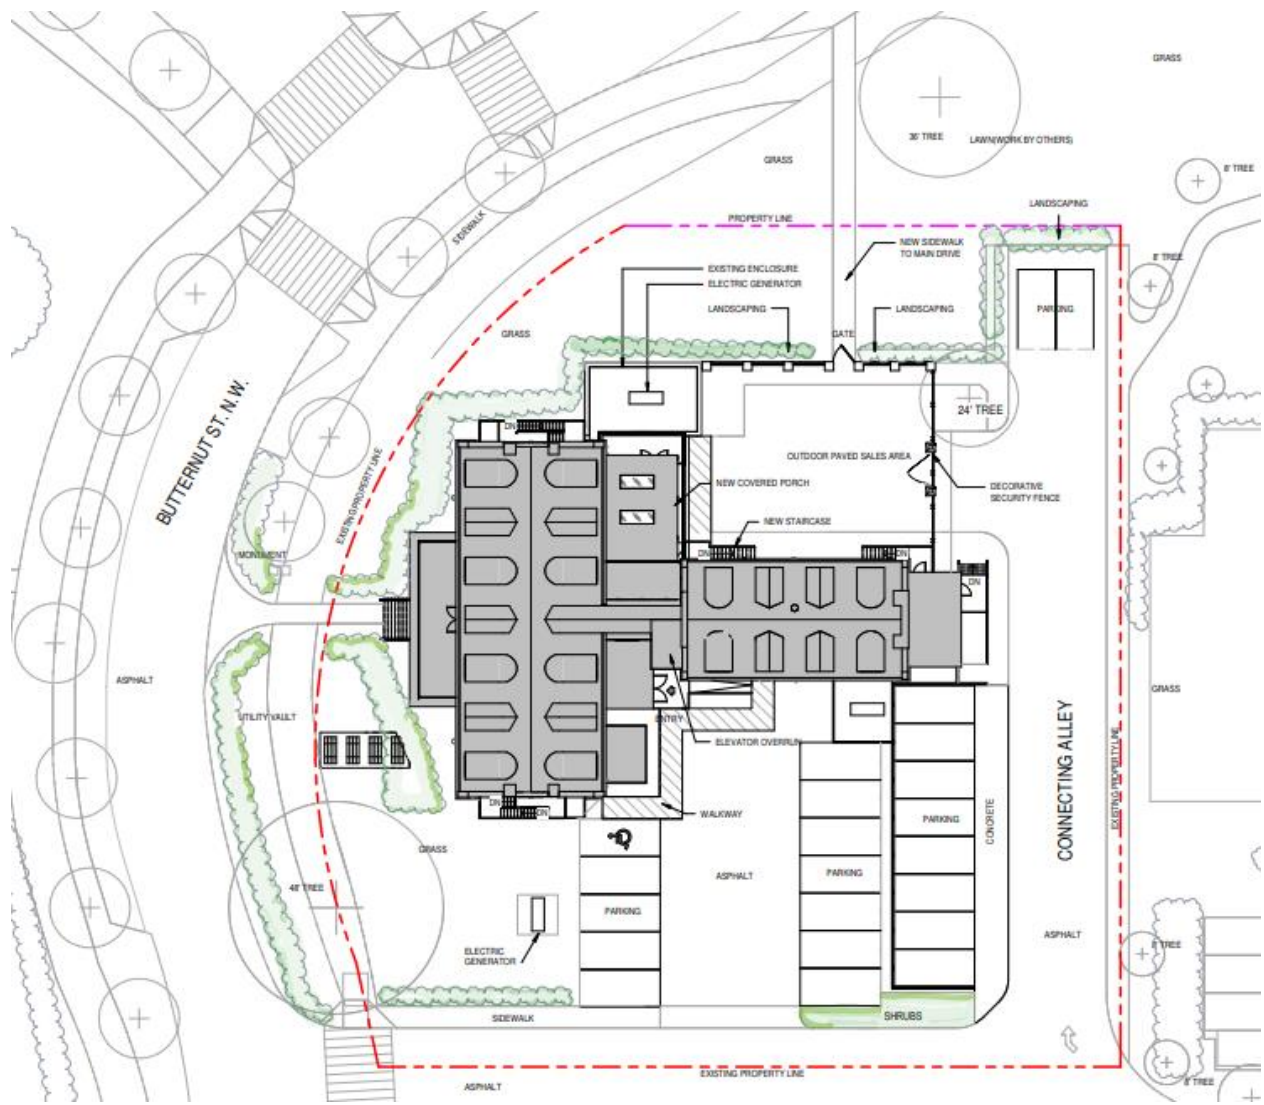
Revised site plan.

- The outdoor garden storage corral has been replaced by two parking spaces. There should not be parking located there, for the same reasons as previously stated for the storage pen. The paving is already proposed to expand westward, from a point even with the east side of the generator enclosure to one west of it. The two new parking spaces are nearly in the front yard of the building next door. (For comparison, see the previous site plan on the next page.)

- A fenced area west of the building appears to be the relocated outdoor storage and perhaps a corral for carts. While we now get some sense of the fencing itself (it is unclear how it is “decorative”), it should be further detailed. The rails and pickets should be solid stock, like those of the perimeter fence referenced, rather than tubular fencing, which typically has U-channel rails, bracket connections and applied or pinched finials.
