Homeowner Grant Program

2111 13th Street, SE

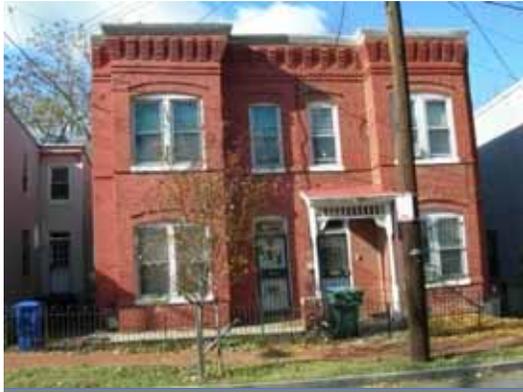
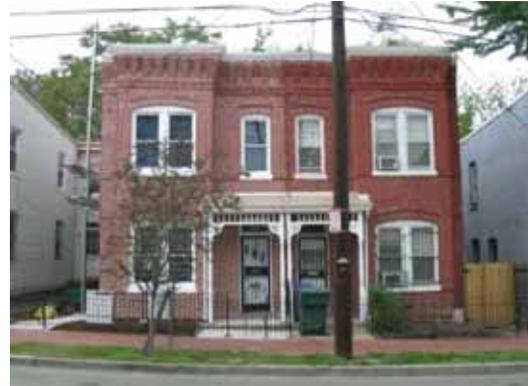
Removed the existing front porch and front yard concrete slabs, the broken south side concrete walk & rear porch slab. Removed rotted wood basement windows & all existing aluminum storm windows, Remove all paint from, and thoroughly clean the existing exterior masonry walls, Brick tuck pointed the entire house with new mortar to match the color and consistency of the existing historic masonry mortar joints, Install new glass block into, to fill the 2 existing basement window openings. Installed new nominal 4"

reinforced concrete sidewalk and rear porch slabs, front porch slab replaced to replicate the existing front porch slab on the adjacent sister house to the north. Infilled front yard with new topsoil for planting, Restored historic metal roof cornice, parapet flashing. Restored historic windows and doors. Replicated the existing historic porch on the adjacent sister house to the north including new turned wood posts, new saw cut fan brackets and new roof and restored the adjacent sister house porch was fully restored. The historic iron post
