**HISTORIC PRESERVATION REVIEW BOARD
STAFF REPORT AND RECOMMENDATION**

Landmark/District:	Capitol Hill Historic District	<input type="checkbox"/> Agenda
Address:	327-331 Pennsylvania Avenue, SE	<input checked="" type="checkbox"/> Consent
		<input checked="" type="checkbox"/> Concept
Meeting Date:	September 22, 2011	<input checked="" type="checkbox"/> Alteration
Case Number:	11-475	<input type="checkbox"/> New Construction
Staff Reviewer:	Amanda Molson	<input type="checkbox"/> Demolition
		<input type="checkbox"/> Subdivision

Restaurant owner Xavier Cervera, with drawings prepared by Orestes del Castillo, requests concept approval for storefront and fenestration modifications at 327-331 Pennsylvania Avenue, SE in the Capitol Hill Historic District.

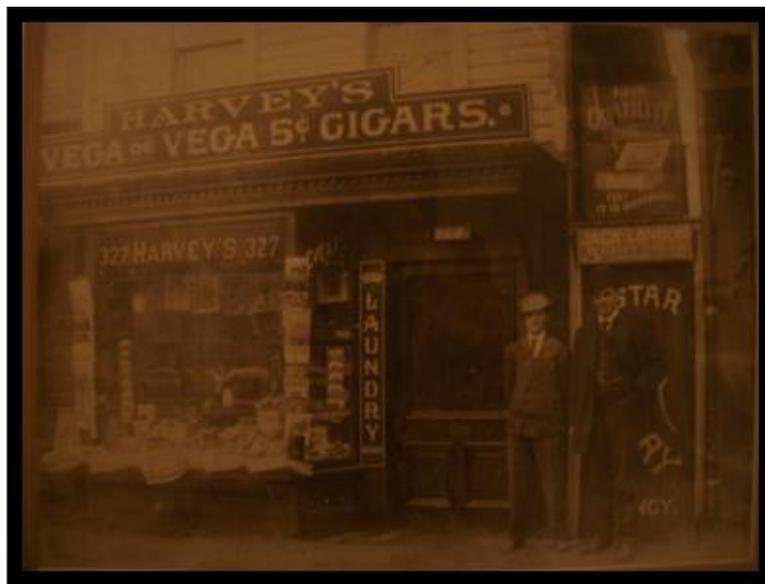
327 Pennsylvania Avenue, SE (date unknown). Courtesy Hawk 'n' Dove.

Designed as three separate buildings, 327-331 Pennsylvania Avenue, SE appear on historic maps as early as 1888. Although permit data is not available, the frame construction at 327 and the bracketed cornices at all three properties suggest the buildings may date to the 1870s. Map research and a continuous masonry façade suggest that 331 originally included the building next door as well (now the Tune Inn restaurant and bar), with the expanse now divided into two narrower buildings. Photographic evidence shows that the existing projecting storefront at 327 pre-dated the 1960s changes, and the side court shown in the photo also evidences that this narrow passageway has long been open.
