Homeowner Grant Program

1317 U Street, SE

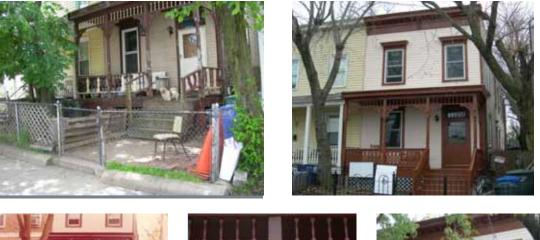
Removed the vinyl siding on the front (north) elevation, non-historc porch railings, ballusters, 2 x 6 floor boards, rotted wood ceiling, and stair assembly. Removal of the front elevation vinyl windows. Restoration of the front elevation wood siding .Installed new insulated, wood double hung windows to match the original configuration. Restored historic porch roof framing. Replaced porch roof with a new metal roof with integrated gutter assembly. Installed new wood beaded porch ceiling, new T&G porch floor, new saw-cut ballusters and

handrail, new porch steps and porch skirt. Replicated and replaced 2 porch posts & brackets to match the existing. All remaining historic elements were restored and painted.Existing chain link fence was removed and replced with a hand wrought iron fence.Outside the grant the contractor also trimmed the front yard maple tree away from the house and removed an invasive sucker tree.
