**HISTORIC PRESERVATION REVIEW BOARD  
STAFF REPORT AND RECOMMENDATION**

Landmark/District:	<b>Anacostia Historic District</b>	(x) Consent Calendar
Address:	<b>1347 Maple View Place SE</b>	
Meeting Date:	<b>December 17, 2020</b>	(x) Alteration/addition
Case Number:	<b>21-093</b>	(x) Concept

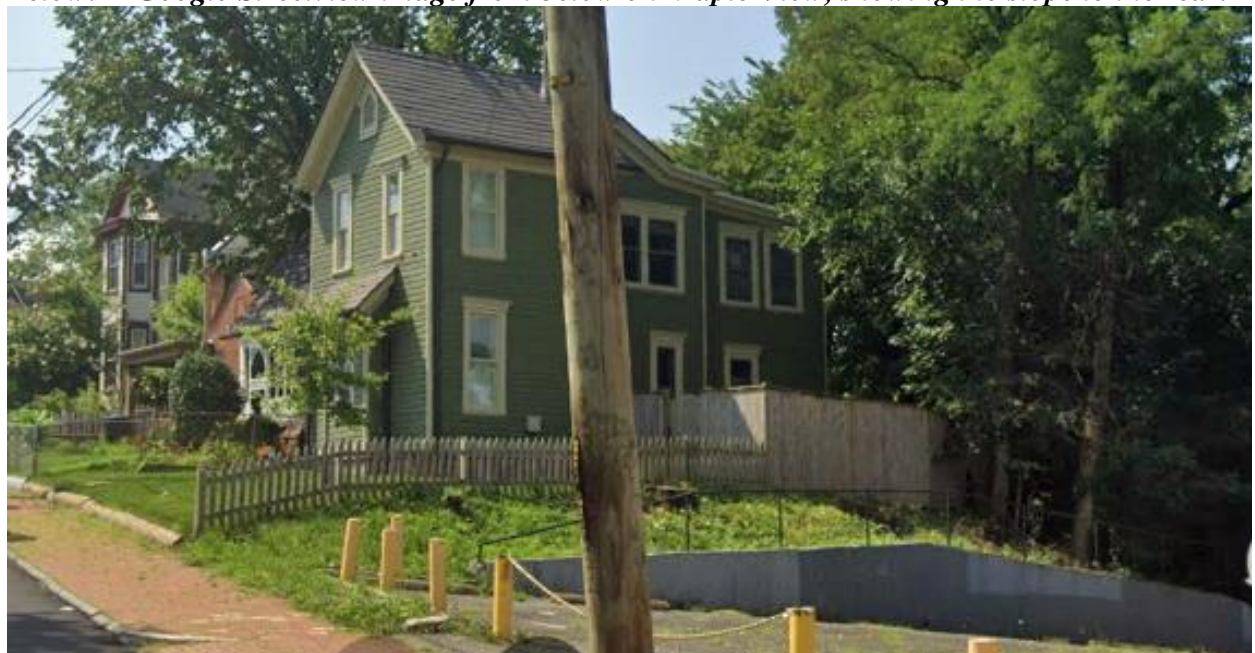
*Below: A Google Streetview image from below on Maple View, showing the slope to the rear.*

A more substantial revision is anticipated, based on the property's topography, which slopes downward from the east corner to the southwest. The side elevations portray the site as nearly flat front to back, but as the submitted photo of the rear elevation suggests, it drops somewhat more—and much more sharply beyond that point. A twenty-foot-deep addition would reach to the location of the back fence and would have much more basement exposed—a walkout basement, if desired, rather than the indicated crawlspace. This raises a question of whether the proposed patio ends up at the basement level, with a deck above at the main floor. With the soils

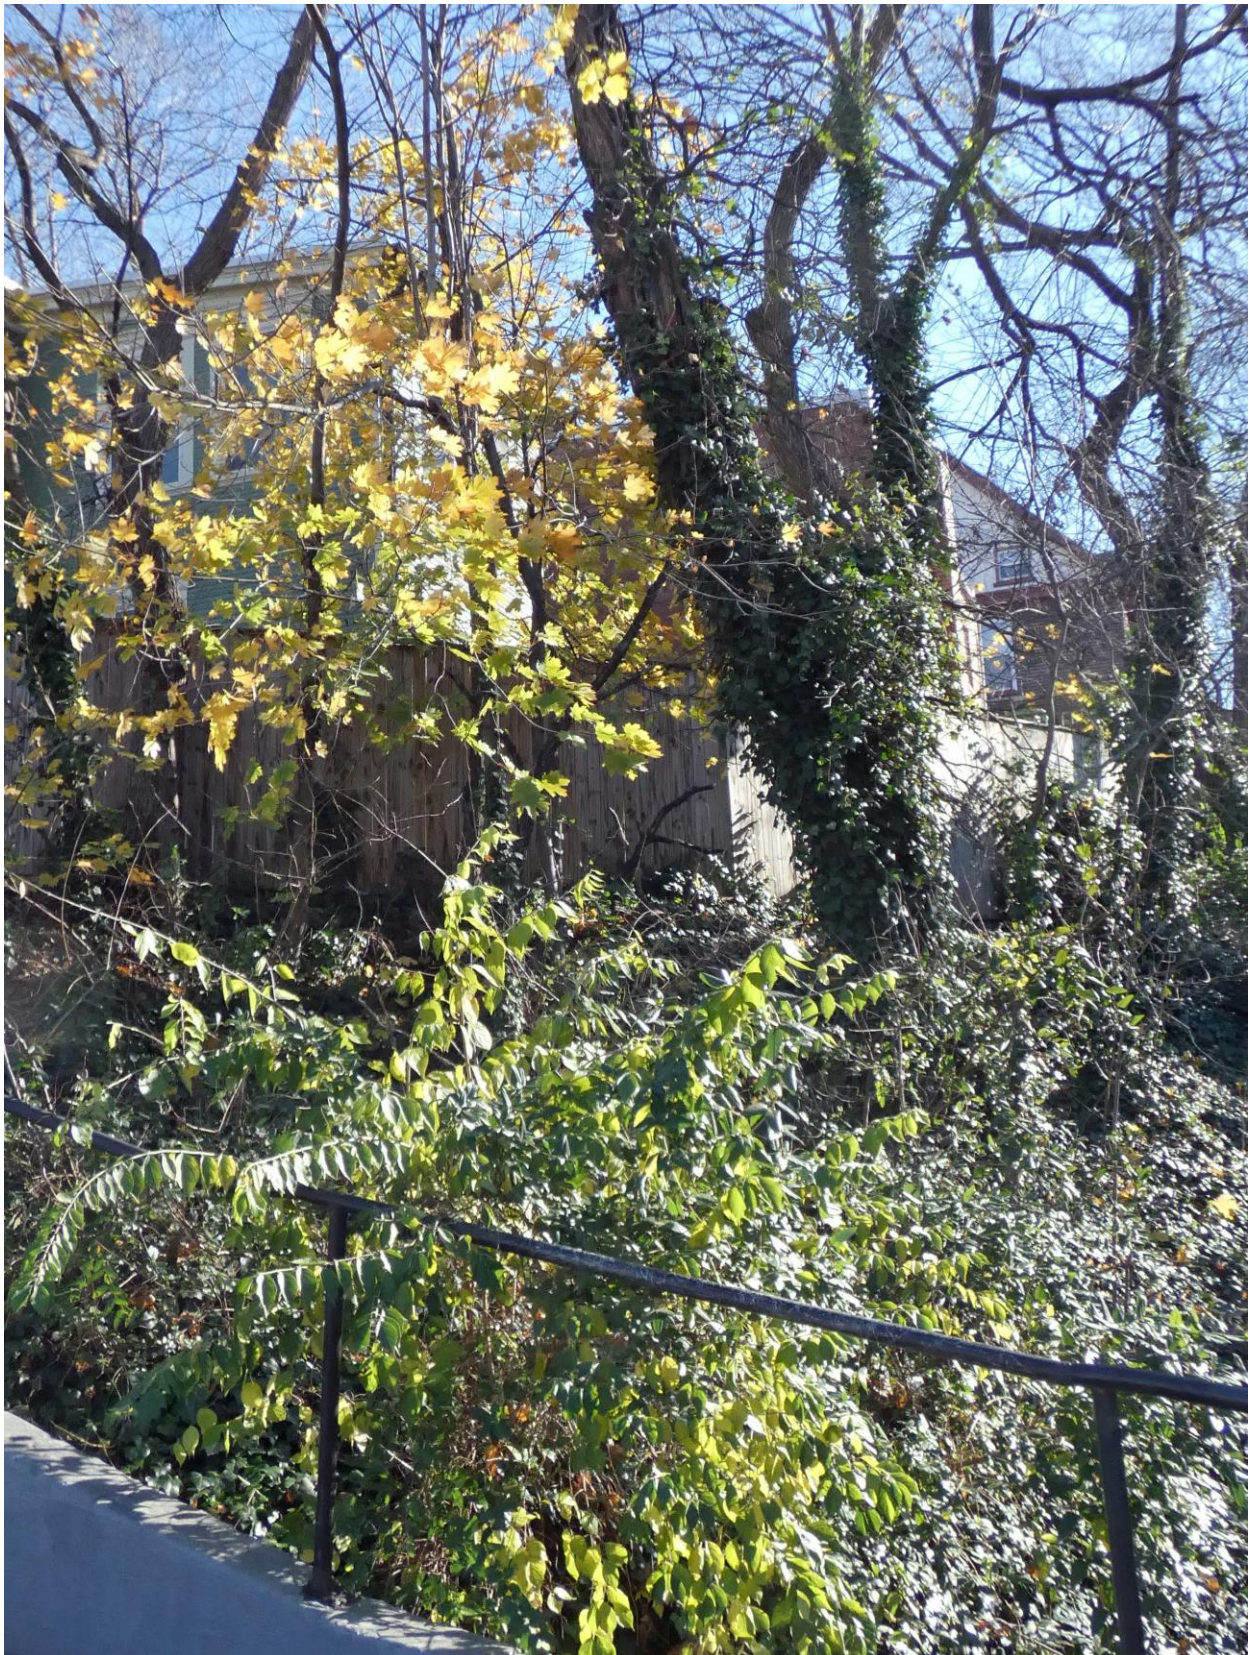
*An obstructed view of the rear of the house and the back fence. The ground drops off still more steeply beyond the fence.*
