**HISTORIC PRESERVATION REVIEW BOARD
STAFF REPORT AND RECOMMENDATION**

Landmark/District:	Capitol Hill Historic District	<input checked="" type="checkbox"/> Agenda
Address:	1007 8th St SE	<input type="checkbox"/> Consent
ANC:	6B	<input checked="" type="checkbox"/> Concept
		<input checked="" type="checkbox"/> Alteration
Meeting Date:	December 2, 2021	<input checked="" type="checkbox"/> New Construction
Case Number:	21-548	<input type="checkbox"/> Demolition
		<input type="checkbox"/> Subdivision

Applicant Calle Ocho LLC seeks concept review for construction of an elevated wood deck structure in front of a non-contributing building in the Capitol Hill Historic District.

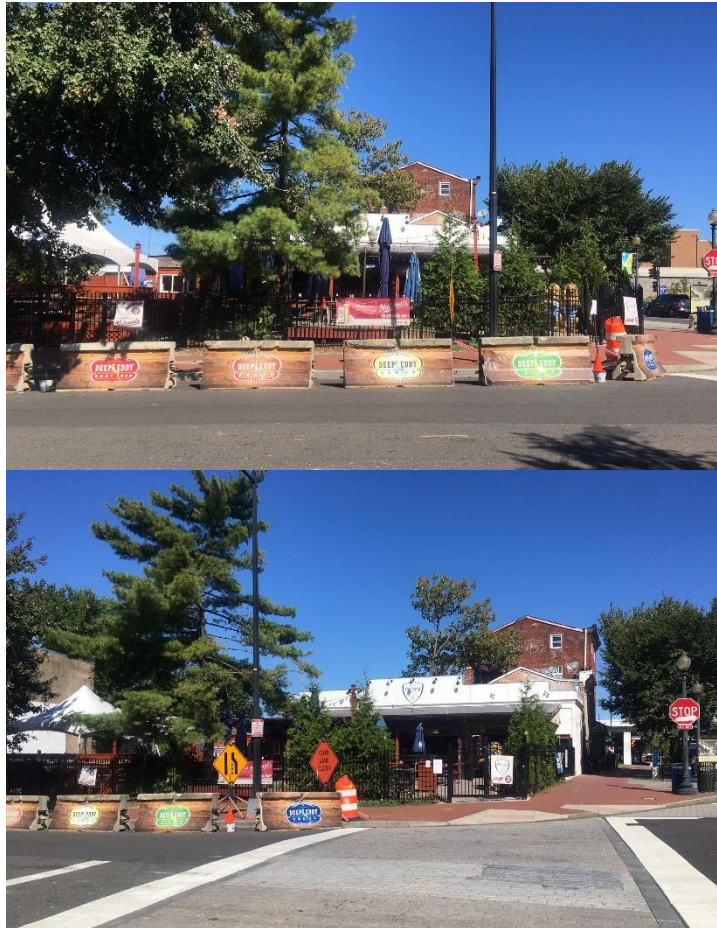
Views of 1007 8th St SE from L Street

The subject property is a one-story commercial building constructed in 2015 with the intention of being temporary. The building is set back from the corner of 8th and L Streets. Currently used as a beer garden, there is a large outdoor seating area that is enclosed with a perimeter fence. A lean-to canopy has been added to create a covered outdoor area.

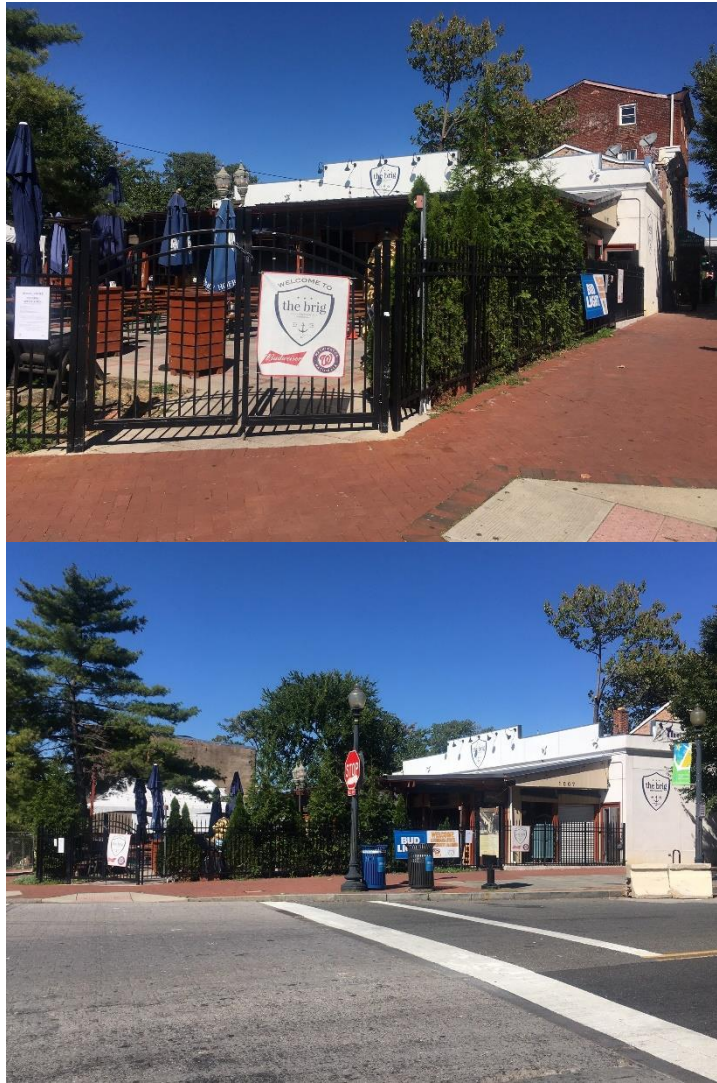
Views of 1007 8th St SE from 8th Street

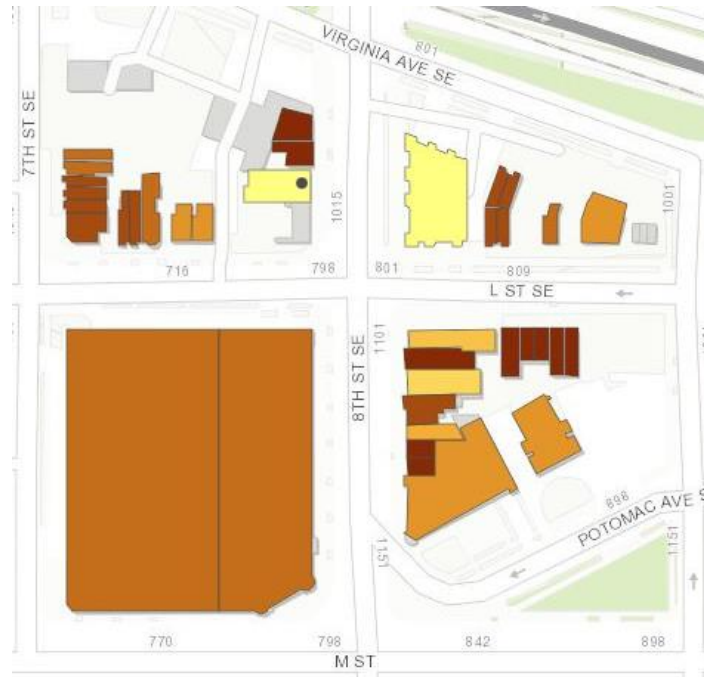
Aerial view of the subject property (indicated with black dot) in context from History Quest. Darker shades of orange indicate older buildings, bright yellow shows more contemporary construction.

Both 1003 and 1005 8th Street SE appear on the 1857 Boschke Map. There are contributing buildings on all sides of this, except for a non-contributing building across 8th Street. Across L Street is an individual landmark, the Navy Yard Car Barn (popularly referred to as the Blue Castle). Although intended to be temporary, 1007 8th Street was designed in a way to respect the scale of the nearby historic buildings.
