HISTORIC PRESERVATION REVIEW BOARD STAFF REPORT AND RECOMMENDATION

Capitol Hill Historic District Landmark/District: (x) Agenda 142 D Street SE () Consent Address: (x) Permit ANC: 6**B**

Case Number: 19-329 () Demolition

Applicants Carter and Julia Collison, with plans prepared by architect Adam Carballo, seek concept review for new rear, side, and rooftop additions on a property located in the Capitol Hill Historic District.

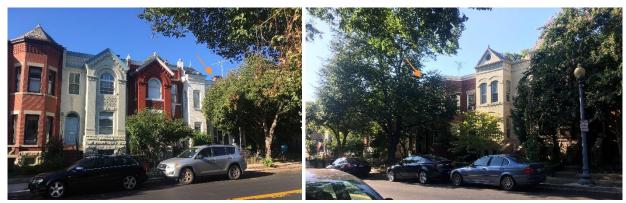
Contextual views of 142 D Street, SE

The subject property was built in 1885 alongside its matching twin, 140 D Street SE, as a brick two-story bay-front house. The houses were originally approximately 12 feet wide and 30 feet deep. 142 D Street is largely intact on its front and rear elevations, retaining its original dogleg at the rear. 140 D Street has been altered through a large rear, side, and rooftop addition built around 2000.

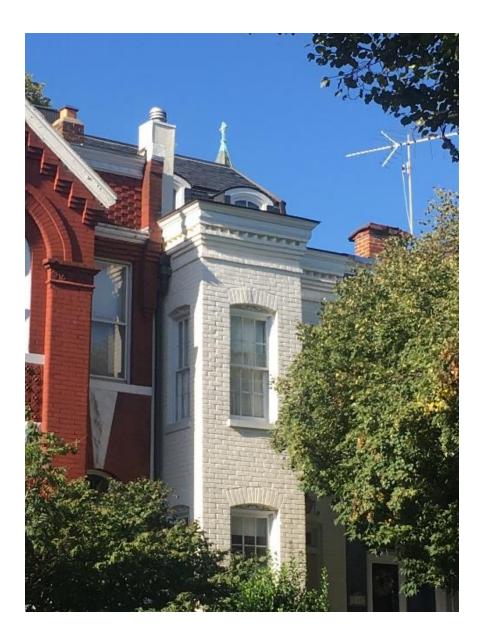
Visible rooftop addition at 140 D Street SE

The intention of this project is to replicate the addition at 140 D Street SE, giving the Board a rare chance to see a proposed project already built. Twenty years ago, the third story at 140 D Street was one of the first rooftop additions considered by the Board. At that time, the novelty of adding height was attempted using traditional and traditional-inspired roof shapes. This is an example of an instance where a traditional roof form has been applied in a somewhat non-traditional way, as mansard roofs are not usually set-back from the front of the building. While more visually recessive than if set flush with the façade, even with the setback, the addition is clearly visible from multiple points of view along the D Street right-of-way.
