HISTORIC PRESERVATION REVIEW BOARD STAFF REPORT AND RECOMMENDATION

Landmark/District: Capitol Hill Historic District (x) Agenda Address: 203 3rd Street, N.E. () Consent ANC: 6B (x) Concept

Applicants Eammon Atkinson and John Ashton, with plans by Ricardo Hendi, seek concept review for a partial fourth floor and roof deck, and new basement entry, on a contributing building in the Capitol Hill Historic District.

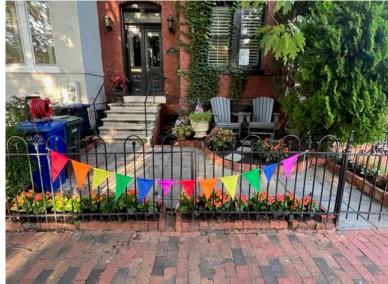
203 3rd Street NE was built for Emmons and King as one of seven in 1889. The three-story brick rowhouse has a raised basement. There is a narrow existing basement stair that runs parallel to the main stair, and a door in the projecting bay at the basement level. The front yard is currently mostly paved, although HPO and DDOT's Public Space Committee generally require that about half of public space (forward of the flat face of the building) be plantable area. The adjacent corner property has a visible roof deck of unknown age but dating to before August 2007.

$203 \ 3^{rd} \ St \ NE$ and the front yard

The current proposal severs the relationship of the bay to the ground, dominates the shallow front yard with a significant topographical change, likely exceeds public space requirements for projection and plantable area, and requires above-ground railings that visually obstruct the front of the house. In sum, it is not a compatible proposal for this property or historic district.

The orientation of the existing stair is compatible and options should be explored that utilize that stair, extend it down to below the main stair and perhaps recess the basement entrance to allow for a longer run of stairs.

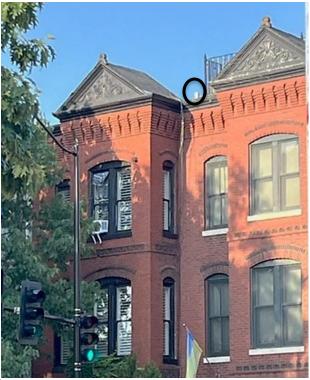
The drawings also show additional rooftop appurtenances like an outdoor shower and hot tub that are not proposed at this time and have not been mocked up but would be further forward of the proposed addition and would likely increase visibility from the West.

510 9th Street viewed from the West; flag test visible over the roof

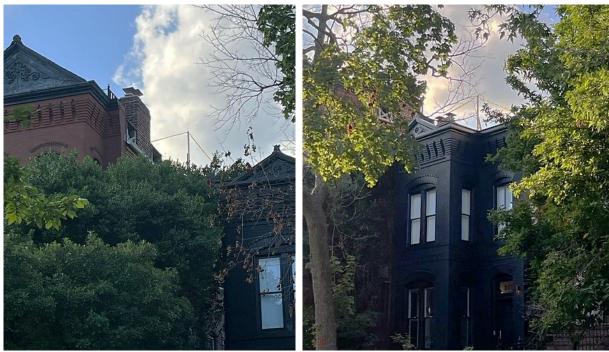
A flag test showed that the addition would be visible from multiple points along several surrounding streets. While not highly visible from 3rd Street or from the west, it was quite visible along Constitution Avenue from the east. The condensers would add height from this view towards the rear and likely also be visible.

Lumber mockup visible along Constitution Avenue from the East

The addition is visible from the field test lumber mock up, and that impact will be much more apparent were those areas to be solid walls instead of tape stretch between lumber pieces. The additional appurtenances and raised parapet will also add to the visibility of the addition and alterations at the roof. This exceeds the minimal visibility generally supported by the Board.

The HPO recommends the Board find the project incompatible with the Capitol Hill Historic District.
