**HISTORIC PRESERVATION REVIEW BOARD  
STAFF REPORT AND RECOMMENDATION**

Property Address:	<b>3000 Tilden Street, NW</b>	<b>X</b>	Agenda
Landmark/District:	<b>Cleveland Park Historic District</b>		Consent Calendar
		<b>X</b>	Concept Review
Meeting Date:	<b>January 28, 2021</b>	<b>X</b>	Alteration
H.P.A. Number:	<b>21-052</b>		New Construction
			Demolition

Tilden Gardens Inc., with plans prepared by P.B.S. Inc. (The Window Man), seeks permit approval for removal and replacement of 1,483 windows in three buildings at the Tilden Gardens apartments in the Cleveland Park Historic District.

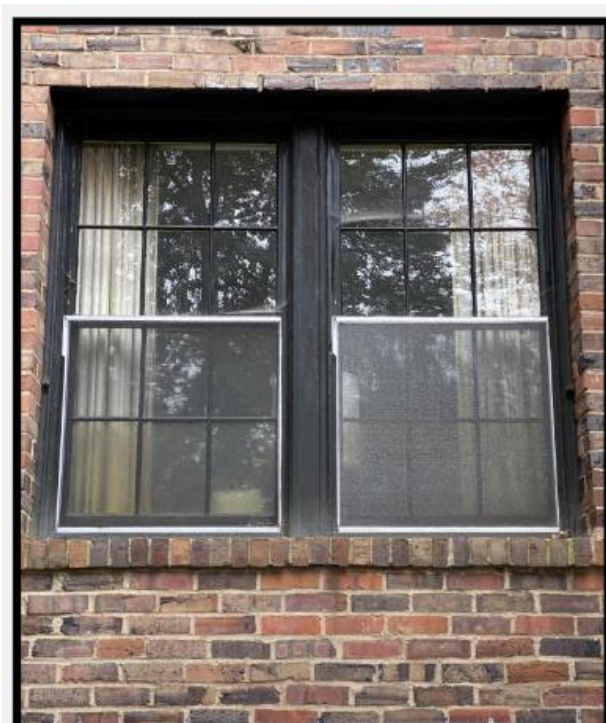
*Existing Windows*

Several on-site mocks were prepared to refine and customize the installation to achieve a close visual match to the original windows. The windows would be custom sized to minimize the frame and sash dimensions (which are often slightly thicker in modern double-insulated glass windows) and will have screens and jams in the same color as the frame. The final mock-up of the proposed replacements, located on the front elevation of 3900 Connecticut Avenue just south of the lobby entrance, is pictured below.

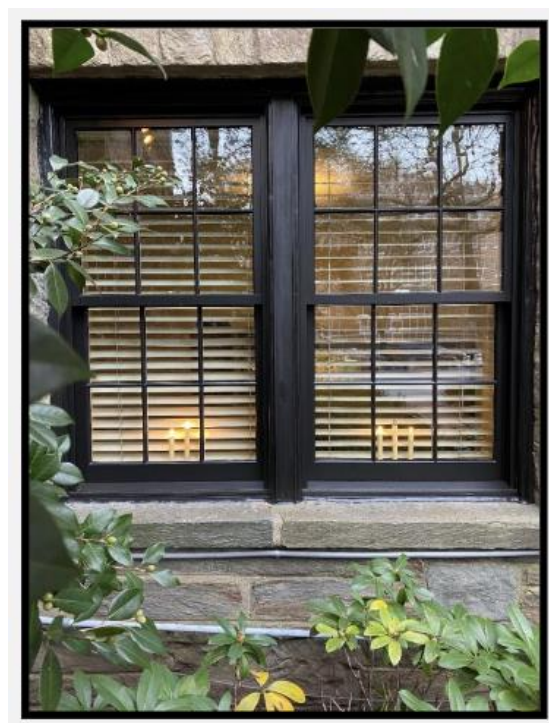
*Proposed Replacements*

Of the two issues raised by the application – whether the windows should be replaced or retained and whether the replacement windows are compatible – the second is the easy one. Through careful attention to dimensions, profiles, installation and detailing, fine-tuned through several mock-ups and customization, the proposed replacement window is an extraordinarily good replica of the originals and consistent with the design standard that replacement windows match the historic in terms of configuration, operation, profile, dimensions and finish.
