District of Columbia Historic Preservation Guidelines

ROOFS ON HISTORIC BUILDINGS

Design of Roofs

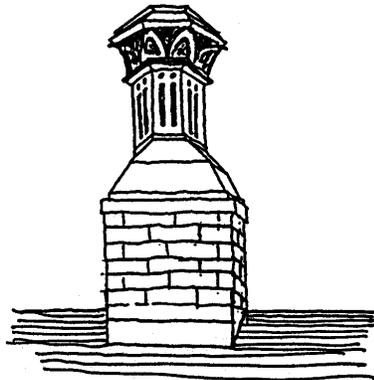
Chimneys are character-defining elements of many historic residential buildings.

Chimneys are often prominent character-defining elements on free-standing residential buildings. Chimneys are commonly made of brick, although stone and stucco are sometimes used. A chimney may be located on the front, side or rear walls projecting above the eave, or through roof slopes or ridges.
