**HISTORIC PRESERVATION REVIEW BOARD  
STAFF REPORT AND RECOMMENDATION**

Property Address:	<b>1808 S Street NW</b>	<b>X</b>	Agenda
Landmark/District:	<b>Dupont Circle Historic District</b>		Consent Calendar
Meeting Date:	<b>September 22, 2020</b>	<b>X</b>	Concept Review
H.P.A. Number:	<b>20-396</b>	<b>X</b>	Alteration

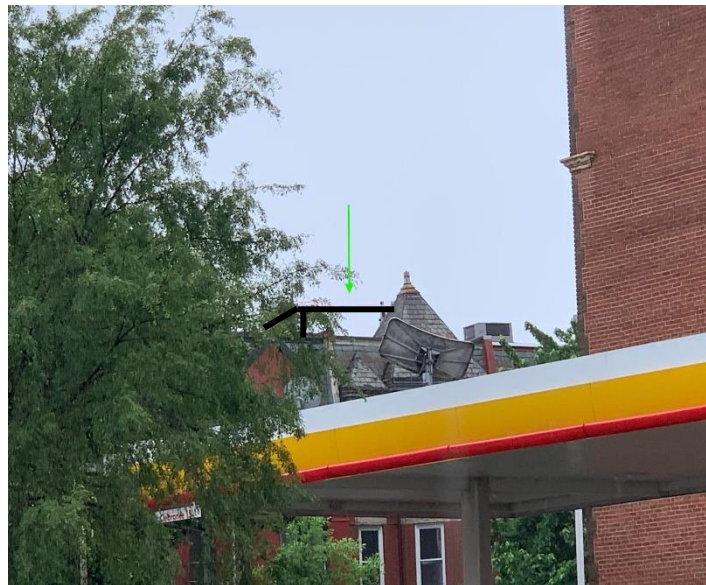
The design proposes to add a roof addition and basement entry to convert this building from a single-family residence to 4-unit building. The addition would be set back 11’7” from the façade and would open onto a rear-facing deck, setting it back 9’10” from the rear. It would be clad in cementitious board with no windows facing the front. The addition will be visible from north along 18<sup>th</sup> Street, as shown in images 4, 5, and 6 of the visibility study and the staff’s augmented image below.

As demonstrated, the addition will be visible from the north from both sides of 18<sup>th</sup> Street. Staff asked if the design could be reconfigured to put the roof deck on the front to set the addition back onto the ell, but this design would be inconsistent with zoning setback requirements. The addition has been pushed back and lowered, per staff’s request, but still would present a visible intrusion to the historic

roofline of this row. The argument could be made that the view is impeded for a certain distance by the gas station canopy at the northwest corner of the intersection of 18<sup>th</sup> and S Streets. In addition, the gas station may, at some point, be replaced. However, the visible addition detracts from the view of the building's distinctive turret as a three-dimensional form. It sits on more than half of the main roof and is not compatible with the historic district or consistent with prior Board approvals for roof additions.
