THE EFFECTS OF ENERGY EFFICIENCY TREATMENTS ON HISTORIC WINDOWS

THE EFFECTS OF ENERGY EFFICIENCY TREATMENTS
ON HISTORIC WINDOWS

Project # 2008-M1-024

Grant Recipient: The Center for ReSource Conservation

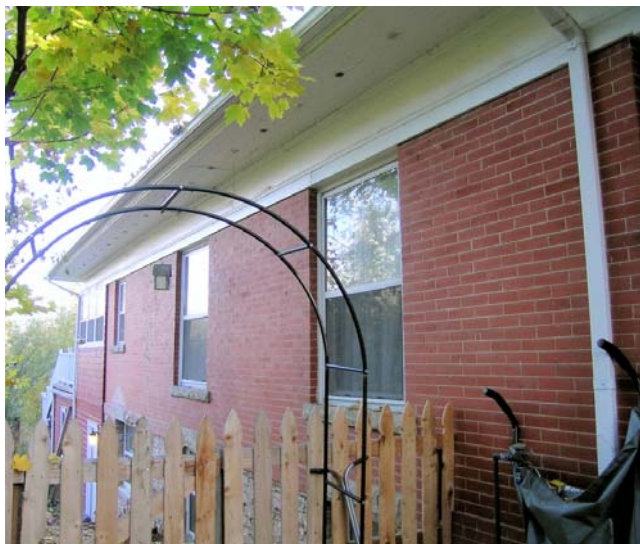
Figure 2-4. Northwest Elevation (The closest 3 windows were chosen for retrofit)

The study team identified three window systems on the north and three on the south of the home to be studied (see Figures 2-4 and 2-5). The three windows of interest on the south side of the home are each associated with single rooms. The team was able to largely isolate two of these from the rest of the dwelling for testing (the third cannot be fully isolated from a foyer in the front of the home).

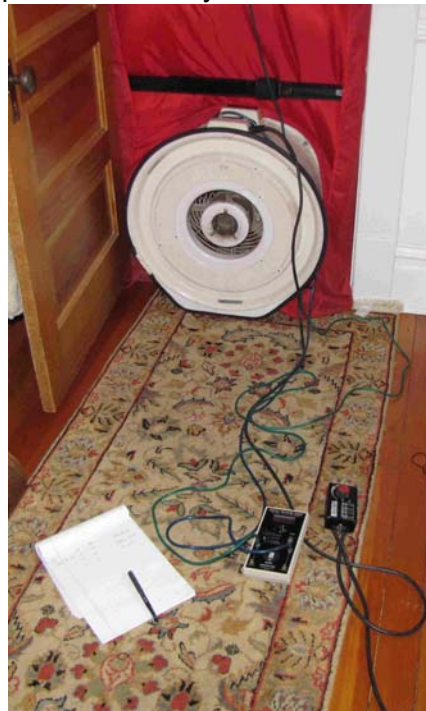
Figure 2-7. Blower Door Installed in Bedroom
(Speed control on floor on right; digital manometer in center)

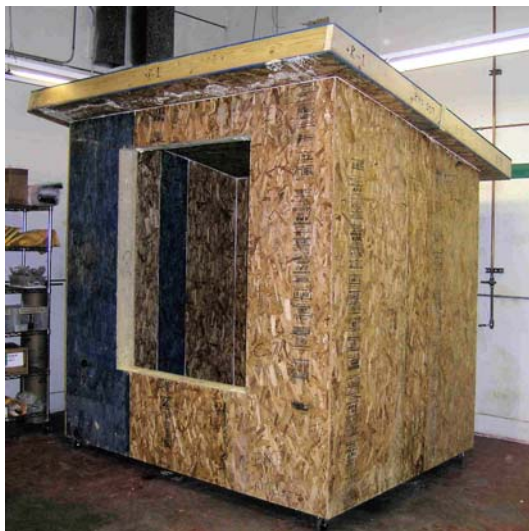
Figure 2-8. Test cell after first day of assembly

The study team designed and constructed a super-insulated, tightly-sealed 390 cubic foot test cell using six inch thick, urethane-based structurally insulated panels (SIPs) on all six sides. It is capable of testing window system samples of up to 20 cubic feet. The cell is heated with electric resistance radiant panels, controlled to maintain a constant warm temperature within a tenth of a degree F (e.g., 122°F). The test cell can be rolled into and out of a cold chamber built into the inside corner of a building. The cold chamber, which is insulated with 2 inches of polyisocyanurate and 3.5 inches of fiberglass (R-22), is accessed through a 280-pound door, weather sealed and insulated to R-25. The door opens and closes by means of a winch and pulley system suspended from steel roof rafters. The chamber is cooled by a modified room air conditioner to approximately 52F, thereby exposing fenestration samples to a temperature difference of 70 F. Figures 2-8 and 2-9 show the test cell and chamber during construction.

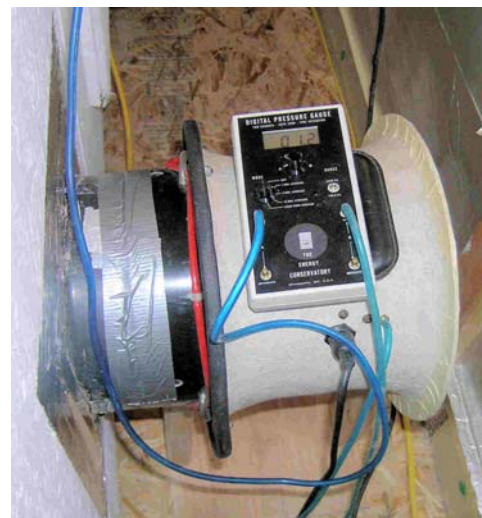
Figure 2-12. Duct blaster with manometer

The chamber was built to be extremely tight (see Appendix B), so leakage is very close to zero. The test cell has one access door (itself carefully weather-stripped and insulated to R-35) and the aforementioned 20 square foot opening for testing windows into which calibration plugs or plugs with sample windows are inserted. Two additional holes accommodate leakage testing (both of which are insulated with tight-fitting plugs of 7 inches of urethane and air sealed when not conducting leakage tests). Leakiness was measured using a custom-calibrated duct blaster and two digital pressure gauges from the Energy Conservatory. One 12 inch diameter hole accommodates the duct blaster and allows for precise leakage measurement. The other hole is used to introduce leakage air of a known area (3.14 square inches) via a 2 inch diameter hole. This allows the fan to operate in the “sweet area” of its calibration curve to maximize accuracy.

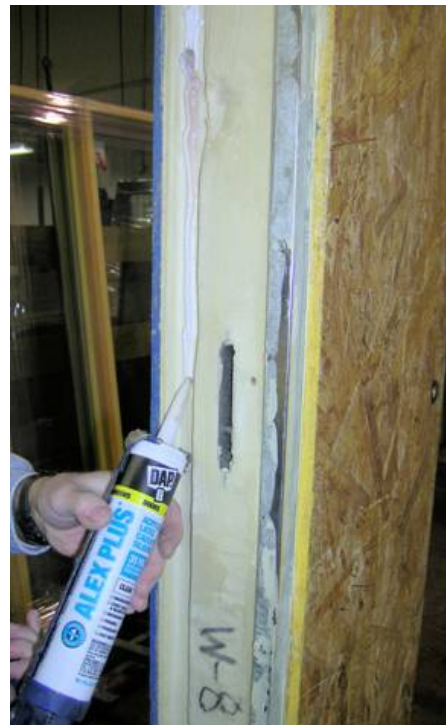
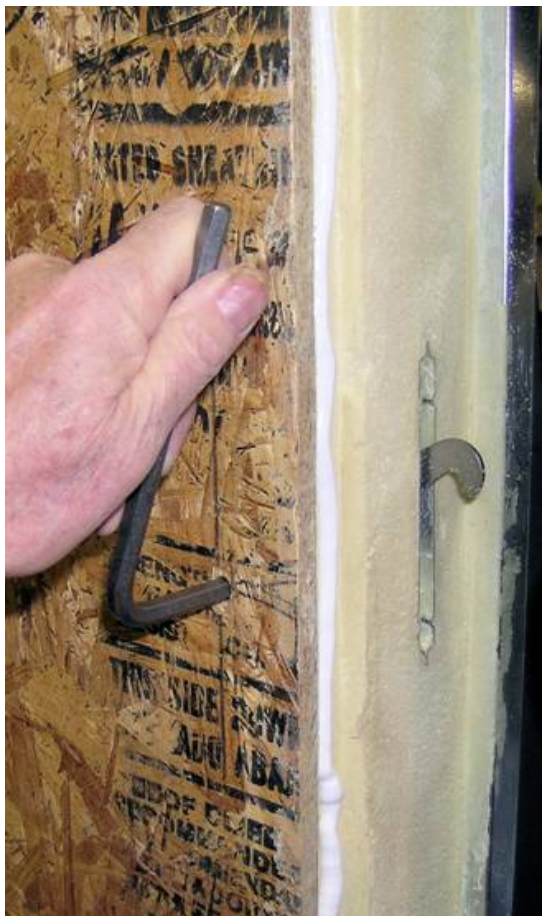
Each joint was sealed using urethane foam insulation and caulk to ensure joints were well sealed. The team used clamp hooks to snug the walls together. Then, wheels were installed to roll the test cell in and out of the chamber. The photo below shows the constructed test cell following a day's work.

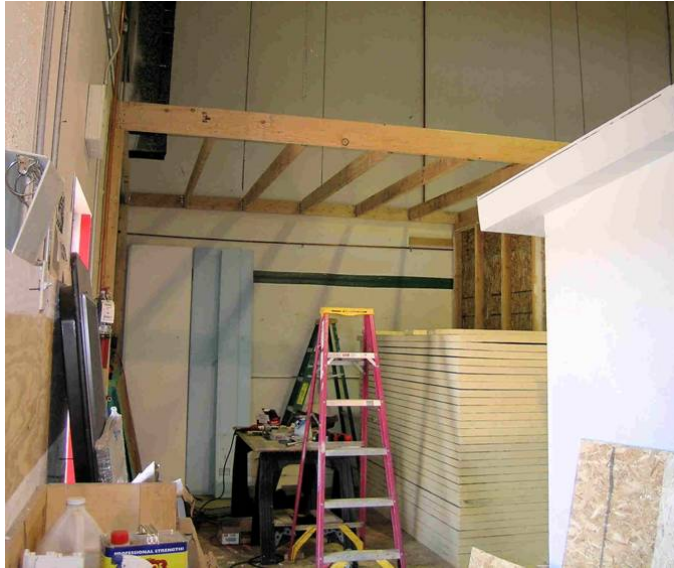
The chamber was framed into the corner of a warehouse. The existing walls were first covered in two inches of polyisocyanurate (R-13).

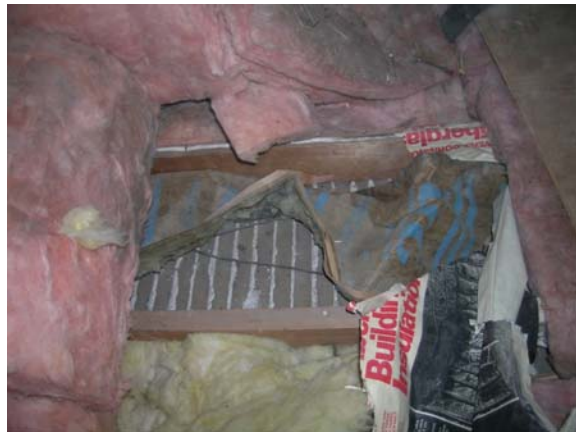
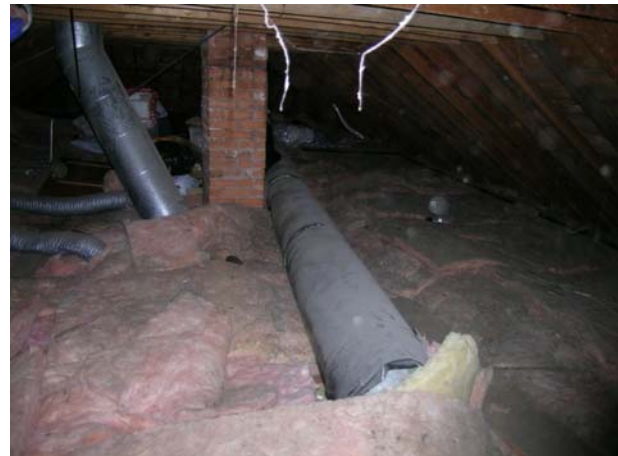
In spite of spotty insulation in the attic (see photos at left and below) and none in the walls of the old portion of the home (there's a newer addition on the back—east—façade of the home), air leakage accounts for approximately half of the heating load on the home. Such leakage causes energy waste and discomfort, and can shorten the lifetime of beautiful old homes like this one.

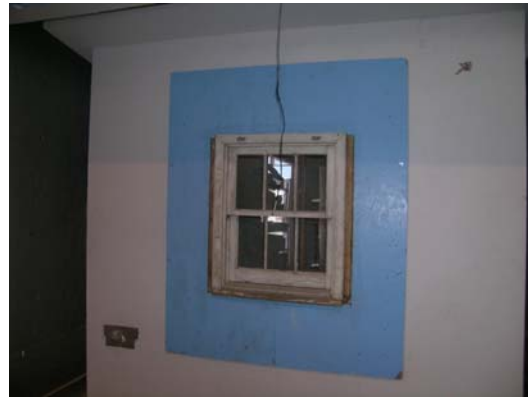
First, we tested the window “as is” in the test chamber. A 4 x 5 foot insulated plug was adapted to fit the window. The plug was fitted in the chamber and tested for air leakiness, then U value.

Window in the test chamber

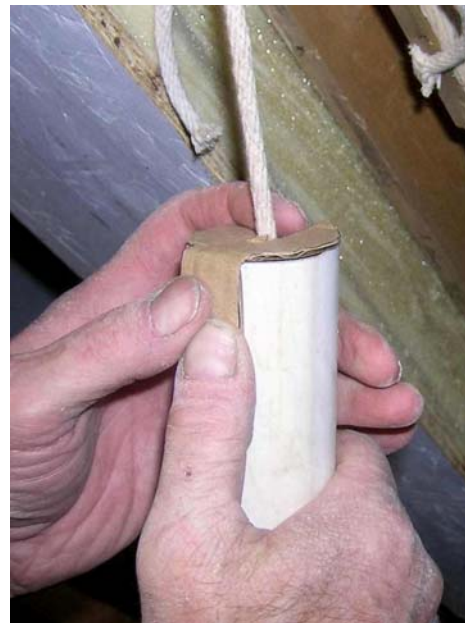
New weight ropes are installed and cardboard and packing tape is used to seal up both ends of the PVC tubes to prevent urethane from penetrating the area where the weight slides.

Cardboard in place over PVC tube

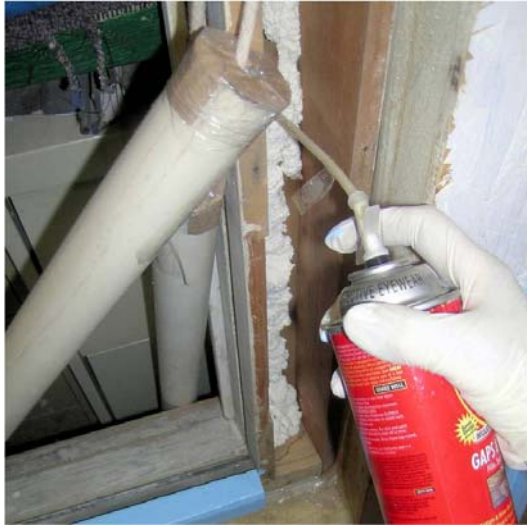
Adding urethane to pocket

Urethane is applied in layers to ensure weight tubes are completely surrounded – foam (shown), 1st tube inserted, foam, second tube, and still more foam. Foam expands several fold while curing.
