**HISTORIC PRESERVATION REVIEW BOARD  
STAFF REPORT AND RECOMMENDATION**

Property Address: **1340 Corcoran Street, NW**  
Landmark/District: **14<sup>th</sup> Street Historic District**

Meeting Date: **January 24, 2019**  
H.P.A. Number: **19-069**

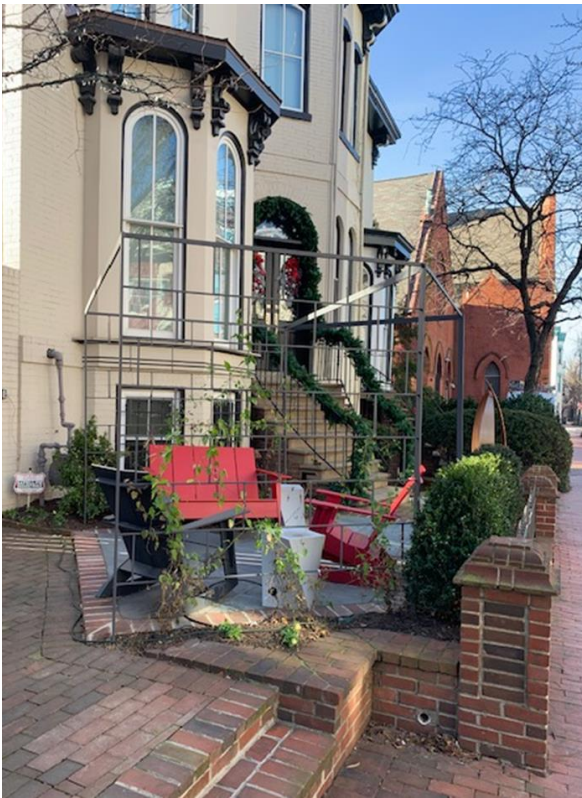
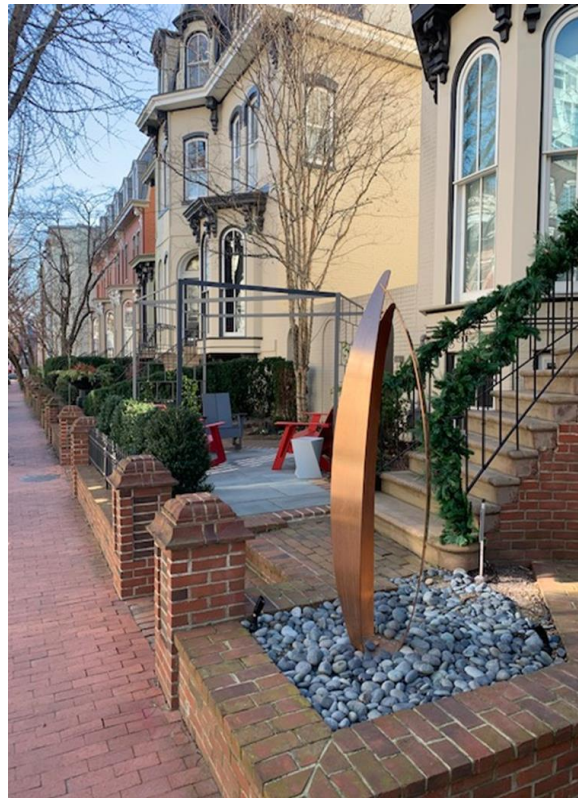
The applicants are seeking a permit for the constructed trellis, and for flagstone and brick patio paving. A metal sculpture has also been erected but was not cited at the time of inspection and is not included in the permit application. The brick walks leading to the front stairs and to the side yard and the retaining wall adjacent to the public sidewalk are pre-existing.

The extent of the front yard that is paved for the patio is somewhat greater as a percentage of area than is typical for the block but maintains landscaping against the fence at the edge of the sidewalk and at the foundation of the house to an extent that is sufficiently compatible. While garden arbors and trellises can often be compatible elements for historic properties, they are more typically located in side and rear yards rather than directly in front of an historic

property. While the metal trellis erected at 1340 has relatively thin framing elements, it appears more as a frame work for a room-sized structure than as an incidental garden element. The trellis's size, height, projection so close to the sidewalk, proportional size relative to the open front yard, and its visual impact in interrupting views of the front yards and projecting bays along the block are incompatible with the open character of front yards in a rowhouse neighborhood.

*The HPO recommends that the Review Board find the front yard patio paving maintains a balance of paving and landscaping that is compatible with the character of front yards in the 14<sup>th</sup> Street Historic District but that the trellis structure is incompatible with the historic district.*
