National Park Service
Cultural Landscapes Inventory

2005
Revised 2011

Franklin Park
National Mall & Memorial Parks - L'Enfant Plan
Reservations

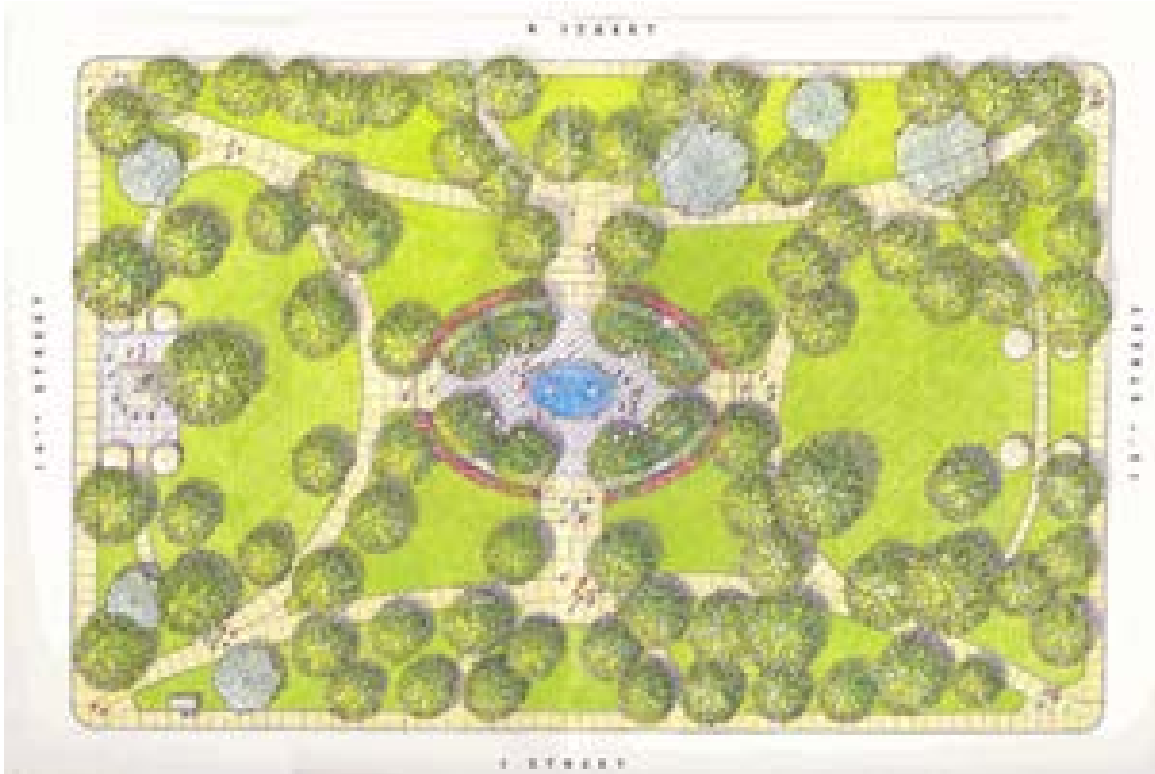
Site Plan

This plan, prepared by the Downtown Business Improvement District in 2003, depicts the conditions existing in Franklin Park in 2005, except for the flower beds around the plaza, which have not been installed. ("Downtown BID franklin park plan 200")

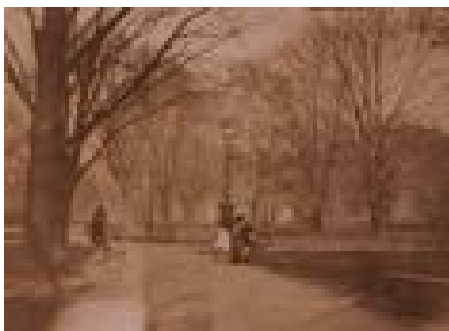
Photo from 1907, showing benches, walks, Bishop's Crook electric light, and combination gas light/drinking fountain. (CLP digital photofile "MS/CLI/history/1907 Fawcett"; print in Wash. Div. MLK #7833)

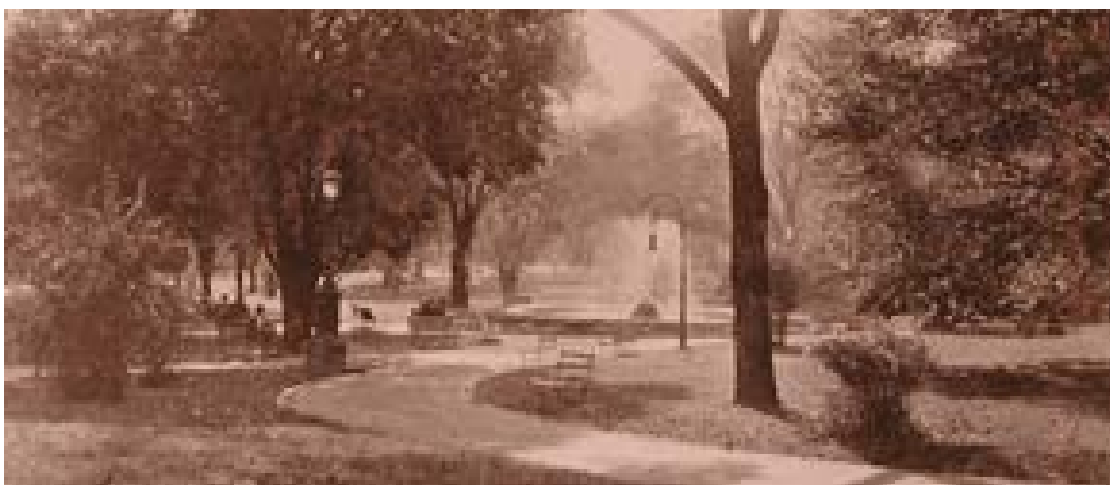
This 1907 view looks west towards the original fountain. Note again the two types of lights as well as the variety of benches and shrubs. (CLP digital photofile "MS/CLI/history/Jan. 1907," from MLK Wash. Div. #8053)

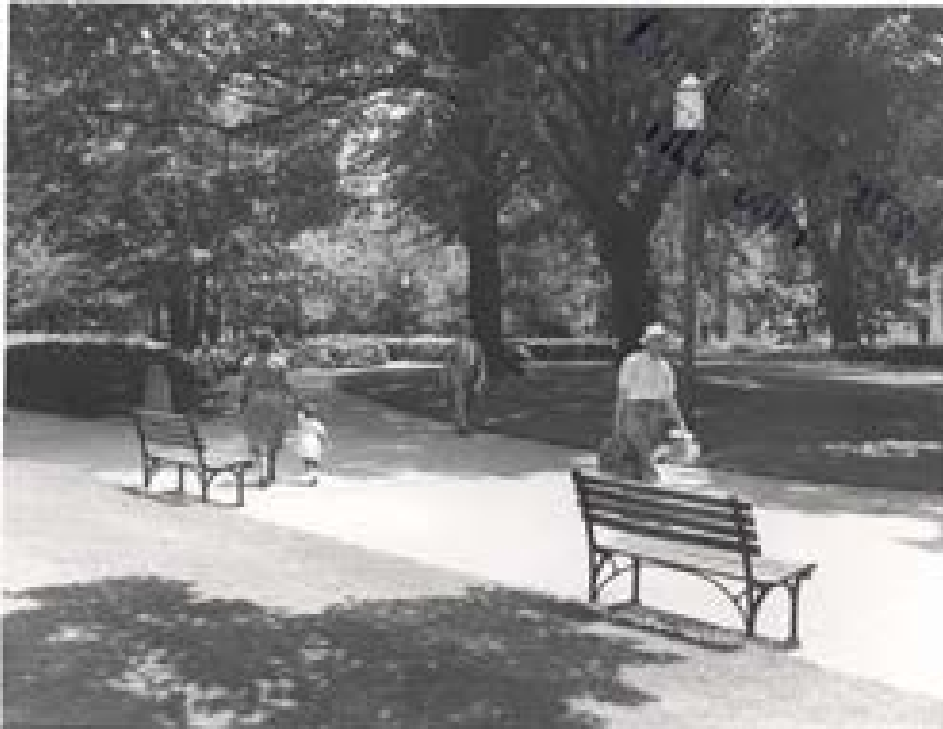
This scene from the 1950s shows only a couple of elements that are missing today, notably the hedges and the concrete drinking fountain. (MRCE, A. Rowe, 16.19, 1988-A, June 10, 1953)

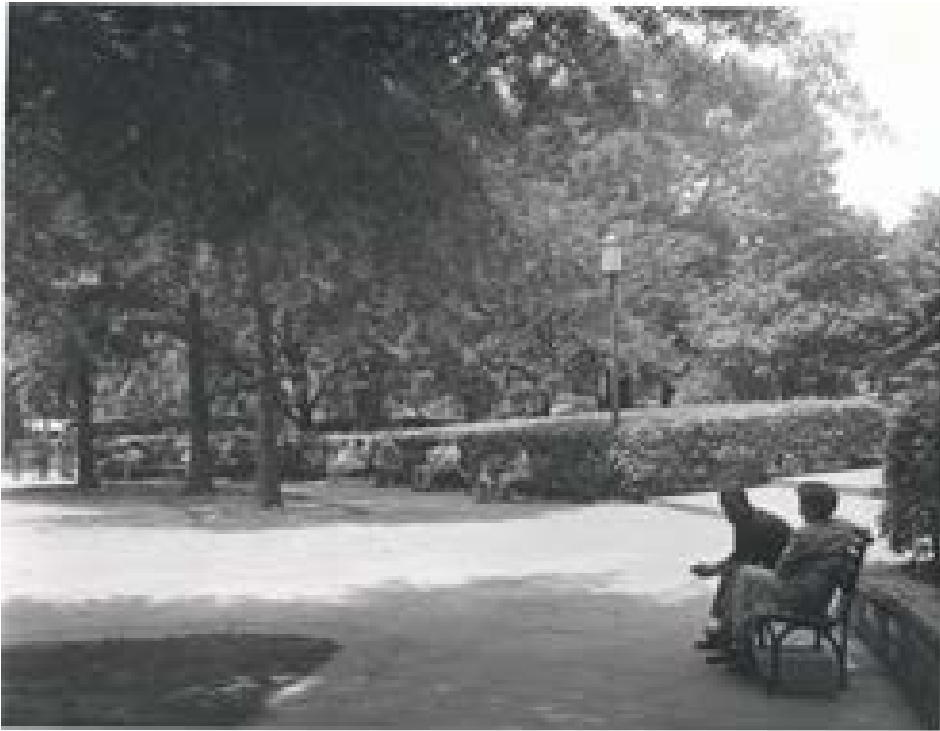
The hornbeam hedges created a dense wall around the plaza, defining it as a distinct space. (MRCE, A. Rowe, 1988-C, June 10, 1953)

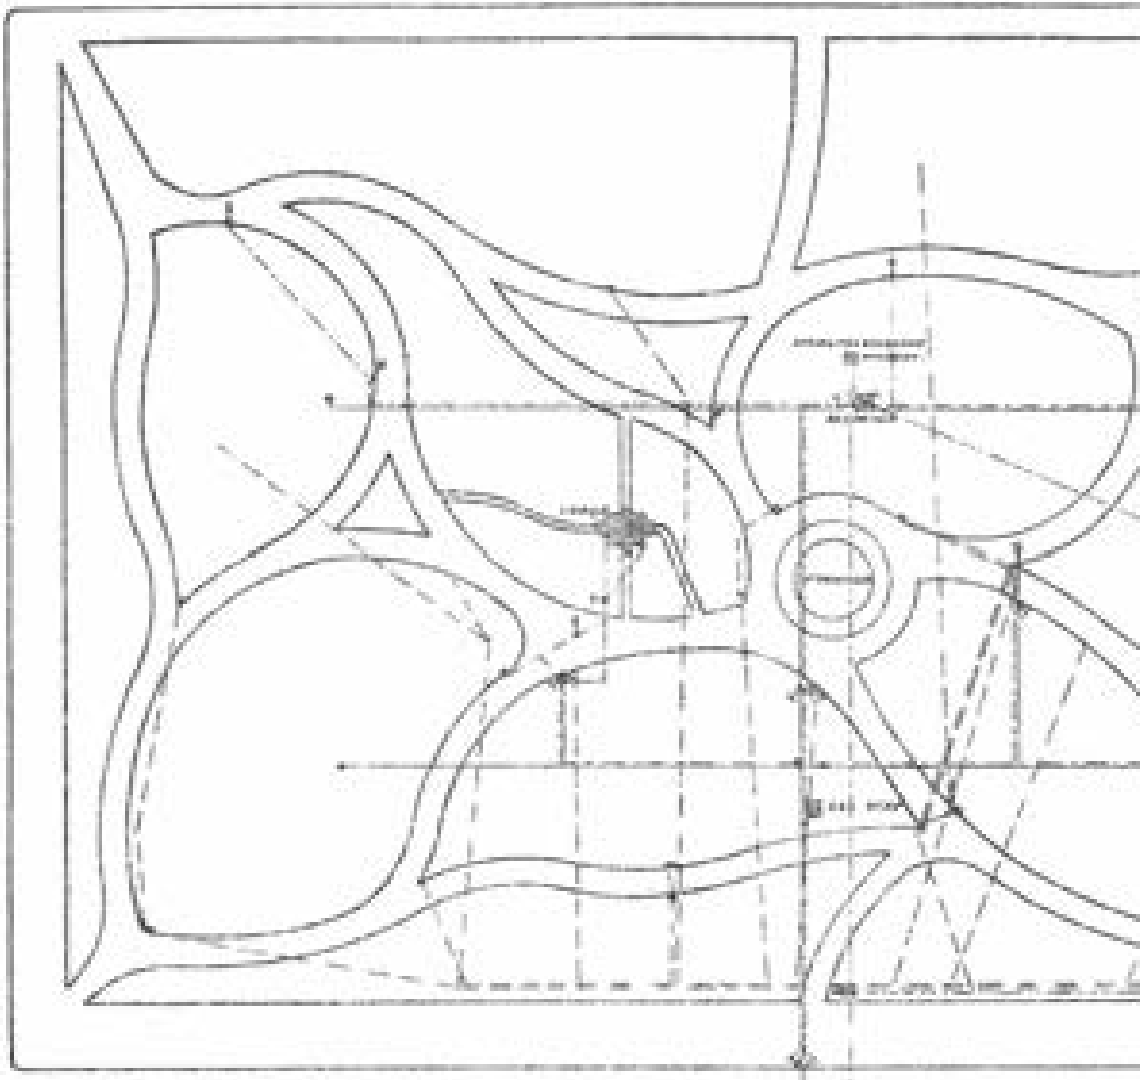
The original circulation plan of Franklin Park was curvilinear and irregular. On this 1886 plan, the spring(s) and its reservoir appear in the upper center. (CLP digital photo, "1886 plan showing spring, cropped")

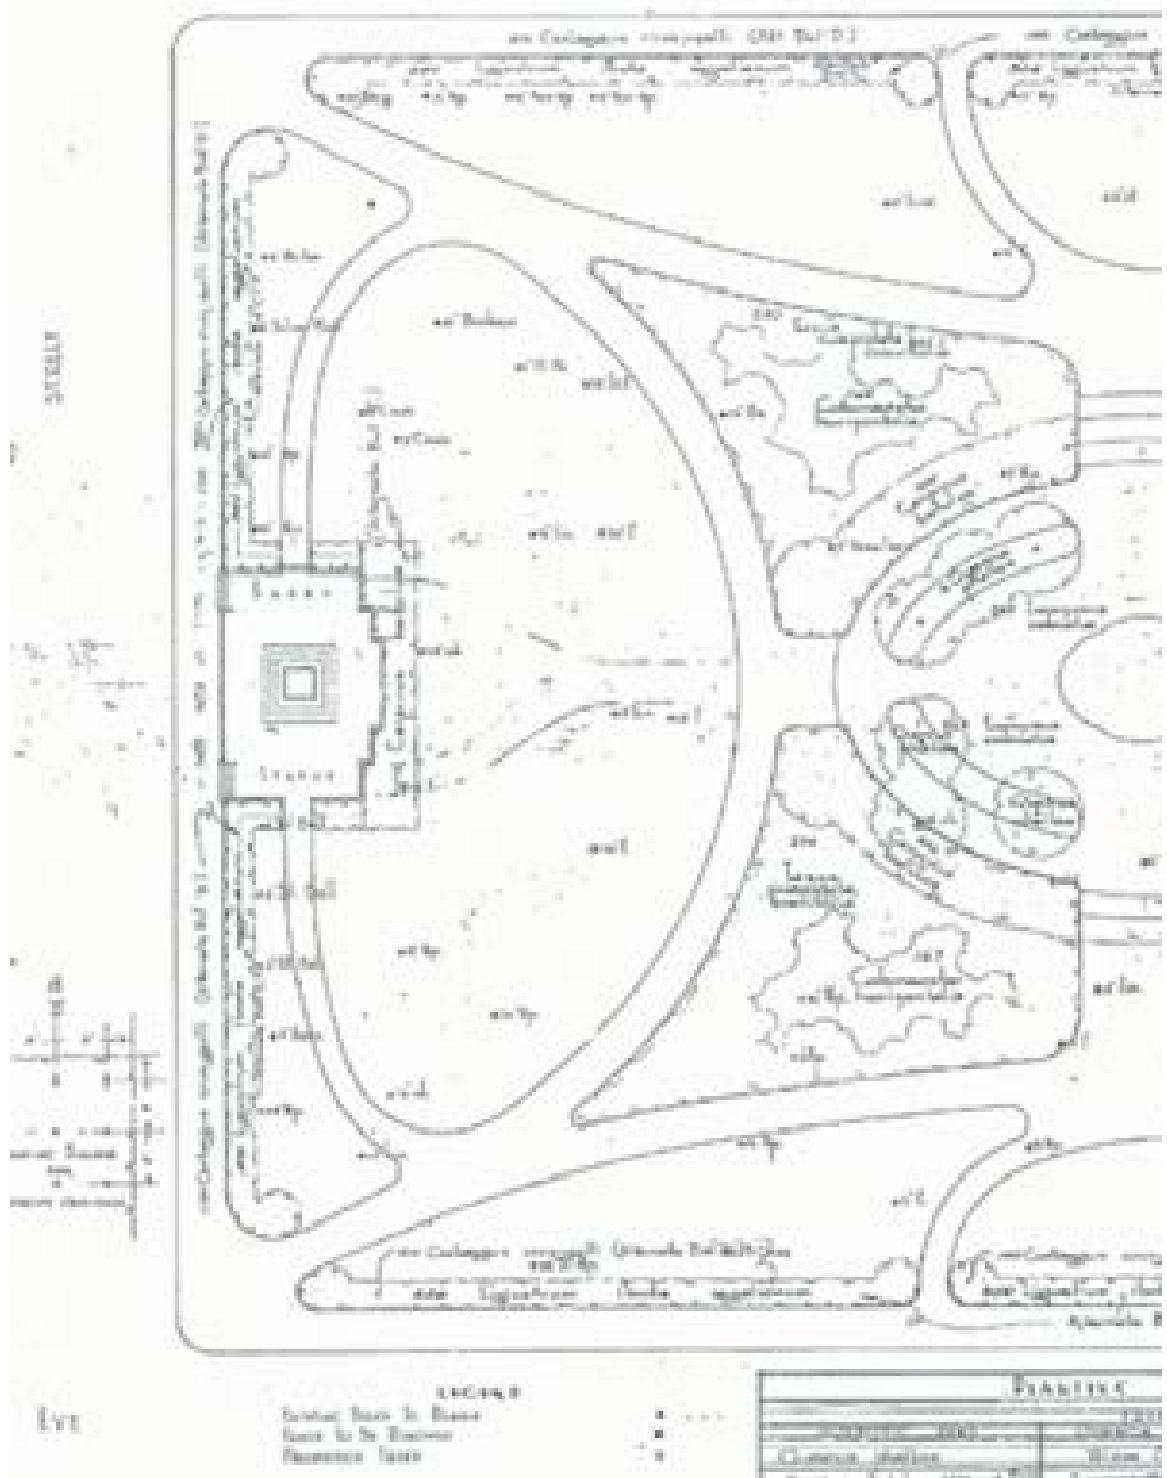
The existing circulation system of Franklin Park was designed in 1935 and installed the following year. This plan also shows the vegetation planted at that time, which has since changed a great deal. (TIC 812_1687 Franklin 1935 plan copy)

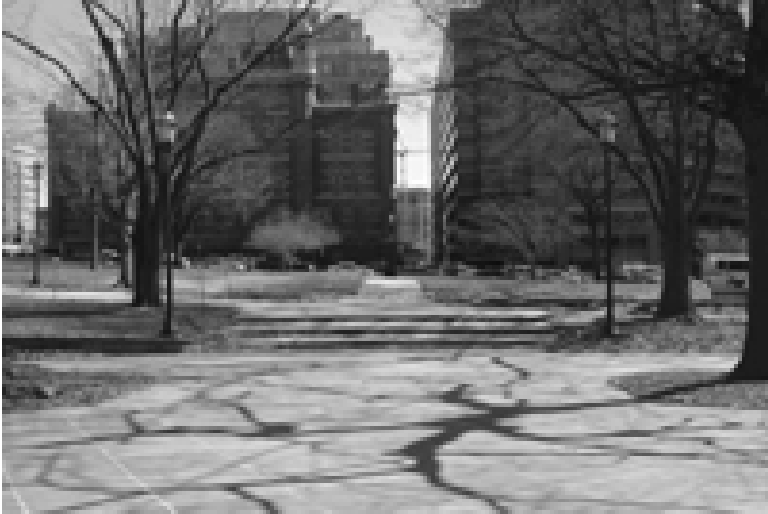
Axial views from the plaza are framed by trees and lightposts. This view looks east to the Franklin School, on the left. (March 2004; CLP digital photofile "Franklin Park/CLI/circulation/view to east")

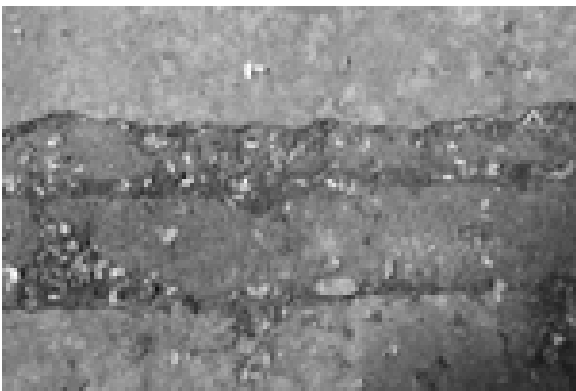
In areas on the walks where the 1976 synthetic bitumen paving has broken off, expansion joints of the 1936 asphalt paving are visible. (July 2004; CLP digital photofile "Franklin Park/CLI/circulation/pavement joint")

When they were built in 1936, the main walks were paved with a concrete base that was overlaid with a bituminous asphalt to reduce glare. Double bands of concrete were installed at the ends of pavement sections, with expansion joints between them. When the park was rehabilitated in the 1970s as part of the Bicentennial Program, the walks were overlaid with a beige-colored synthetic bitumen containing a mineral aggregate, known as "Pavebrite." As part of this project, joints were to have been scored above the original expansion joints; however, this was not done, with the result that cracks have since developed over the concrete bands and expansion joints. In the last year or two some damaged sections have been further overlaid with concrete.

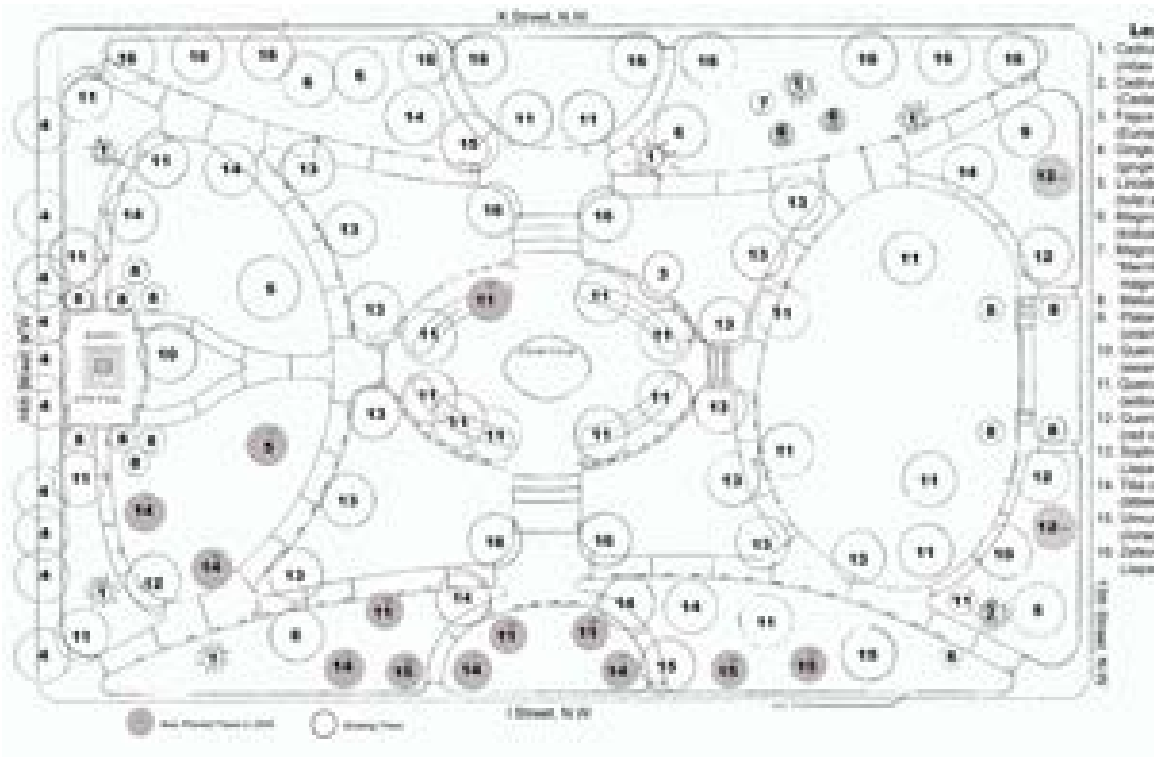
This plan of the vegetation in Franklin Park notes trees that were added in 2004. ("Veg plan July 2005 final 250")

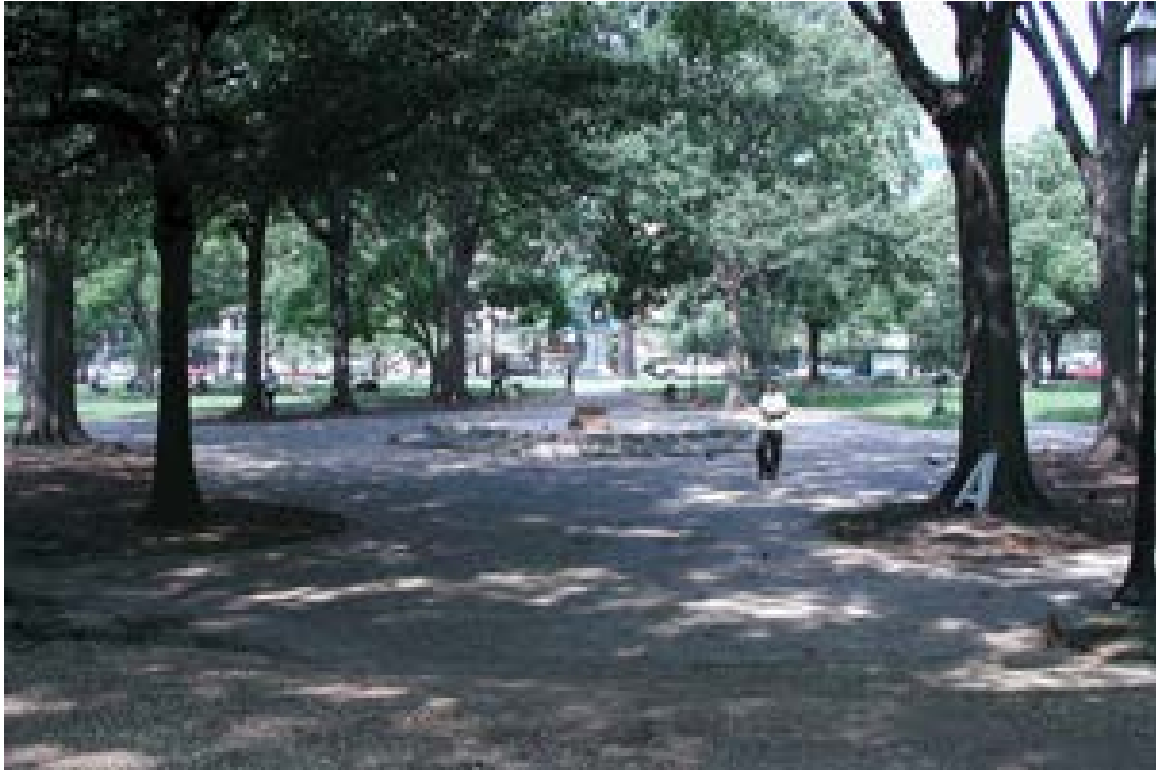
Within the central plaza, and surrounding the fountain, are four planting areas containing willow oaks, most of which date from 1936. (July 2004; CLP digital photofile "Franklin Park/CLI/vegetation/plaza looking W 2")

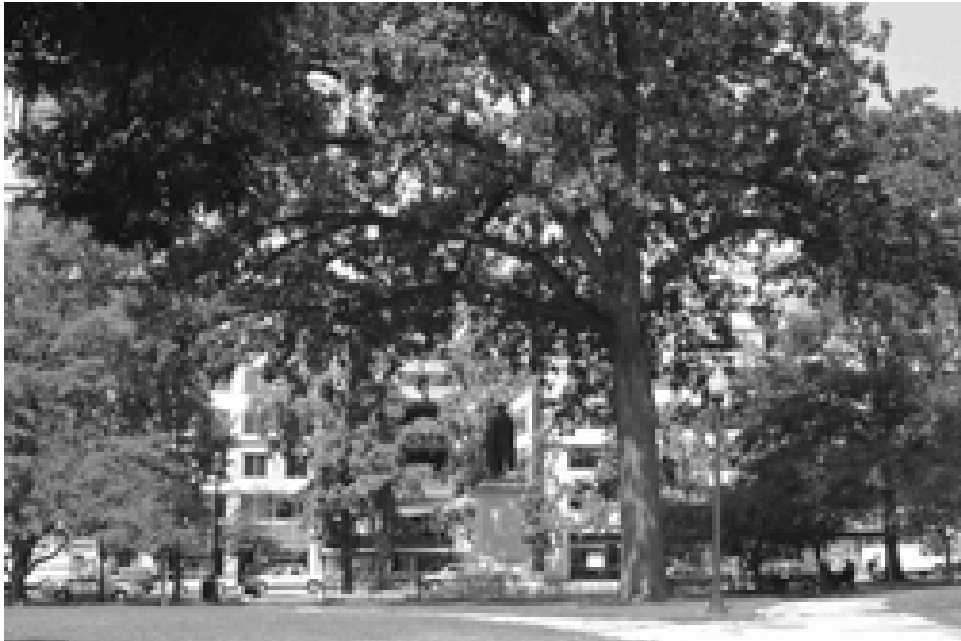
Among the many fine specimen trees in Franklin Park is this swamp white oak behind the Barry Monument. View is looking west, toward the rear of the monument. (July 2004; CLP digital photofile "Franklin Park/CLI/vegetation/oak behind Barry from SE")

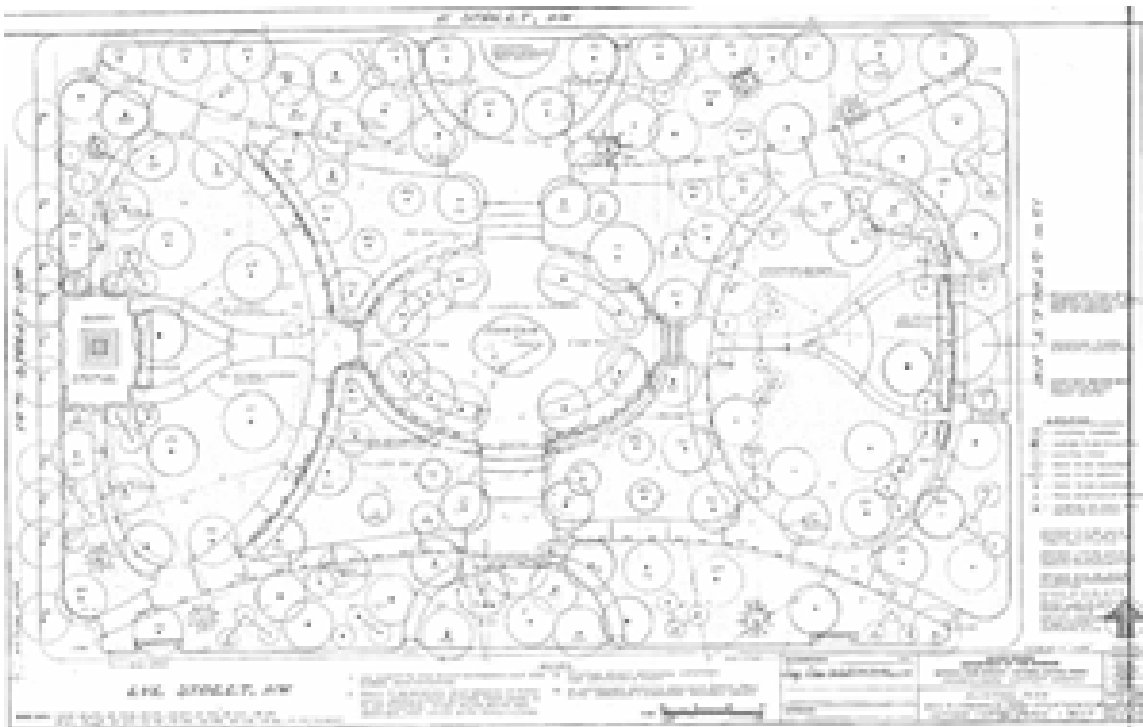
Numerous trees were added in 1974. (TIC 812_1876E; CLP digital image, "Franklin Park planting plan 1974")

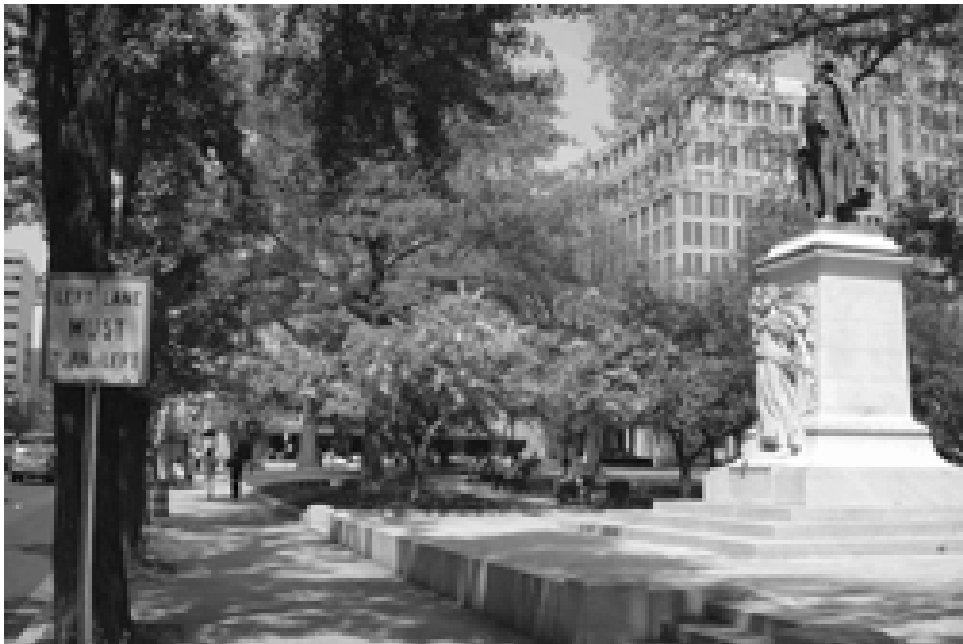
The Commodore John Barry Monument faces 14th Street from the center of a small marble plaza. An allegorical victory figure adorns its pedestal. (July 2004; CLP digital photofile "Franklin Park/CLI/B&S/Barry Mon and plaza reduced")

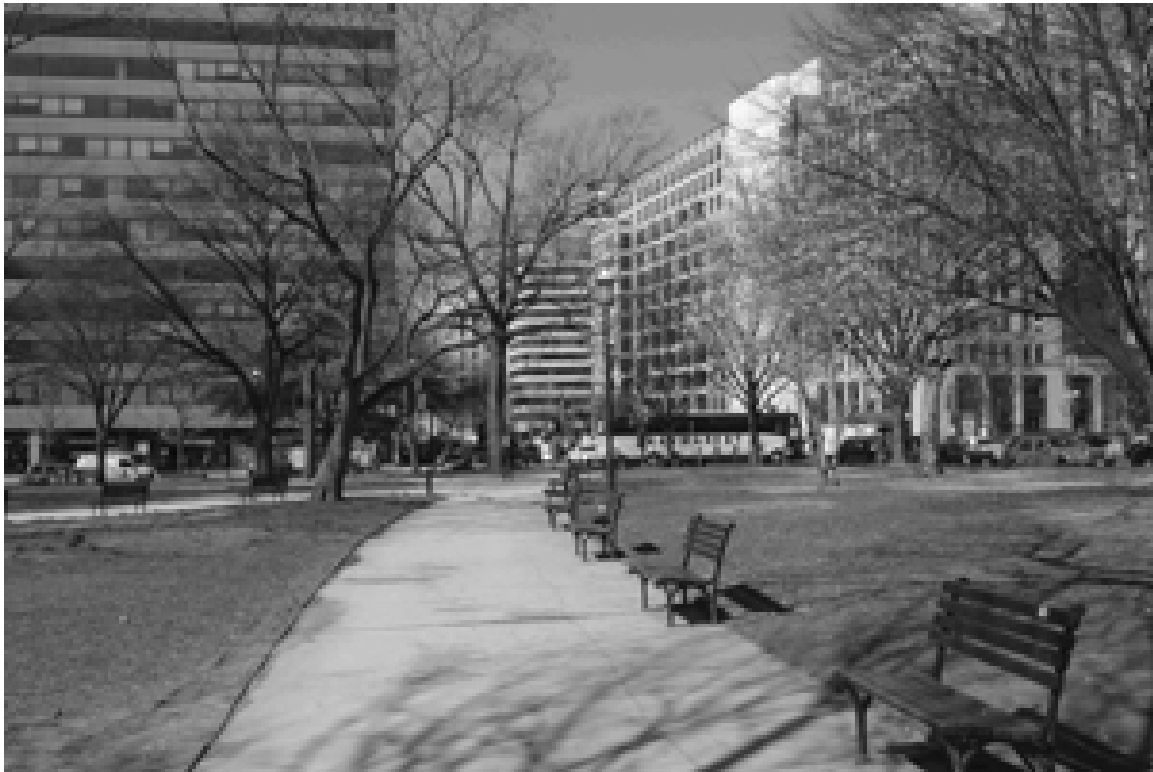
Benches and trees, including the flowering deciduous magnolias visible here, line the sweeping walks that extend the length of the park along the north and south. View looking NW. (April 2004; CLP digital photofile "Franklin Park/CLI/V&V/view to NW")

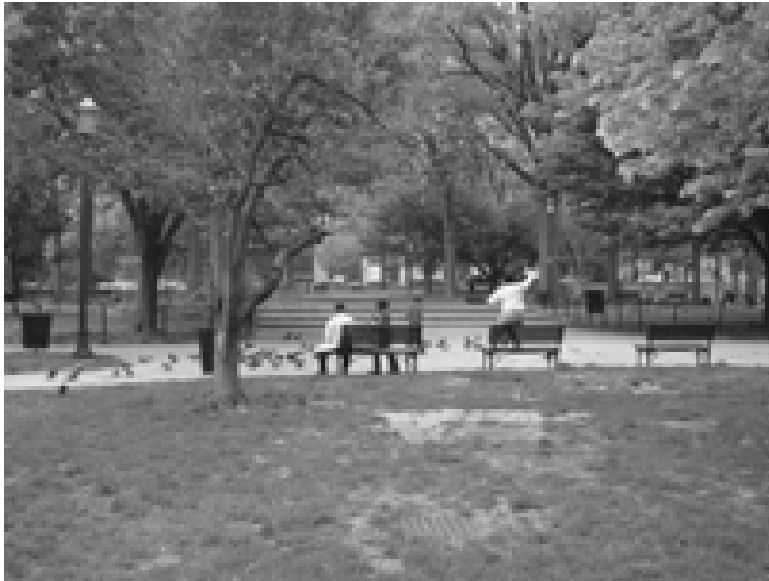
Broad walks leading to the plaza emphasize the central north-south cross axis. (CLP digital photofile "Franklin Park/photos spring 2003/DSCN4139 south axis bw 200")

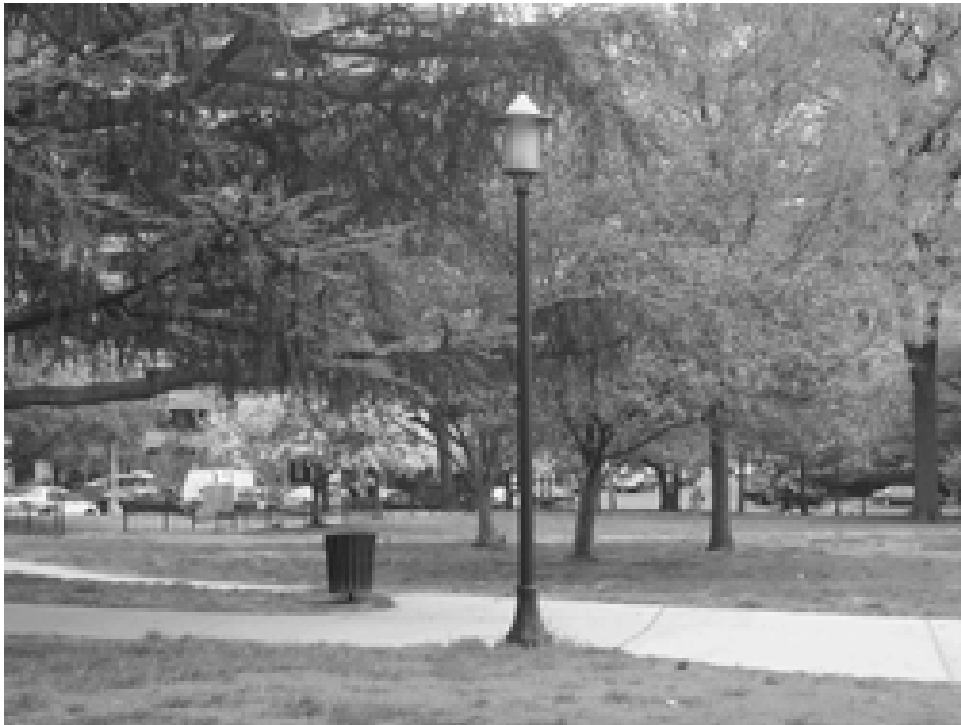
The Saratoga lightposts, installed in the early 1990s, reproduce the park's historic lighting from the 1936. (April 2004; CLP digital photofile "Franklin Park/CLI/SSF/Saratoga light post and crabapples")

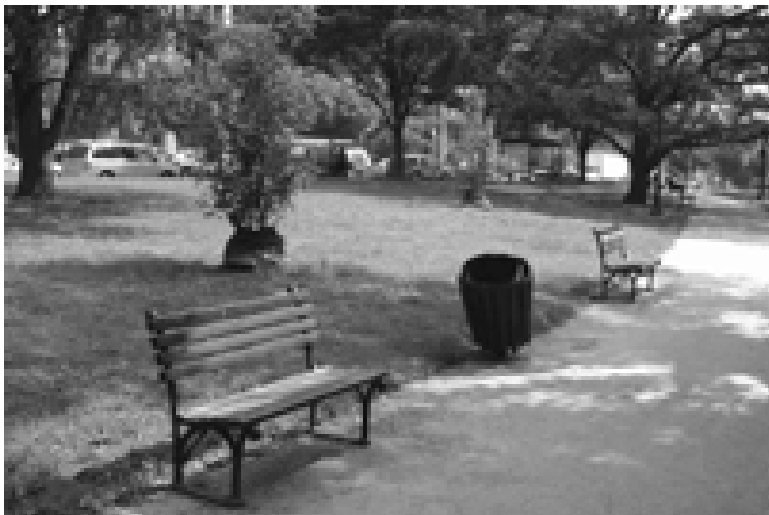
This bench style, from 1936 rehabilitation, is still used in the park. Tulip-style trash receptacles (1960s) are in poor condition. The two Kobus magnolias were planted in 2004. (July 2004; CLP dig. photo "Franklin Park/CLI/SSF/benches can and new mags")

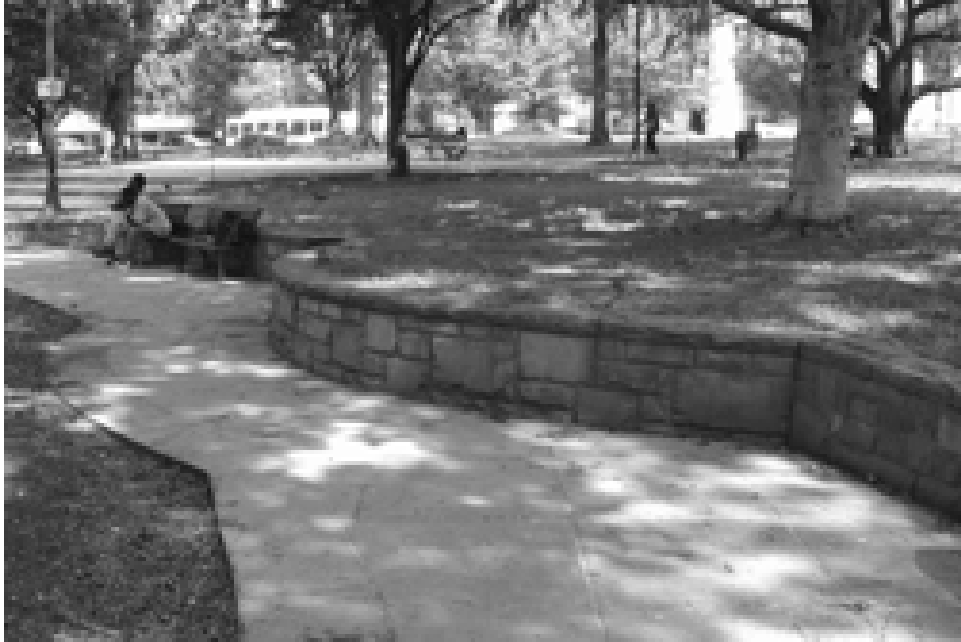
This rough-faced ashlar stone retaining wall extends along the plaza's northeast quadrant and incorporates a rounded projection, allowing for tree roots. (July 2004; CLP digital photofile "Franklin Park/CLI/SSF/stone wall looking W")

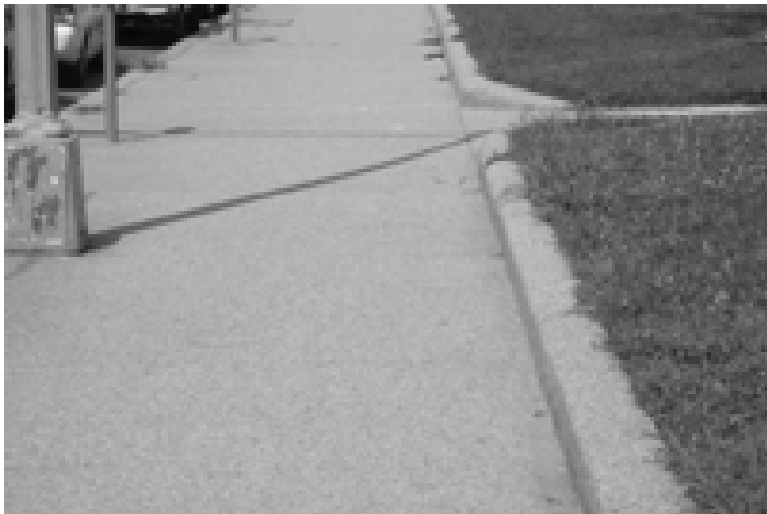
Recent (1990) replacement of the historic curbing surrounding the park's grass panels failed to maintain the historic quarter-round profile and does not terminate in corner posts. (July 2004; CLP digital photofile "Franklin Park/CLI/SSF/curbs 1")

The park has a limited number of standard small-scale features developed for use in the National Capital Parks during the early twentieth century. The concrete quarter-round curbing surrounding the outside edges of the grass panels was originally installed in 1904/1905; current curbs are replacements installed in the early 1990s by the District of Columbia in conjunction with perimeter sidewalks, and

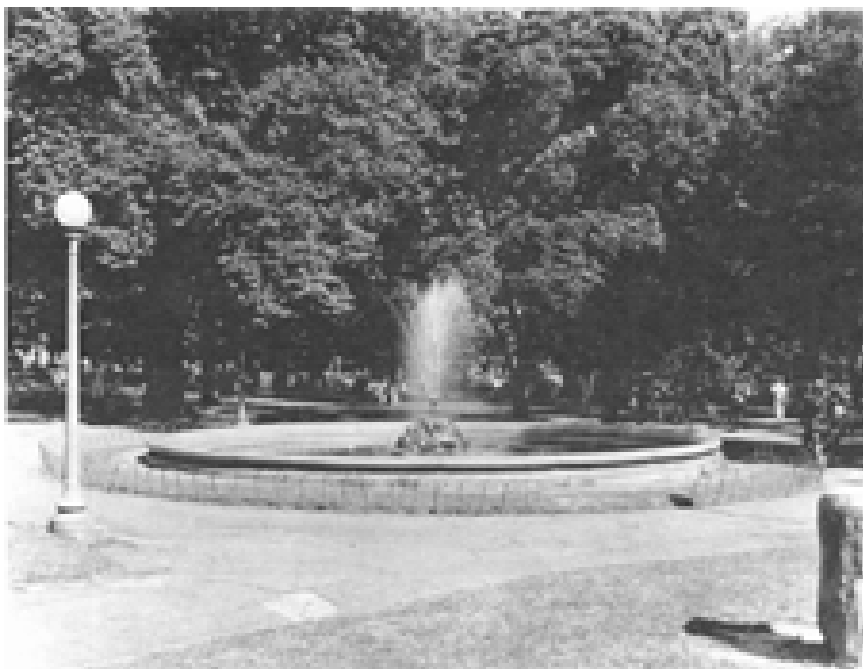
Franklin Park's first fountain was installed in 1873; it had a coping of imported Scottish granite and a central pile of rocks. At left is typical D.C. electric arc lamp. (CLP digital photofile "Franklin Park/CLI/water feature/historic fountain in 1930")

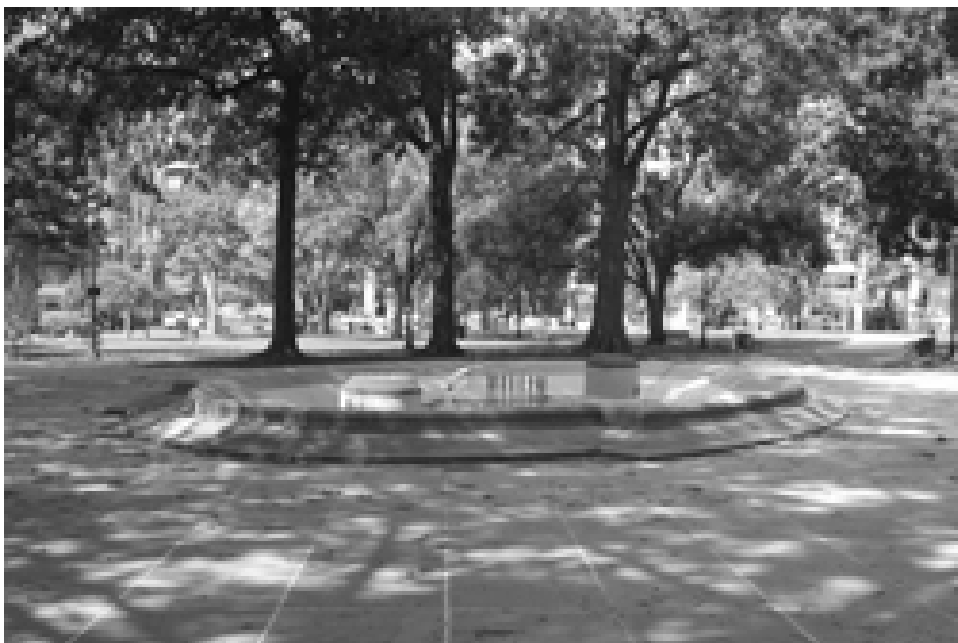
The current fountain, from 1936, is more carefully integrated into the park's design than the original. The center fountain jets were added in 1988. (July 2004; CLP digital photofile "Franklin Park/CLI/water feature/fountain looking W")

The focal point of Franklin Park is the elliptical, flagstone-paved plaza in the center. In turn, the central feature of this plaza is a large, elliptical fountain surrounded with a broad, simply molded sandstone coping. The fountain has two "French" jets, installed in the 1930s, and a central jet that was a later addition. (It is not known what is meant by "French jet," a term used in historic documents on the park.) Two of the three jets are operating under city water pressure. A motor replacement, sponsored by the Golden Triangle Business Improvement District (BID), is underway to make the fountain fully operational. Four curvilinear planting areas are evenly spaced within the plaza around the fountain. These beds originally had three willow oak trees; now only one bed has three. (The park intends for there ultimately to be two willow oak trees in each bed.) These willow oaks create a visual boundary defining the plaza as a distinct space (dense hornbeam hedges were originally installed in 1936 along the
